Profile/Photo Observation Report

Date:	10/17/2021	Weather:		Coding:	PACP 6.0
Pipe Length (ft):		Owner:	Hobart, IN	Pre Clean:	Not Known
P.O.#:	855_1	Surveyor:	M. Pielacha	PSR:	P-105-005-006
Customer:	Hobart, IN	Clean Date:		Shape:	C

Street:	Off 49th Avenue	Flow Control:	
City:	Hobart, IN	Year Renewed:	
Location:	Easement/Right of Way	Tape/Media #:	855
Purpose:	Routine Assessment	Dia/Height:	12"
Use:	Sanitary	Material:	VCP
Drain Area:		Lining:	
Category:	NA		
Comment:

Location Details:		Direction of Survey:	Downstream
US MH:	M-105-5	DS MH:	M-105-6
		Total Length Surveyed (ft):	10.6

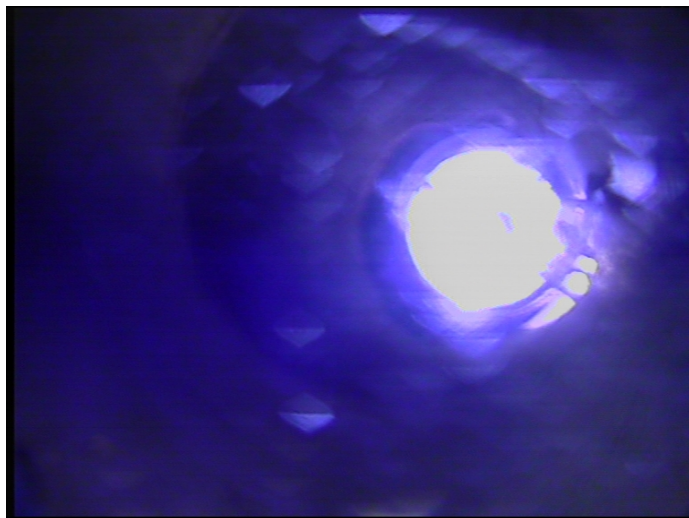
Code: **AMH**
Description: **Manhole**

Distance (ft): **.0**
Structural Grade: **0**
O&M Grade: **0**
Clock Start/From:
Clock To:
1st Value:
2nd Value:
Value Percent:
Continuous Index:
Within 8" of Joint: **NO**
Remarks: **M-105-5**

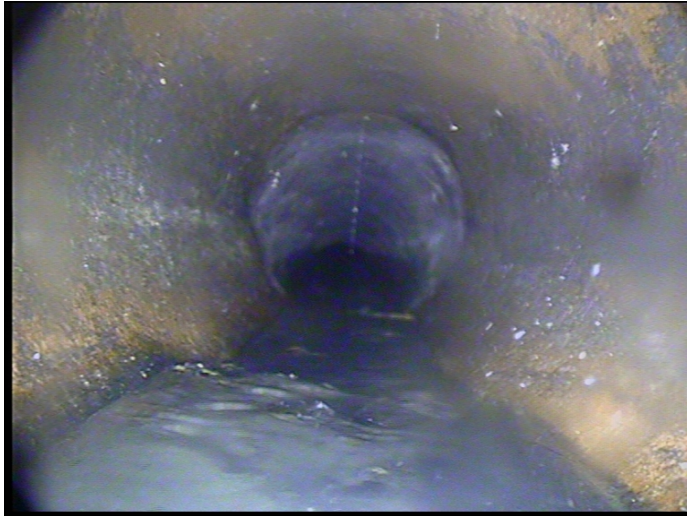
Code:	MWL
Description:	Water Level
Distance (ft):	.0
Structural Grade:	0
O&M Grade:	0
Clock Start/From:	
Clock To:	
1st Value:	
2nd Value:	
Value Percent:	5.000
Continuous Index:	
Within 8" of Joint:	NO
Remarks:

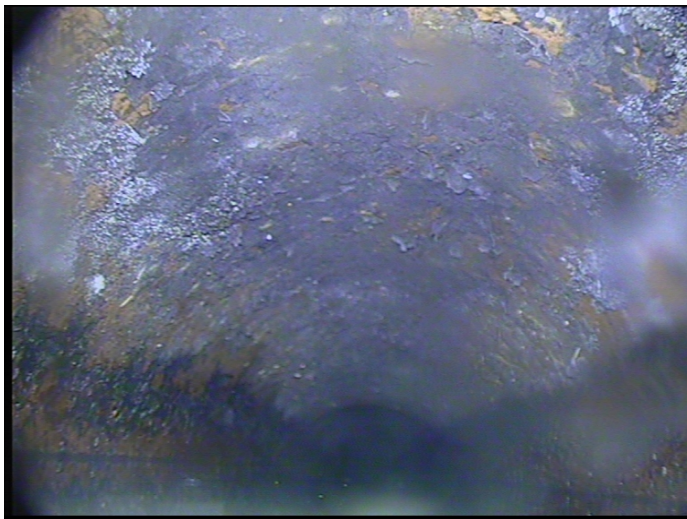
Code:	MWL
Description:	Water Level
Distance (ft):	6.6
Structural Grade:	0
O&M Grade:	0
Clock Start/From:	
Clock To:	
1st Value:	
2nd Value:	
Value Percent:	40.000
Continuous Index:	
Within 8" of Joint:	NO
Remarks:

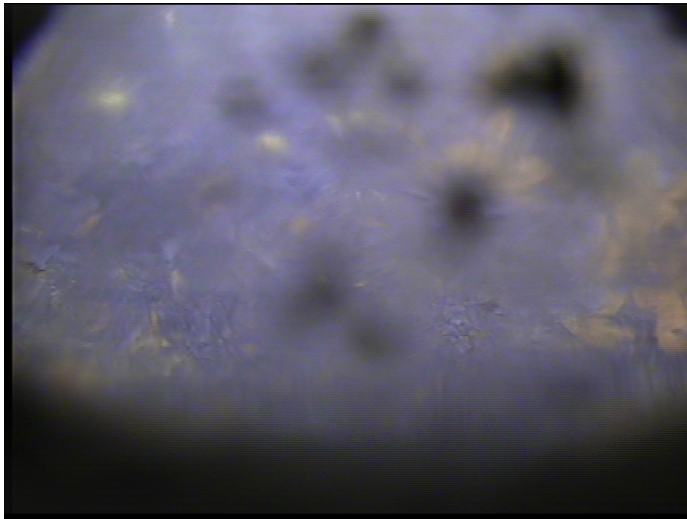
Code:	MCU
Description:	Camera Underwater
Distance (ft):	7.3
Structural Grade:	0
O&M Grade:	4
Clock Start/From:	
Clock To:	
1st Value:	
2nd Value:	
Value Percent:	
Continuous Index:	S01
Within 8" of Joint:	NO
Remarks:
