Profile/Photo Observation Report

Date:	10/17/2021	Weather:		Coding:	PACP 6.0
Pipe Length (ft):		Owner:	Hobart, IN	Pre Clean:	Not Known
P.O.#:	857_1	Surveyor:	M. Pielacha	PSR:	P-105-009-013
Customer:	Hobart, IN	Clean Date:		Shape:	C

Location Details:		Direction of Survey:	Downstream
US MH:	M-105-9	DS MH:	M-105-13
		Total Length Surveyed (ft):	47.4

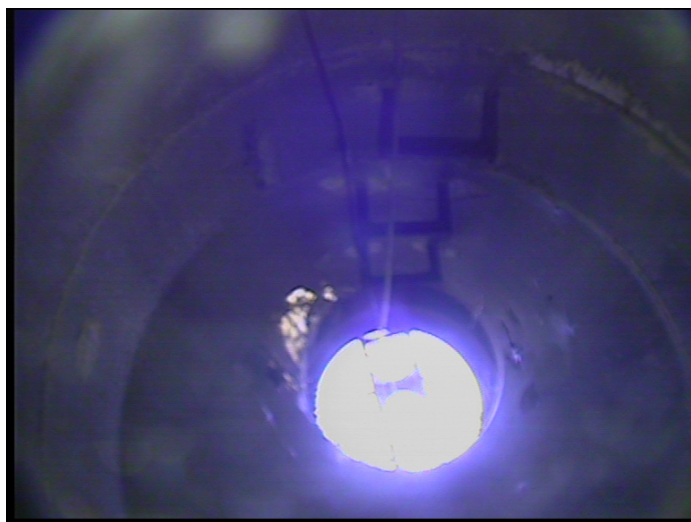
Code: **AMH**
Description: **Manhole**

Distance (ft): **.0**
Structural Grade: **0**
O&M Grade: **0**
Clock Start/From:
Clock To:
1st Value:
2nd Value:
Value Percent:
Continuous Index:
Within 8" of Joint: **NO**
Remarks: **M-105-9**

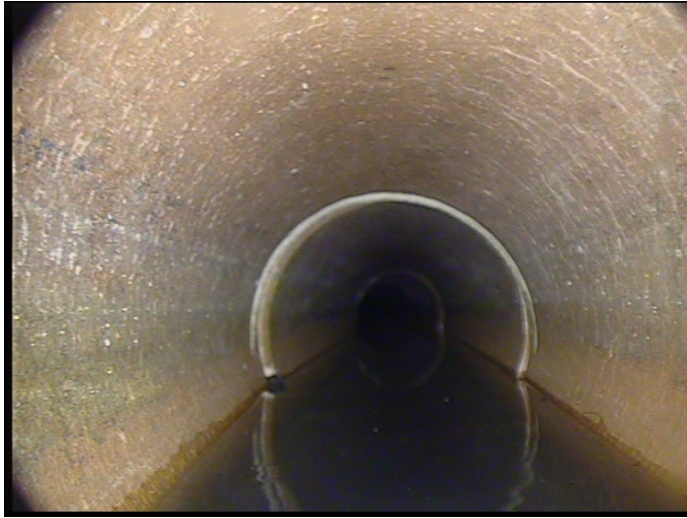
Code:	MWL
Description:	Water Level
Distance (ft):	.0
Structural Grade:	0
O&M Grade:	0
Clock Start/From:	
Clock To:	
1st Value:	
2nd Value:	
Value Percent:	10.000
Continuous Index:	
Within 8" of Joint:	NO
Remarks:

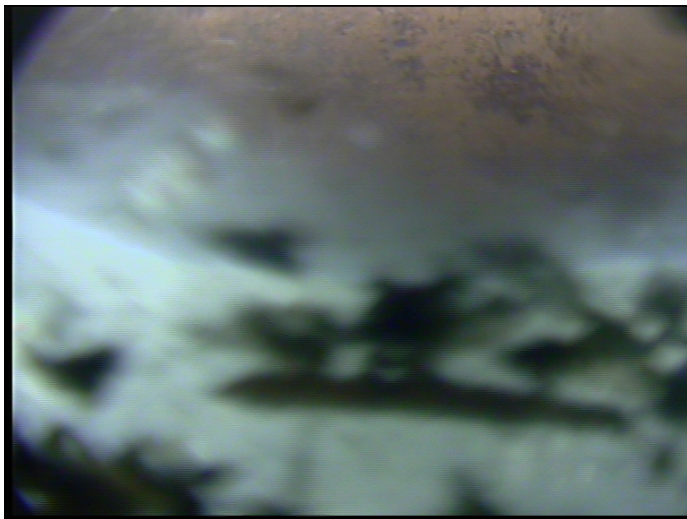
Code:	MWL
Description:	Water Level
Distance (ft):	20.7
Structural Grade:	0
O&M Grade:	0
Clock Start/From:	
Clock To:	
1st Value:	
2nd Value:	
Value Percent:	60.000
Continuous Index:	
Within 8" of Joint:	NO
Remarks:

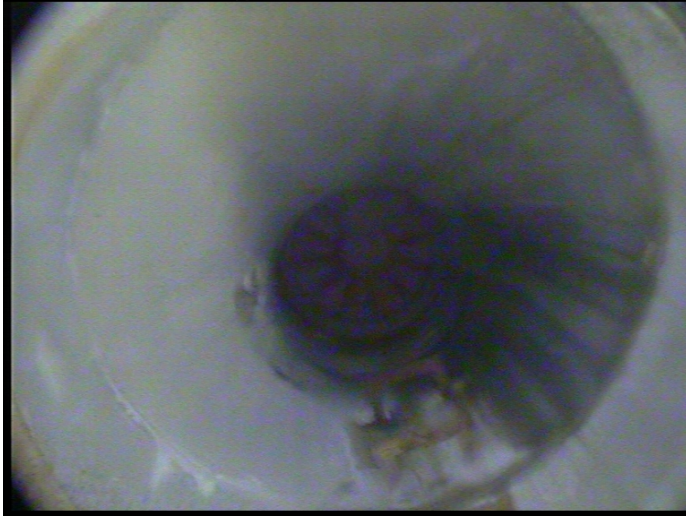
Code:	AMH
Description:	Manhole
Distance (ft):	47.4
Structural Grade:	0
O&M Grade:	0
Clock Start/From:	
Clock To:	
1st Value:	
2nd Value:	
Value Percent:	
Continuous Index:	
Within 8" of Joint:	NO
Remarks:	M-105-13
