Profile/Photo Observation Report

Date:	10/17/2021	Weather:		Coding:	PACP 6.0
Pipe Length (ft):		Owner:	Hobart, IN	Pre Clean:	Not Known
P.O.#:	860_1	Surveyor:	M. Pielacha	PSR:	P-105-011-012
Customer:	Hobart, IN	Clean Date:		Shape:	C

Location Details:		Direction of Survey:	Upstream
US MH:	M-105-12	DS MH:	M-105-11
		Total Length Surveyed (ft):	245.4

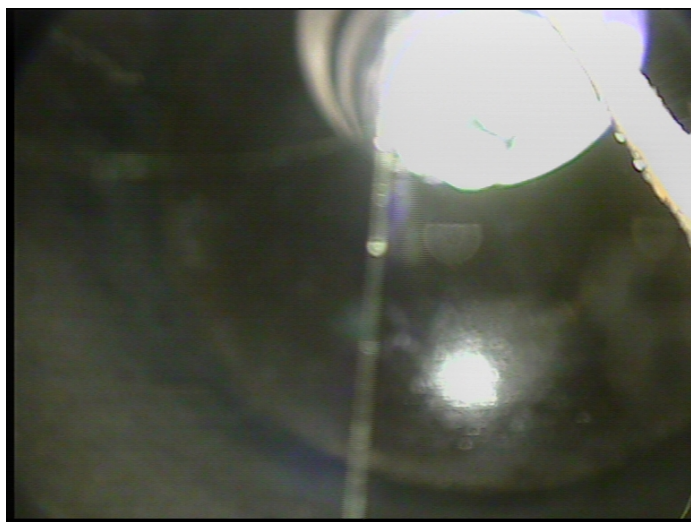
Code: **AMH**
 Description: **Manhole**

Distance (ft): **.0**
 Structural Grade: **0**
 O&M Grade: **0**
 Clock Start/From:
 Clock To:
 1st Value:
 2nd Value:
 Value Percent:
 Continuous Index:
 Within 8" of Joint: **NO**
 Remarks: **M-105-11**

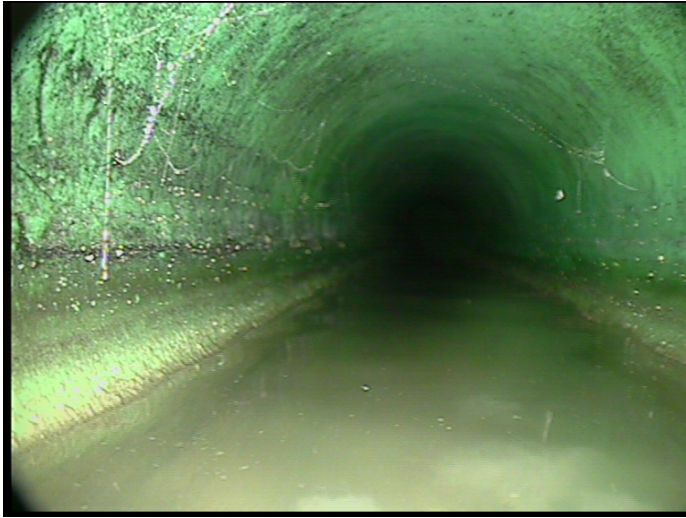
Code: **MWL**
Description: **Water Level**

Distance (ft): **.0**
Structural Grade: **0**
O&M Grade: **0**
Clock Start/From:
Clock To:
1st Value:
2nd Value:
Value Percent: **10.000**
Continuous Index:
Within 8" of Joint: **NO**
Remarks:

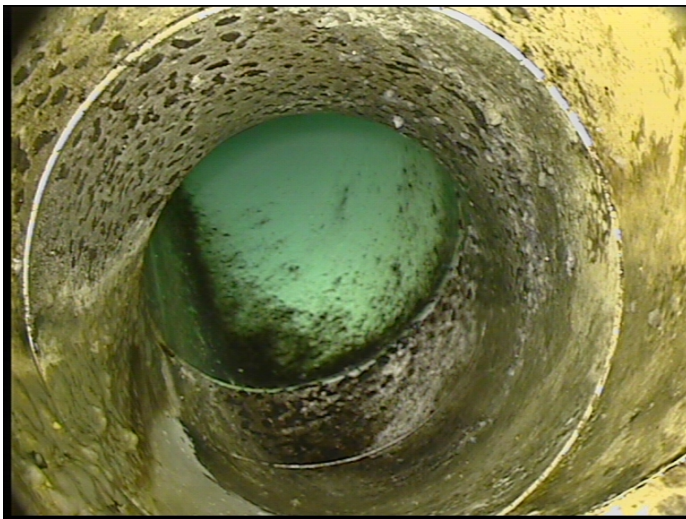
Code: **TF**
Description: **Tap Factory**

Distance (ft): **69.4**
Structural Grade: **0**
O&M Grade: **0**
Clock Start/From: **10**
Clock To:
1st Value: **4.000**
2nd Value:
Value Percent:
Continuous Index:
Within 8" of Joint: **NO**
Remarks:

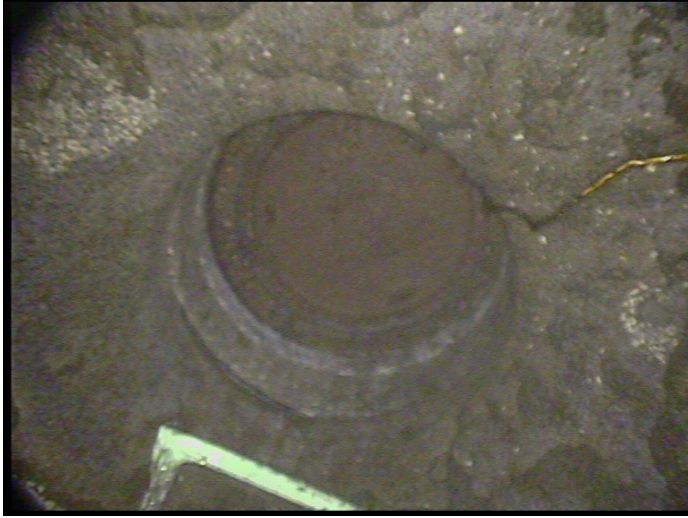
Code:	AMH
Description:	Manhole
Distance (ft):	245.4
Structural Grade:	0
O&M Grade:	0
Clock Start/From:	
Clock To:	
1st Value:	
2nd Value:	
Value Percent:	
Continuous Index:	
Within 8" of Joint:	NO
Remarks:	M-105-12
