## Profile/Photo Observation Report

Street:	<b>49th Avenue</b>	Flow Control:	
City:	<b>Hobart, IN</b>	Year Renewed:	
Location:	<b>Light Highway</b>	Tape/Media #:	<b>858</b>
Purpose:	<b>Routine Assessment</b>	Dia/Height:	<b>12"</b>
Use:	<b>Sanitary</b>	Material:	<b>VCP</b>
Drain Area:		Lining:	
Category:	<b>NA</b>		
Comment:

Location Details:		Direction of Survey:	<b>Downstream</b>
US MH:	<b>M-105-13</b>	DS MH:	<b>M-105-16</b>
		Total Length Surveyed (ft):	<b>113.7</b>

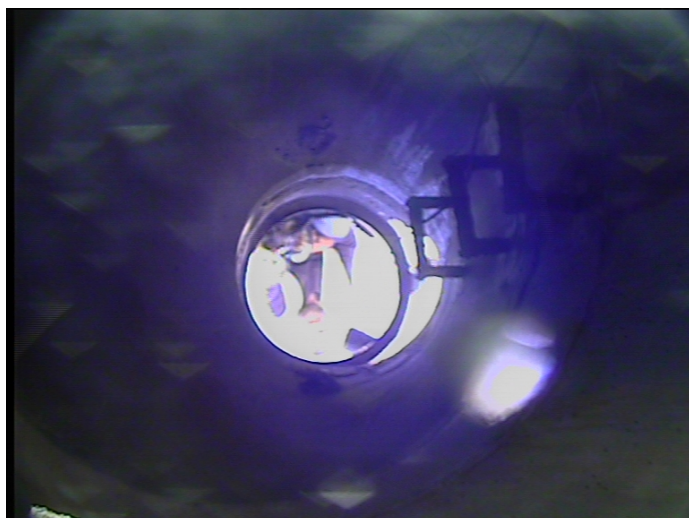
Code: **AMH**  
Description: **Manhole**

Distance (ft): **.0**  
Structural Grade: **0**  
O&M Grade: **0**  
Clock Start/From:  
Clock To:  
1st Value:  
2nd Value:  
Value Percent:  
Continuous Index:  
Within 8" of Joint: **NO**  
Remarks: **M-105-13**

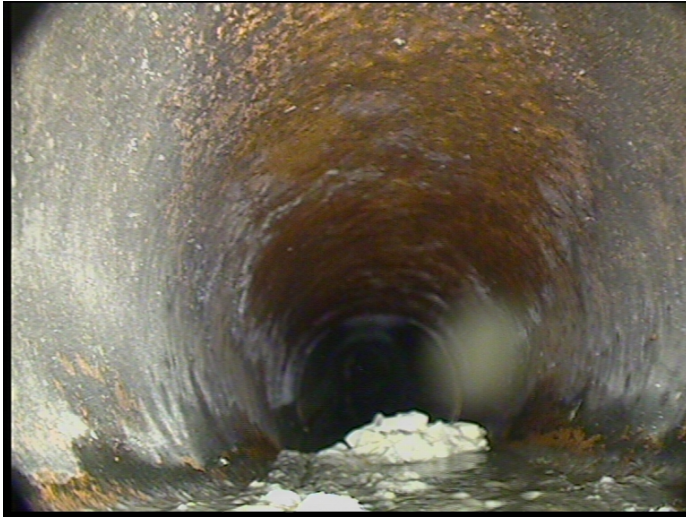
Code: **MWL**  
Description: **Water Level**

Distance (ft): **.0**  
Structural Grade: **0**  
O&M Grade: **0**  
Clock Start/From:  
Clock To:  
1st Value:  
2nd Value:  
Value Percent: **5.000**  
Continuous Index:  
Within 8" of Joint: **NO**  
Remarks:

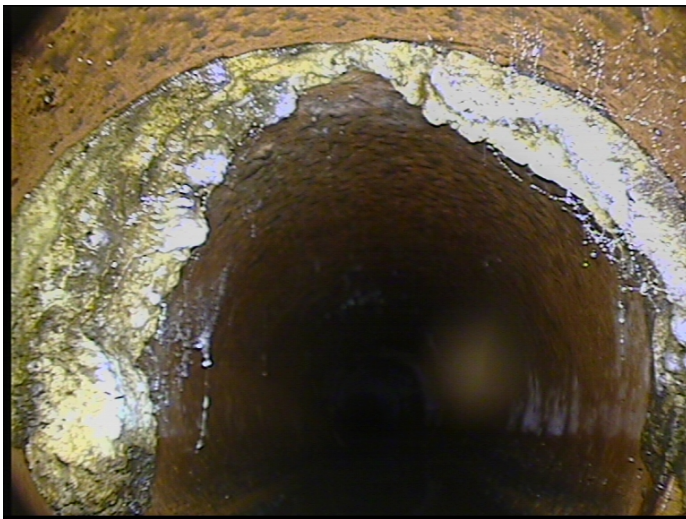
Code: **DAE**  
Description: **Deposits Attached Encrustation**

Distance (ft): **13.9**  
Structural Grade: **0**  
O&M Grade: **2**  
Clock Start/From: **7**  
Clock To: **5**  
1st Value:  
2nd Value:  
Value Percent: **5.000**  
Continuous Index:  
Within 8" of Joint: **YES**  
Remarks:

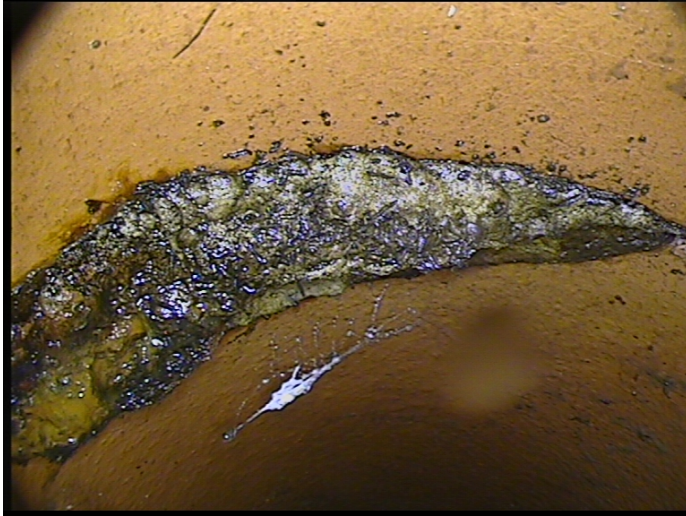
Code:	<b>DAE</b>
Description:	<b>Deposits Attached Encrustation</b>
Distance (ft):	<b>43.5</b>
Structural Grade:	<b>0</b>
O&M Grade:	<b>2</b>
Clock Start/From:	<b>7</b>
Clock To:	<b>5</b>
1st Value:	
2nd Value:	
Value Percent:	<b>5.000</b>
Continuous Index:	
Within 8" of Joint:	<b>YES</b>
Remarks:

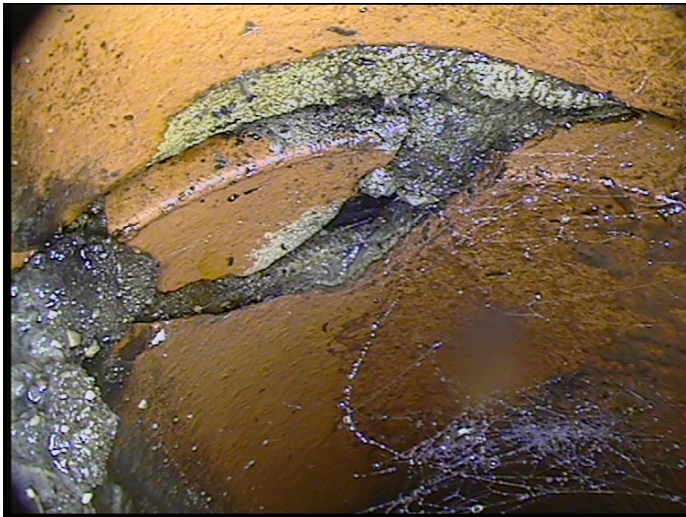
Code:	<b>BVV</b>
Description:	<b>Broken Void Visible</b>
Distance (ft):	<b>48.6</b>
Structural Grade:	<b>5</b>
O&M Grade:	<b>0</b>
Clock Start/From:	<b>7</b>
Clock To:	<b>9</b>
1st Value:	
2nd Value:	
Value Percent:	
Continuous Index:	
Within 8" of Joint:	<b>YES</b>
Remarks:

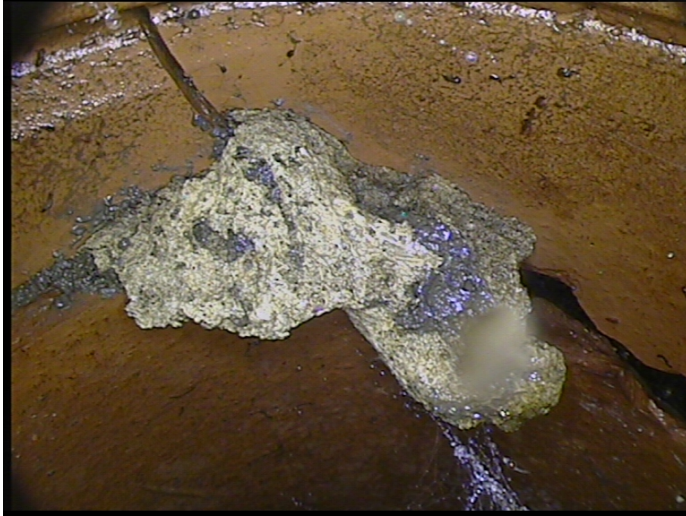
Code: **BVV**  
Description: **Broken Void Visible**

Distance (ft): **58.8**  
Structural Grade: **5**  
O&M Grade: **0**  
Clock Start/From: **9**  
Clock To: **5**  
1st Value:  
2nd Value:  
Value Percent:  
Continuous Index:  
Within 8" of Joint: **YES**  
Remarks:

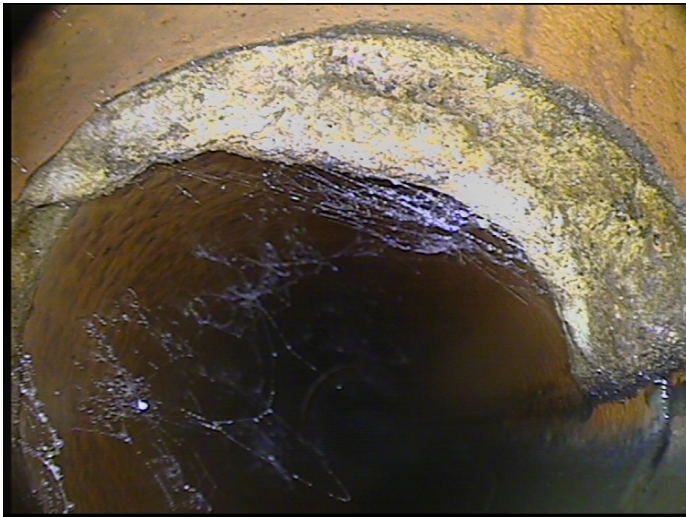
Code: **DAE**  
Description: **Deposits Attached Encrustation**

Distance (ft): **83.0**  
Structural Grade: **0**  
O&M Grade: **2**  
Clock Start/From: **1**  
Clock To: **5**  
1st Value:  
2nd Value:  
Value Percent: **5.000**  
Continuous Index:  
Within 8" of Joint: **YES**  
Remarks:

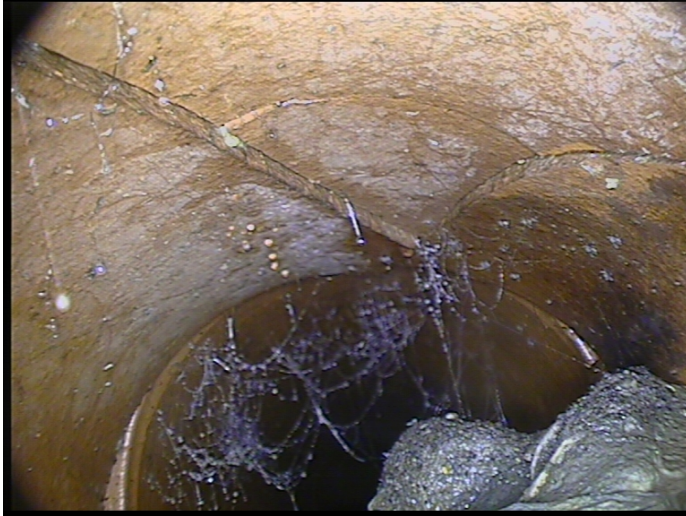
Code:	<b>FH2</b>
Description:	<b>Fracture Longitudinal Hinge, 2</b>
Distance (ft):	<b>112.8</b>
Structural Grade:	<b>4</b>
O&M Grade:	<b>0</b>
Clock Start/From:	<b>12</b>
Clock To:	<b>6</b>
1st Value:	
2nd Value:	
Value Percent:	
Continuous Index:	
Within 8" of Joint:	<b>NO</b>
Remarks:

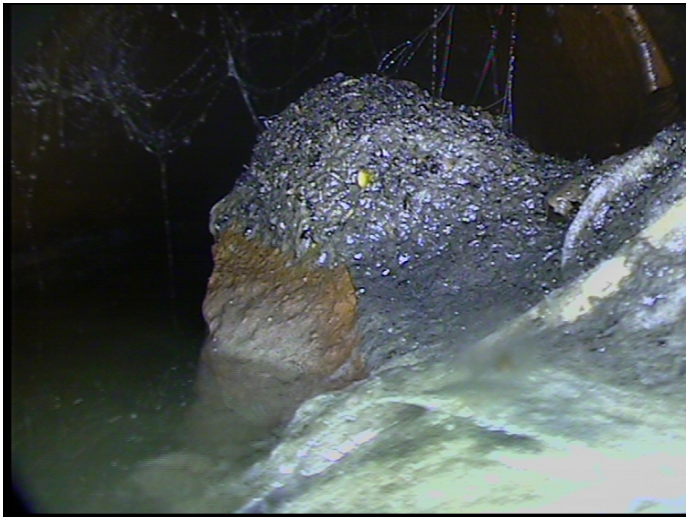
Code:	<b>OBB</b>
Description:	<b>Obstacle Brick</b>
Distance (ft):	<b>113.5</b>
Structural Grade:	<b>0</b>
O&M Grade:	<b>3</b>
Clock Start/From:	<b>4</b>
Clock To:	<b>8</b>
1st Value:	
2nd Value:	
Value Percent:	<b>20.000</b>
Continuous Index:	
Within 8" of Joint:	<b>NO</b>
Remarks:

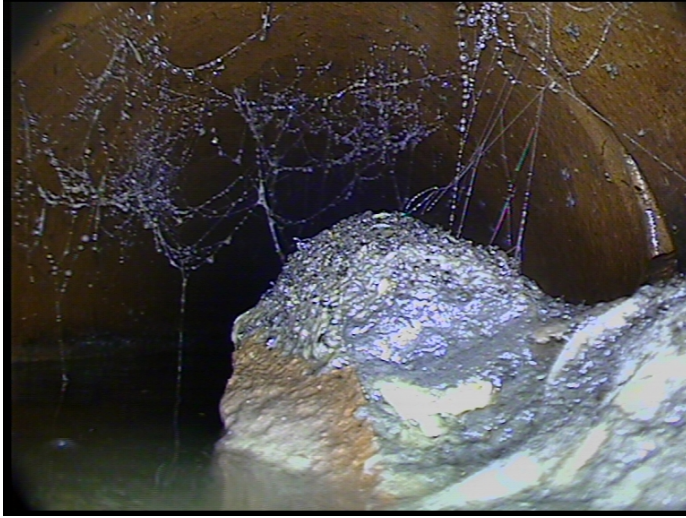
Code:	<b>MSA</b>
Description:	<b>Abandoned Survey</b>
Distance (ft):	<b>113.7</b>
Structural Grade:	<b>0</b>
O&M Grade:	<b>0</b>
Clock Start/From:	
Clock To:	
1st Value:	
2nd Value:	
Value Percent:	
Continuous Index:	
Within 8" of Joint:	<b>NO</b>
Remarks:	<b>Heavy debris</b>
