Profile/Photo Observation Report

Street:	49th Avenue	Flow Control:	
City:	Hobart, IN	Year Renewed:	
Location:	Light Highway	Tape/Media #:	861
Purpose:	Reversal	Dia/Height:	12"
Use:	Sanitary	Material:	VCP
Drain Area:		Lining:	
Category:	NA		
Comment:

Location Details:		Direction of Survey:	Upstream
US MH:	M-105-13	DS MH:	M-105-16
		Total Length Surveyed (ft):	2.5

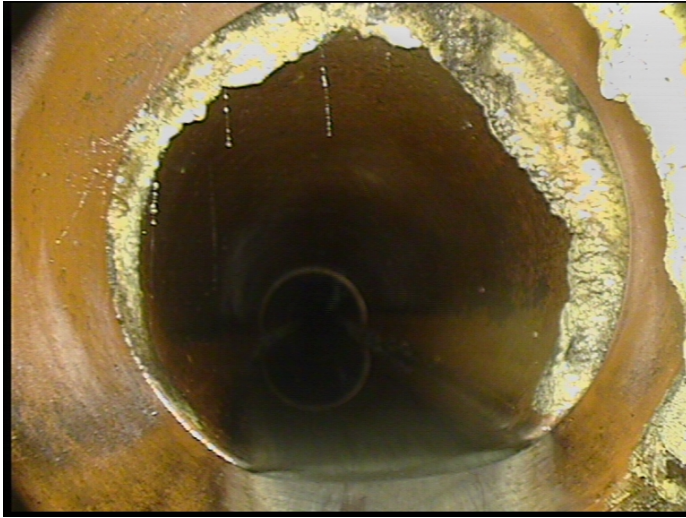
Code:	AMH
Description:	Manhole
Distance (ft):	.0
Structural Grade:	0
O&M Grade:	0
Clock Start/From:	
Clock To:	
1st Value:	
2nd Value:	
Value Percent:	
Continuous Index:	
Within 8" of Joint:	NO
Remarks:	M-105-16

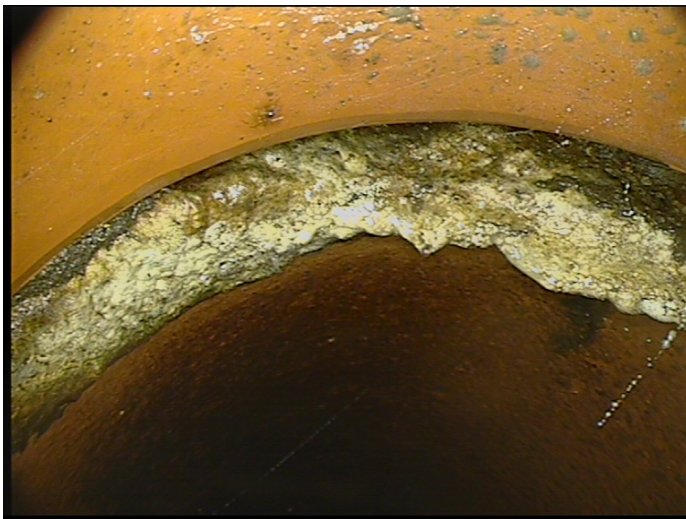
Code: **MWL**
Description: **Water Level**

Distance (ft): **.0**
Structural Grade: **0**
O&M Grade: **0**
Clock Start/From:
Clock To:
1st Value:
2nd Value:
Value Percent: **5.000**
Continuous Index:
Within 8" of Joint: **NO**
Remarks:

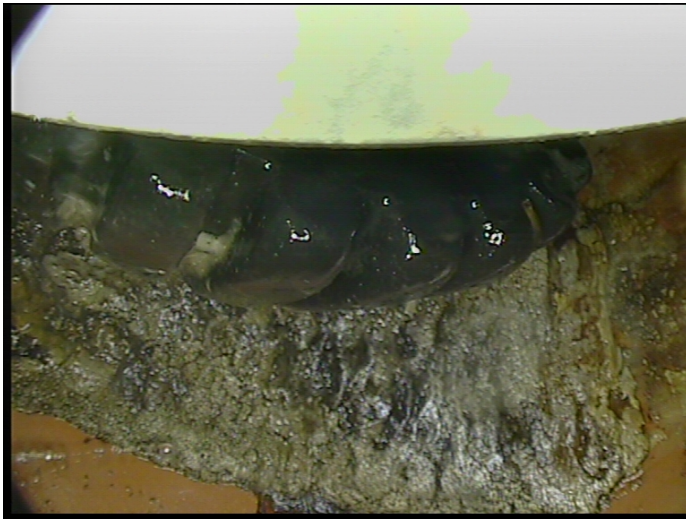
Code: **DAE**
Description: **Deposits Attached Encrustation**

Distance (ft): **1.4**
Structural Grade: **0**
O&M Grade: **2**
Clock Start/From: **7**
Clock To: **5**
1st Value:
2nd Value:
Value Percent: **5.000**
Continuous Index:
Within 8" of Joint: **YES**
Remarks:

Code:	MSA
Description:	Abandoned Survey
Distance (ft):	2.5
Structural Grade:	0
O&M Grade:	0
Clock Start/From:	
Clock To:	
1st Value:	
2nd Value:	
Value Percent:	
Continuous Index:	
Within 8" of Joint:	NO
Remarks:	wheels can not fully pass encrustation
