Profile/Photo Observation Report

Date:	04/24/2018	Weather:		Coding:	PACP 6.0
Pipe Length (ft):		Owner:	City of Hobart	Pre Clean:	No Pre-Cleaning
P.O.#:	72	Surveyor:	M. Pielacha	PSR:	P-105-015-016
Customer:	City of Hobart	Clean Date:		Shape:	C

Street:	Off Willow Street	Flow Control:	Not Controlled
City:	Hobart, IN	Year Renewed:	
Location:	Light Highway	Tape/Media #:	DEP 72
Purpose:	Routine Assessment	Dia/Height:	6"
Use:	Sanitary	Material:	VCP
Drain Area:		Lining:	
Category:	NA		
Comment:	YES501824 Submittal 2		
Location Details:		Direction of Survey:	Upstream
US MH:	M-105-015	DS MH:	M-105-016
		Total Length Surveyed (ft):	101.8

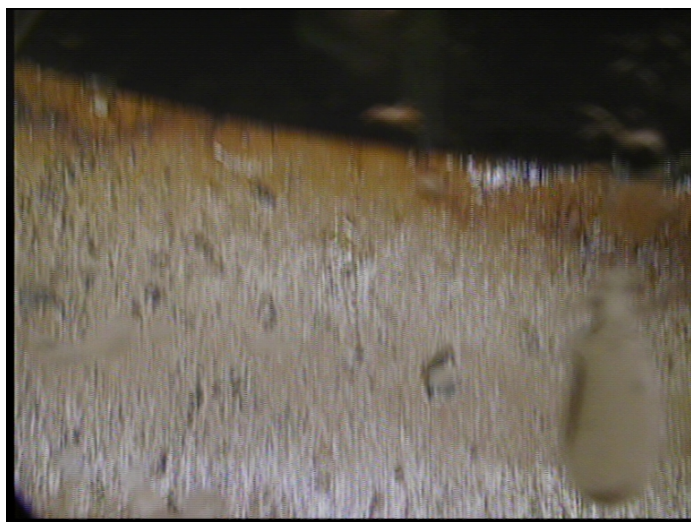
Code: **AMH**
 Description: **Manhole**

Distance (ft): **.0**
 Structural Grade: **0**
 O&M Grade: **0**
 Clock Start/From:
 Clock To:
 1st Value:
 2nd Value:
 Value Percent:
 Continuous Index:
 Within 8" of Joint: **NO**
 Remarks: **M-105-016**

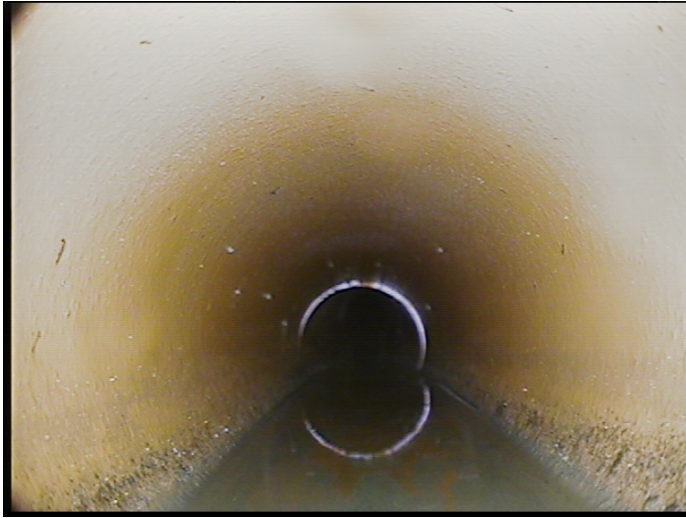
Code: **MWL**
Description: **Water Level**

Distance (ft): **.0**
Structural Grade: **0**
O&M Grade: **0**
Clock Start/From:
Clock To:
1st Value:
2nd Value:
Value Percent: **10.000**
Continuous Index:
Within 8" of Joint: **NO**
Remarks:

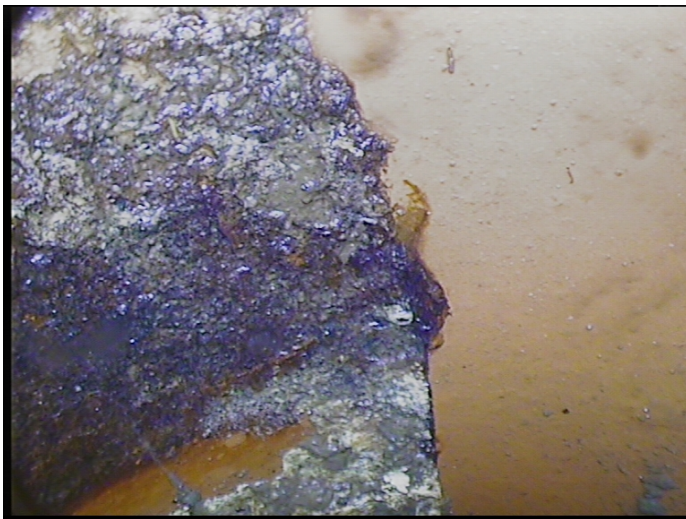
Code: **CL**
Description: **Crack Longitudinal**

Distance (ft): **12.6**
Structural Grade: **2**
O&M Grade: **0**
Clock Start/From: **10**
Clock To:
1st Value:
2nd Value:
Value Percent:
Continuous Index:
Within 8" of Joint: **YES**
Remarks:

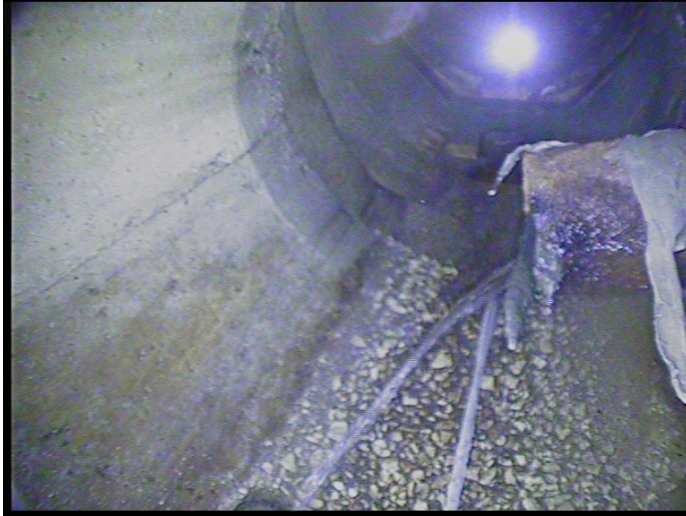
Code:	AMH
Description:	Manhole
Distance (ft):	101.8
Structural Grade:	0
O&M Grade:	0
Clock Start/From:	
Clock To:	
1st Value:	
2nd Value:	
Value Percent:	
Continuous Index:	
Within 8" of Joint:	NO
Remarks:	M-105-015
