Profile/Photo Observation Report

Date:	10/17/2021	Weather:		Coding:	PACP 6.0
Pipe Length (ft):		Owner:	Hobart, IN	Pre Clean:	Not Known
P.O.#:	862_1	Surveyor:	M. Pielacha	PSR:	P-105-016-017
Customer:	Hobart, IN	Clean Date:		Shape:	C

Street:	49th Avenue	Flow Control:	
City:	Hobart, IN	Year Renewed:	
Location:	Light Highway	Tape/Media #:	862
Purpose:	Routine Assessment	Dia/Height:	12"
Use:	Sanitary	Material:	VCP
Drain Area:		Lining:

US MH: **M-105-16** DS MH: **M-105-17** Total Length Surveyed (ft): **220.9**

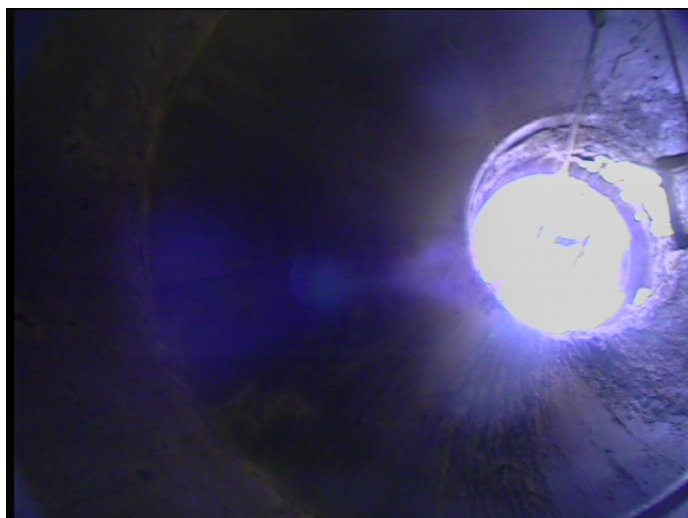
Code: **AMH**
 Description: **Manhole**

Distance (ft): **.0**
 Structural Grade: **0**
 O&M Grade: **0**
 Clock Start/From:
 Clock To:
 1st Value:
 2nd Value:
 Value Percent:
 Continuous Index:
 Within 8" of Joint: **NO**
 Remarks: **M-105-16**

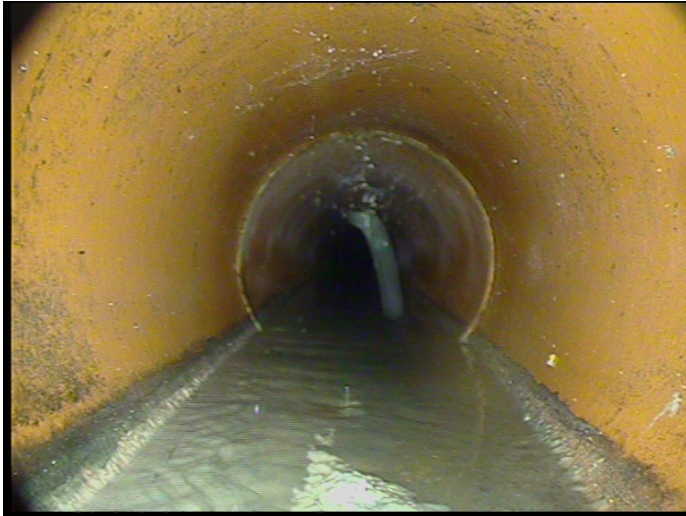
Code: **MWL**
Description: **Water Level**

Distance (ft): **.0**
Structural Grade: **0**
O&M Grade: **0**
Clock Start/From:
Clock To:
1st Value:
2nd Value:
Value Percent: **10.000**
Continuous Index:
Within 8" of Joint: **NO**
Remarks:

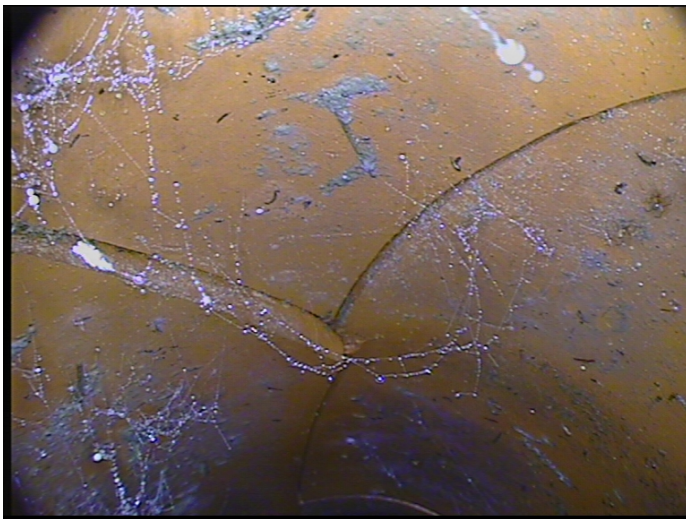
Code: **B**
Description: **Broken**

Distance (ft): **126.8**
Structural Grade: **5**
O&M Grade: **0**
Clock Start/From: **10**
Clock To: **4**
1st Value:
2nd Value:
Value Percent:
Continuous Index:
Within 8" of Joint: **YES**
Remarks:

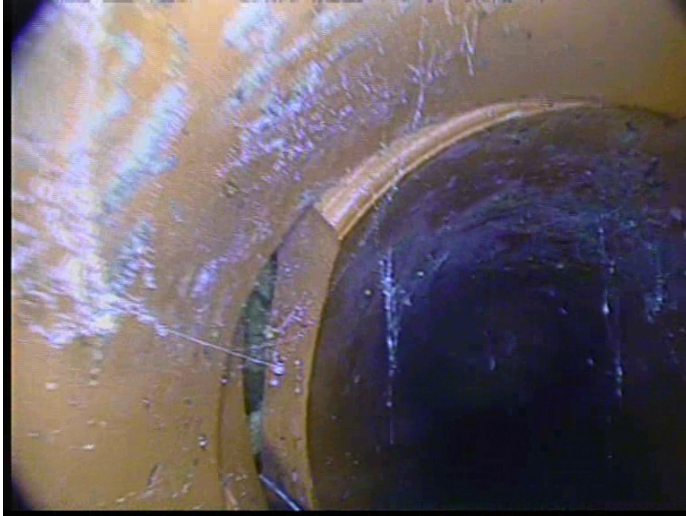
Code: **BSV**
Description: **Broken Soil Visible**

Distance (ft): **127.7**
Structural Grade: **5**
O&M Grade: **0**
Clock Start/From: **8**
Clock To: **10**
1st Value:
2nd Value:
Value Percent:
Continuous Index:
Within 8" of Joint: **YES**
Remarks:

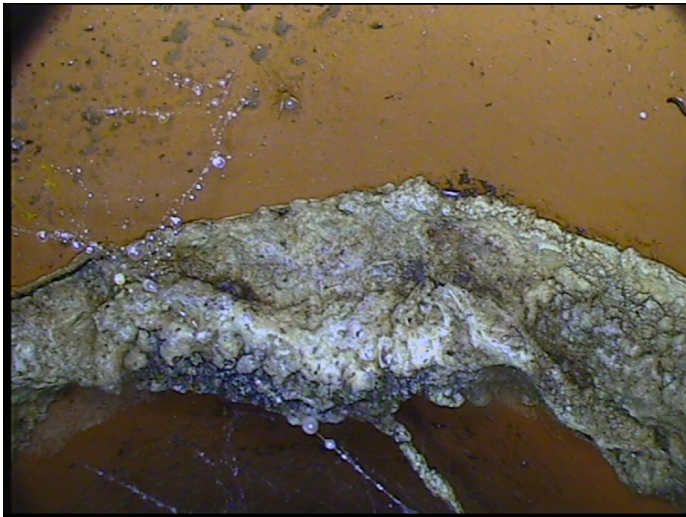
Code: **DAE**
Description: **Deposits Attached Encrustation**

Distance (ft): **139.7**
Structural Grade: **0**
O&M Grade: **2**
Clock Start/From: **7**
Clock To: **5**
1st Value:
2nd Value:
Value Percent: **5.000**
Continuous Index:
Within 8" of Joint: **YES**
Remarks:

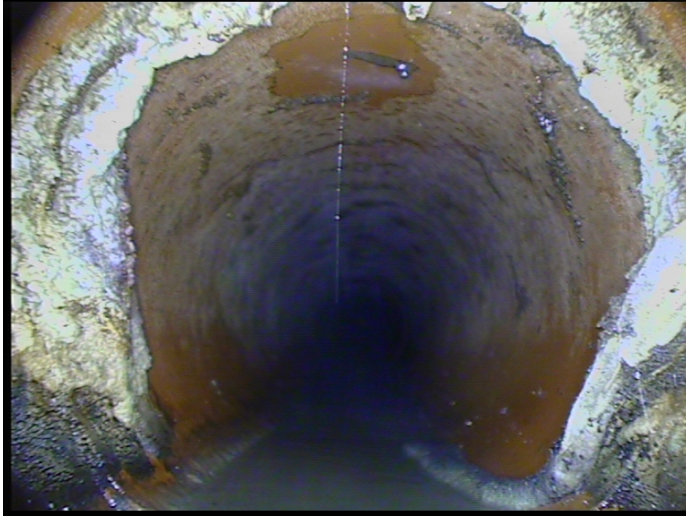
Code:	DAE
Description:	Deposits Attached Encrustation
Distance (ft):	158.1
Structural Grade:	0
O&M Grade:	2
Clock Start/From:	7
Clock To:	5
1st Value:	
2nd Value:	
Value Percent:	5.000
Continuous Index:	
Within 8" of Joint:	YES
Remarks:

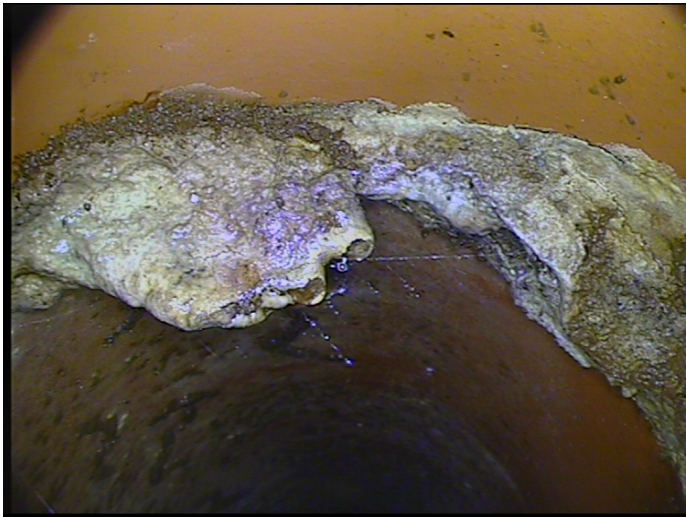
Code:	DAE
Description:	Deposits Attached Encrustation
Distance (ft):	175.9
Structural Grade:	0
O&M Grade:	2
Clock Start/From:	7
Clock To:	5
1st Value:	
2nd Value:	
Value Percent:	5.000
Continuous Index:	
Within 8" of Joint:	YES
Remarks:

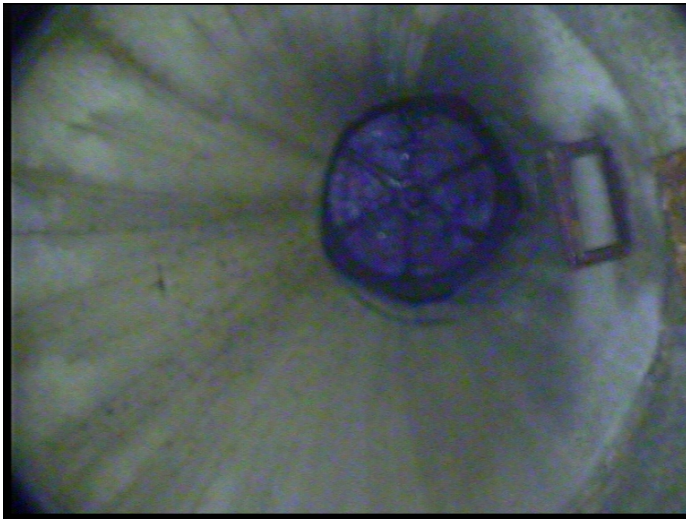
Code:	AMH
Description:	Manhole
Distance (ft):	220.9
Structural Grade:	0
O&M Grade:	0
Clock Start/From:	
Clock To:	
1st Value:	
2nd Value:	
Value Percent:	
Continuous Index:	
Within 8" of Joint:	NO
Remarks:	M-105-17
