Profile/Photo Observation Report

Date:	10/17/2021	Weather:		Coding:	PACP 6.0
Pipe Length (ft):		Owner:	Hobart, IN	Pre Clean:	Not Known
P.O.#:	862_2	Surveyor:	M. Pielacha	PSR:	P-105-017-018
Customer:	Hobart, IN	Clean Date:		Shape:	C

Street:	49th Avenue	Flow Control:	Not Controlled
City:	Hobart, IN	Year Renewed:	
Location:	Light Highway	Tape/Media #:	862
Purpose:	Routine Assessment	Dia/Height:	12"
Use:	Sanitary	Material:	VCP
Drain Area:		Lining:	
Category:	NA		
Comment:			
Location Details:		Direction of Survey:	Downstream
US MH:	M-105-17	DS MH:	M-105-18
		Total Length Surveyed (ft):	.1

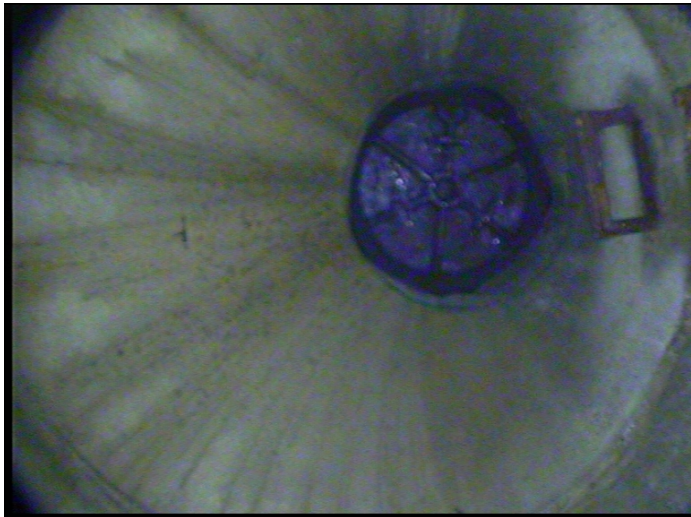
AMH

Manhole

M-105-17

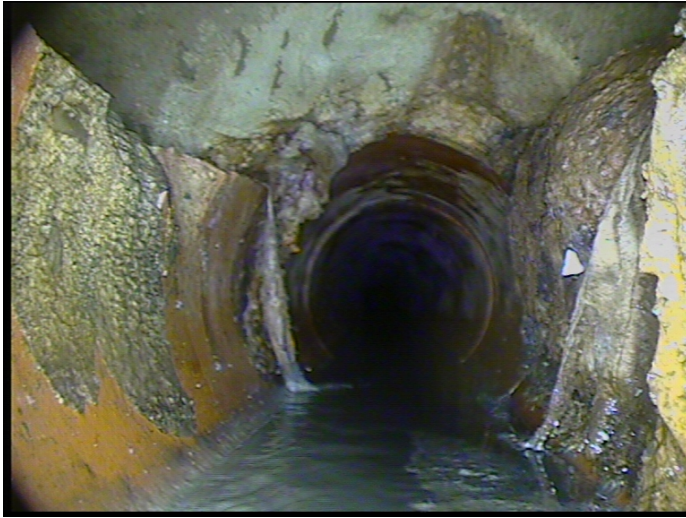
Code: **MWL**
Description: **Water Level**

Distance (ft): **.0**
Structural Grade: **0**
O&M Grade: **0**
Clock Start/From:
Clock To:
1st Value:
2nd Value:
Value Percent: **5.000**
Continuous Index:
Within 8" of Joint: **NO**
Remarks:

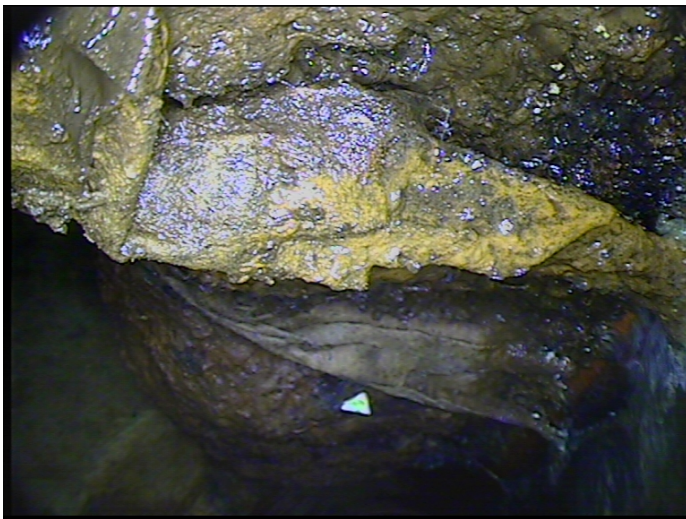
Code: **DAE**
Description: **Deposits Attached Encrustation**

Distance (ft): **.0**
Structural Grade: **0**
O&M Grade: **2**
Clock Start/From: **11**
Clock To: **5**
1st Value:
2nd Value:
Value Percent: **10.000**
Continuous Index:
Within 8" of Joint: **NO**
Remarks:

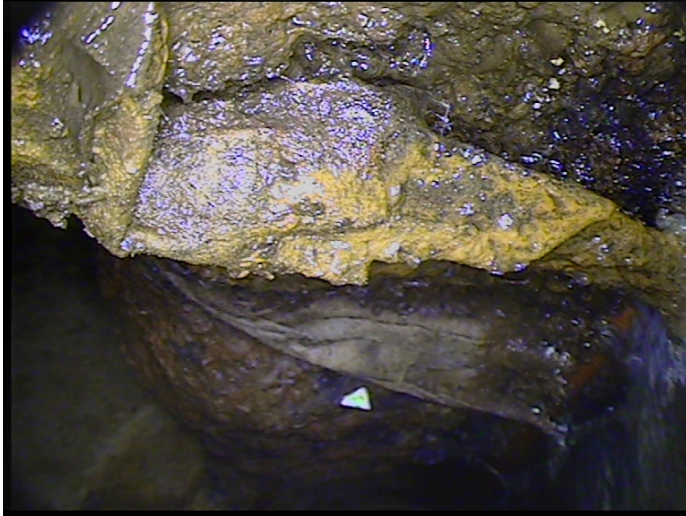
Code:	MSA
Description:	Abandoned Survey
Distance (ft):	.0
Structural Grade:	0
O&M Grade:	0
Clock Start/From:	
Clock To:	
1st Value:	
2nd Value:	
Value Percent:	
Continuous Index:	
Within 8" of Joint:	NO
Remarks:	Wheels can not pass by encrustation; Smaller wheels will no
