Profile/Photo Observation Report

Date:	10/17/2021	Weather:		Coding:	PACP 6.0
Pipe Length (ft):		Owner:	Hobart, IN	Pre Clean:	Not Known
P.O.#:	863_1	Surveyor:	M. Pielacha	PSR:	P-105-017-018
Customer:	Hobart, IN	Clean Date:		Shape:	C

Street:	49th Avenue	Flow Control:	
City:	Hobart, IN	Year Renewed:	
Location:	Light Highway	Tape/Media #:	863
Purpose:	Reversal	Dia/Height:	12"
Use:	Sanitary	Material:	VCP
Drain Area:		Lining:	
Category:	NA		
Comment:

Location Details:		Direction of Survey:	Upstream
US MH:	M-105-17	DS MH:	M-105-18
		Total Length Surveyed (ft):	130.8

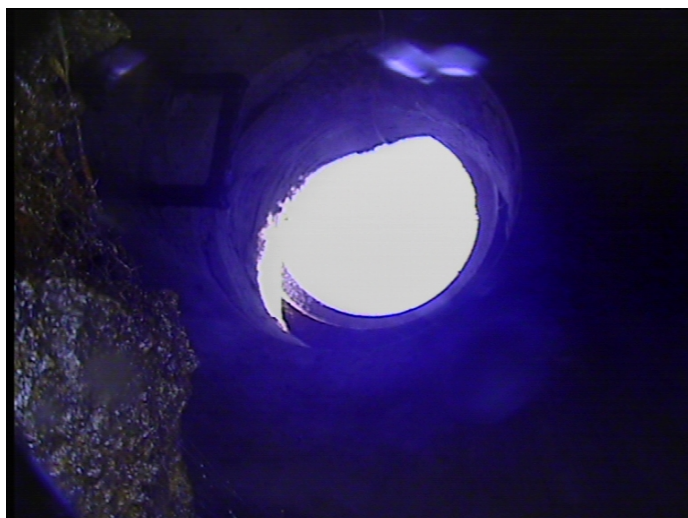
Code: **AMH**
 Description: **Manhole**

Distance (ft): **.0**
 Structural Grade: **0**
 O&M Grade: **0**
 Clock Start/From:
 Clock To:
 1st Value:
 2nd Value:
 Value Percent:
 Continuous Index:
 Within 8" of Joint: **NO**
 Remarks: **M-105-18**

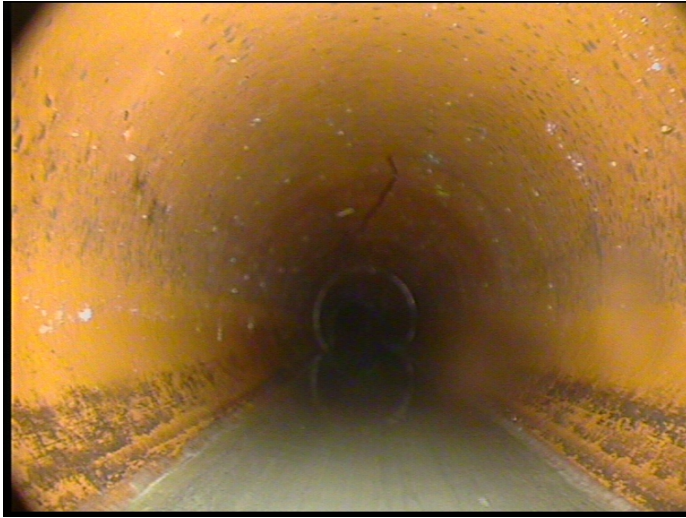
Code:	MWL
Description:	Water Level
Distance (ft):	.0
Structural Grade:	0
O&M Grade:	0
Clock Start/From:	
Clock To:	
1st Value:	
2nd Value:	
Value Percent:	5.000
Continuous Index:	
Within 8" of Joint:	NO
Remarks:

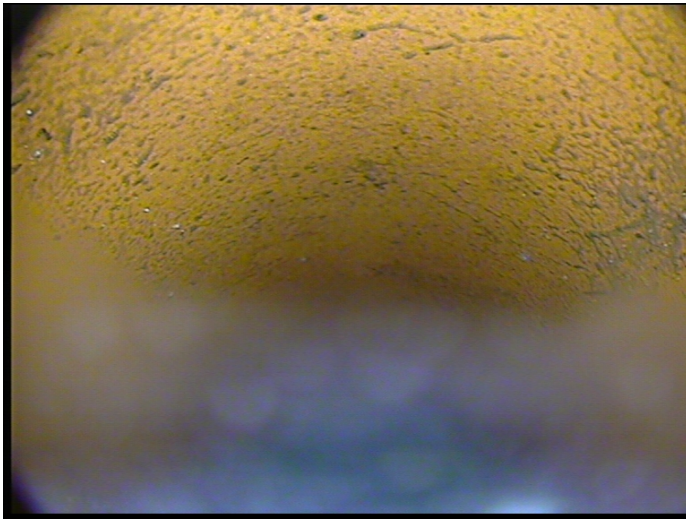
Code:	MWL
Description:	Water Level
Distance (ft):	120.7
Structural Grade:	0
O&M Grade:	0
Clock Start/From:	
Clock To:	
1st Value:	
2nd Value:	
Value Percent:	40.000
Continuous Index:	
Within 8" of Joint:	NO
Remarks:

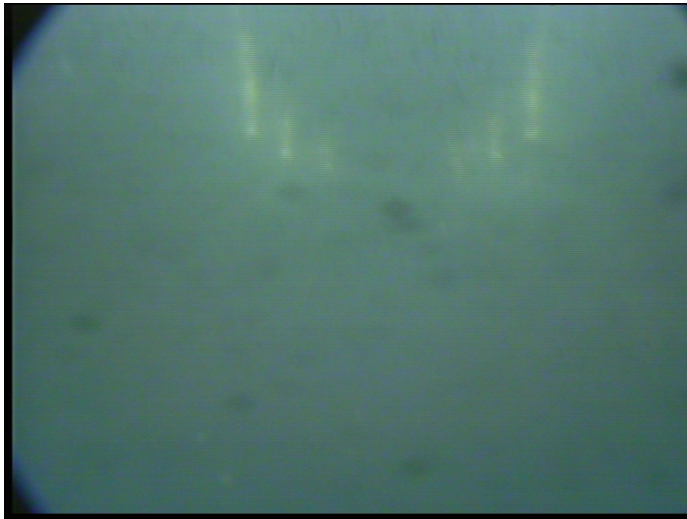
Code: **MCU**
Description: **Camera Underwater**

Distance (ft): **125.8**
Structural Grade: **0**
O&M Grade: **4**
Clock Start/From:
Clock To:
1st Value:
2nd Value:
Value Percent:
Continuous Index: **S01**
Within 8" of Joint: **NO**
Remarks:

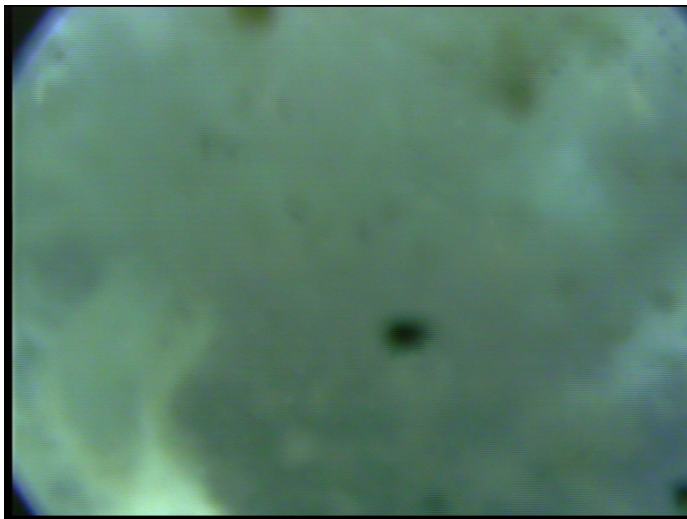
Code: **MGO**
Description: **General Observation**

Distance (ft): **129.5**
Structural Grade: **0**
O&M Grade: **0**
Clock Start/From:
Clock To:
1st Value:
2nd Value:
Value Percent:
Continuous Index:
Within 8" of Joint: **NO**
Remarks: **Under water debris**

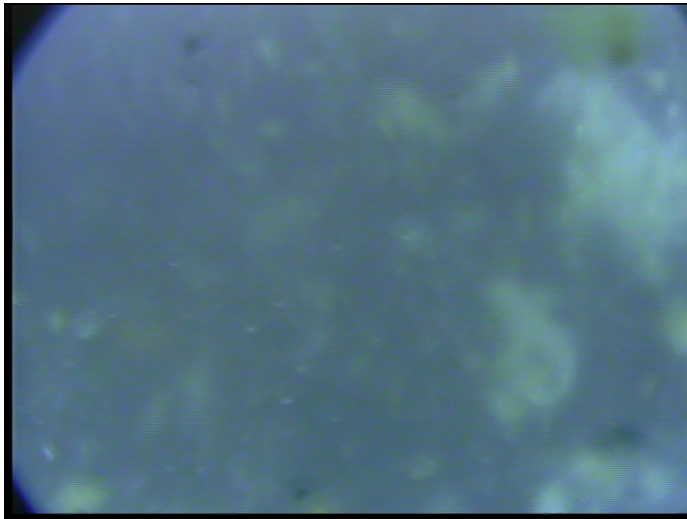
Code: **MCU**
Description: **Camera Underwater**

Distance (ft): **130.0**
Structural Grade: **0**
O&M Grade: **4**
Clock Start/From:
Clock To:
1st Value:
2nd Value:
Value Percent:
Continuous Index: **F01**
Within 8" of Joint: **NO**
Remarks:

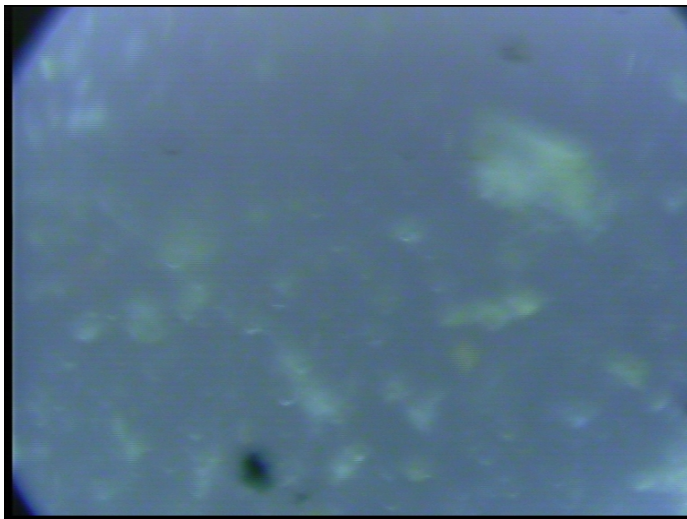
Code: **MSA**
Description: **Abandoned Survey**

Distance (ft): **130.0**
Structural Grade: **0**
O&M Grade: **0**
Clock Start/From:
Clock To:
1st Value:
2nd Value:
Value Percent:
Continuous Index:
Within 8" of Joint: **NO**
Remarks: **under water debris**
