## Profile/Photo Observation Report

Street:	<b>49th Avenue</b>	Flow Control:	<b>Not Controlled</b>
City:	<b>Hobart, IN</b>	Year Renewed:	
Location:	<b>Light Highway</b>	Tape/Media #:	<b>864</b>
Purpose:	<b>Routine Assessment</b>	Dia/Height:	<b>12"</b>
Use:	<b>Sanitary</b>	Material:	<b>VCP</b>
Drain Area:		Lining:	
Category:	<b>NA</b>		
Comment:			
Location Details:		Direction of Survey:	<b>Downstream</b>
US MH:	<b>M-105-18</b>	DS MH:	<b>M-105-19</b>
		Total Length Surveyed (ft):	<b>.1</b>

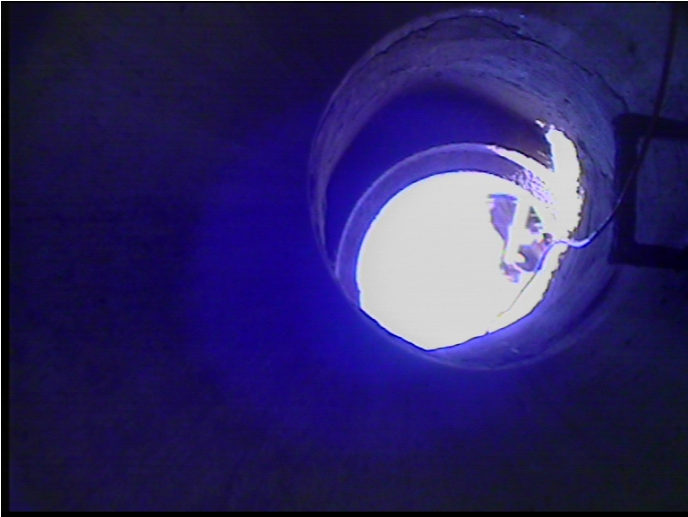
AMH

Manhole

M-105-18

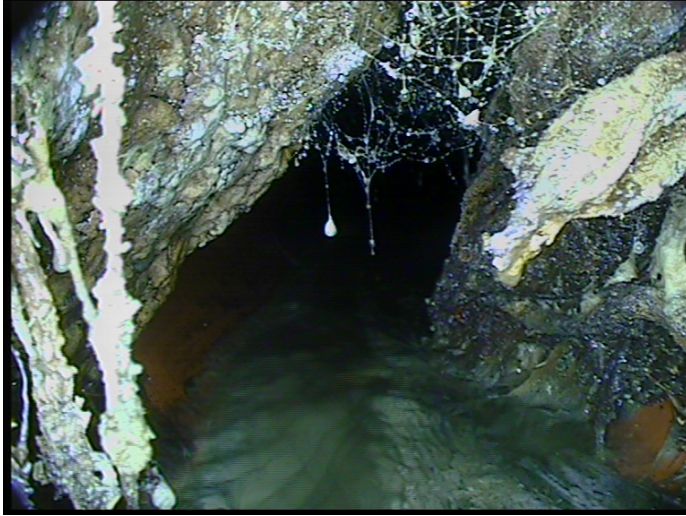
Code: **MWL**  
Description: **Water Level**

Distance (ft): **.0**  
Structural Grade: **0**  
O&M Grade: **0**  
Clock Start/From:  
Clock To:  
1st Value:  
2nd Value:  
Value Percent: **5.000**  
Continuous Index:  
Within 8" of Joint: **NO**  
Remarks:

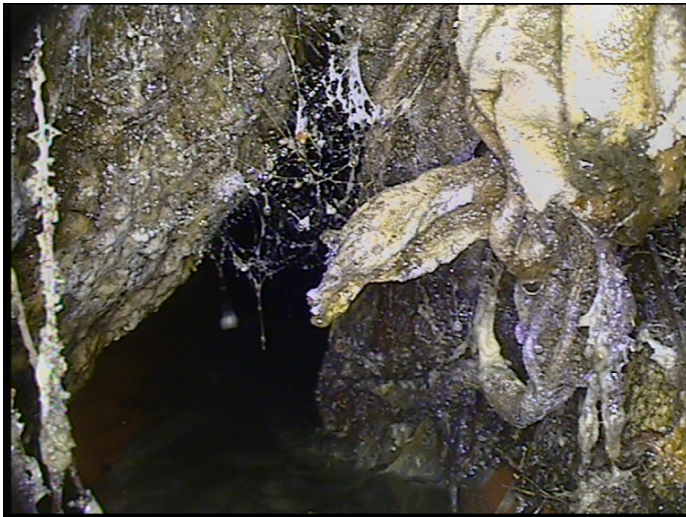
Code: **DAE**  
Description: **Deposits Attached Encrustation**

Distance (ft): **.0**  
Structural Grade: **0**  
O&M Grade: **3**  
Clock Start/From: **8**  
Clock To: **4**  
1st Value:  
2nd Value:  
Value Percent: **20.000**  
Continuous Index:  
Within 8" of Joint: **NO**  
Remarks:

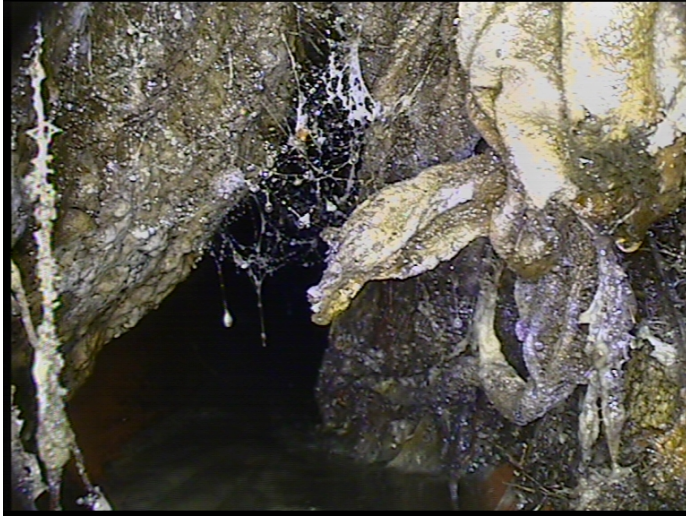
Code:	MSA
Description:	Abandoned Survey
Distance (ft):	.0
Structural Grade:	0
O&M Grade:	0
Clock Start/From:	
Clock To:	
1st Value:	
2nd Value:	
Value Percent:	
Continuous Index:	
Within 8" of Joint:	NO
Remarks:	Pipe entrance has too much encrustation
