Profile/Photo Observation Report

Date:	10/17/2021	Weather:		Coding:	PACP 6.0
Pipe Length (ft):		Owner:	Hobart, IN	Pre Clean:	Not Known
P.O.#:	865_1	Surveyor:	M. Pielacha	PSR:	P-105-018-019
Customer:	Hobart, IN	Clean Date:		Shape:	C

Street:	49th Avenue	Flow Control:	
City:	Hobart, IN	Year Renewed:	
Location:	Light Highway	Tape/Media #:	865
Purpose:	Routine Assessment	Dia/Height:	12"
Use:	Sanitary	Material:	VCP
Drain Area:		Lining:	
Category:	NA		
Comment:

Location Details:		Direction of Survey:	Upstream
US MH:	M-105-18	DS MH:	M-105-19
		Total Length Surveyed (ft):	202.5

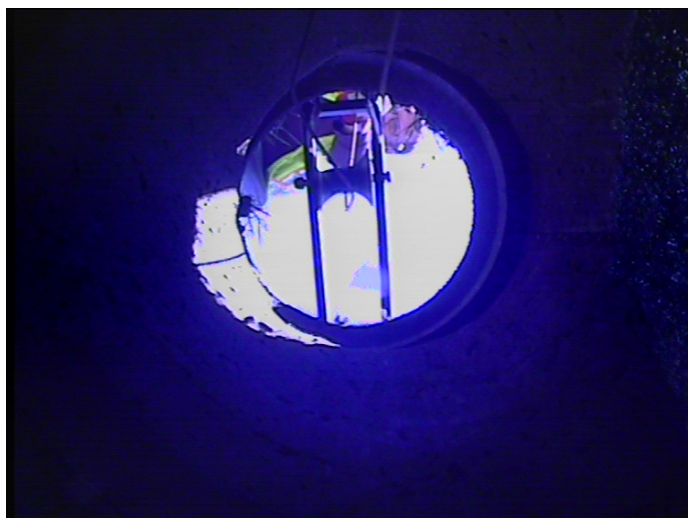
Code: **AMH**
Description: **Manhole**

Distance (ft): **.0**
Structural Grade: **0**
O&M Grade: **0**
Clock Start/From:
Clock To:
1st Value:
2nd Value:
Value Percent:
Continuous Index:
Within 8" of Joint: **NO**
Remarks: **M-105-19**

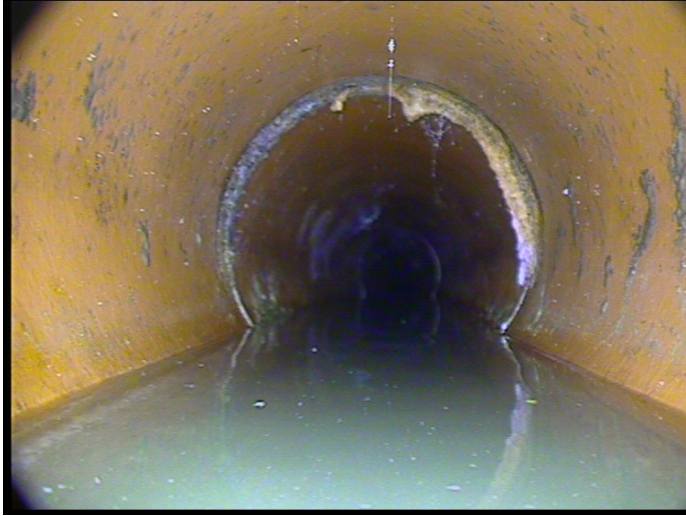
Code: **MWL**
Description: **Water Level**

Distance (ft): **.0**
Structural Grade: **0**
O&M Grade: **0**
Clock Start/From:
Clock To:
1st Value:
2nd Value:
Value Percent: **10.000**
Continuous Index:
Within 8" of Joint: **NO**
Remarks:

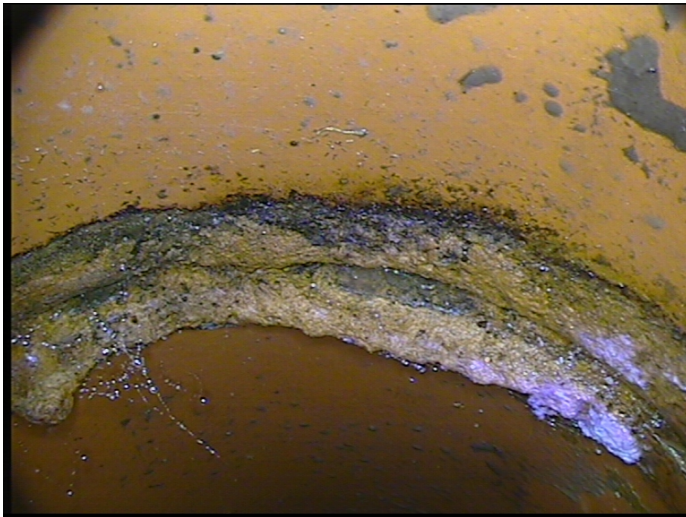
Code: **DAE**
Description: **Deposits Attached Encrustation**

Distance (ft): **2.2**
Structural Grade: **0**
O&M Grade: **2**
Clock Start/From: **12**
Clock To: **5**
1st Value:
2nd Value:
Value Percent: **5.000**
Continuous Index:
Within 8" of Joint: **YES**
Remarks:

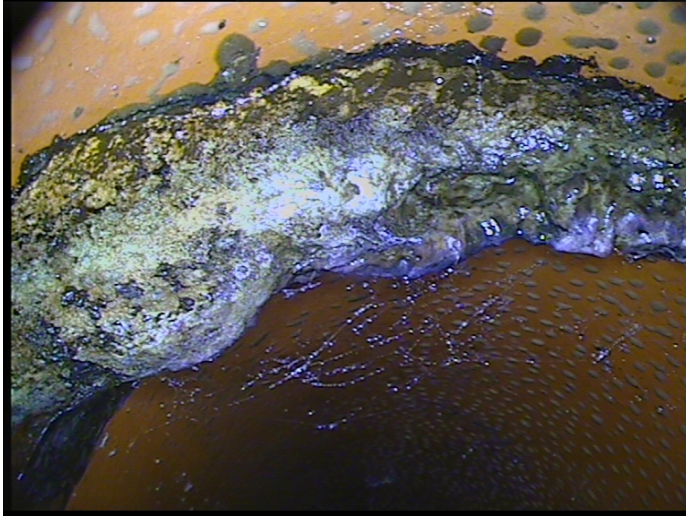
Code:	DAE
Description:	Deposits Attached Encrustation
Distance (ft):	38.1
Structural Grade:	0
O&M Grade:	2
Clock Start/From:	7
Clock To:	3
1st Value:	
2nd Value:	
Value Percent:	5.000
Continuous Index:	
Within 8" of Joint:	YES
Remarks:

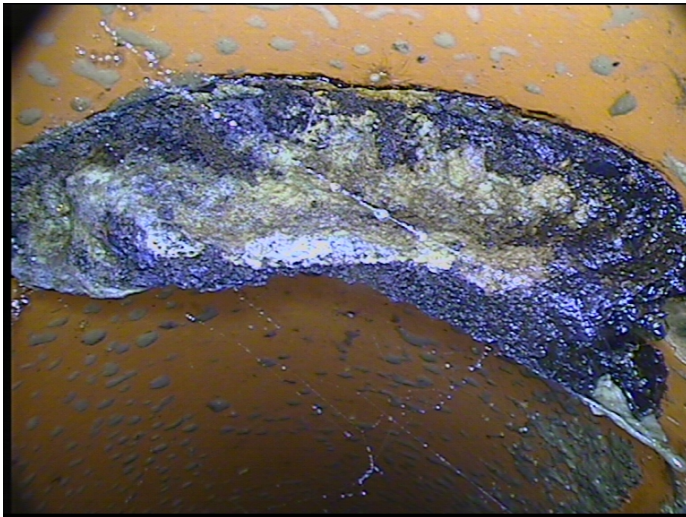
Code:	DAE
Description:	Deposits Attached Encrustation
Distance (ft):	44.2
Structural Grade:	0
O&M Grade:	2
Clock Start/From:	12
Clock To:	4
1st Value:	
2nd Value:	
Value Percent:	5.000
Continuous Index:	
Within 8" of Joint:	YES
Remarks:

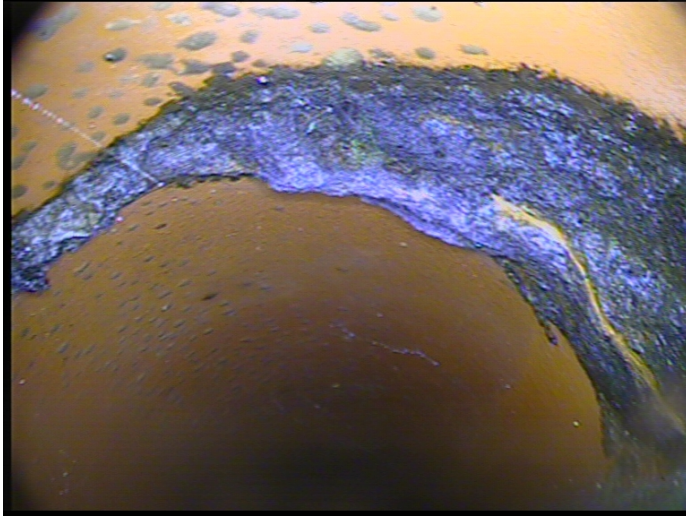
Code:	DAE
Description:	Deposits Attached Encrustation
Distance (ft):	121.5
Structural Grade:	0
O&M Grade:	2
Clock Start/From:	7
Clock To:	5
1st Value:	
2nd Value:	
Value Percent:	5.000
Continuous Index:	
Within 8" of Joint:	YES
Remarks:

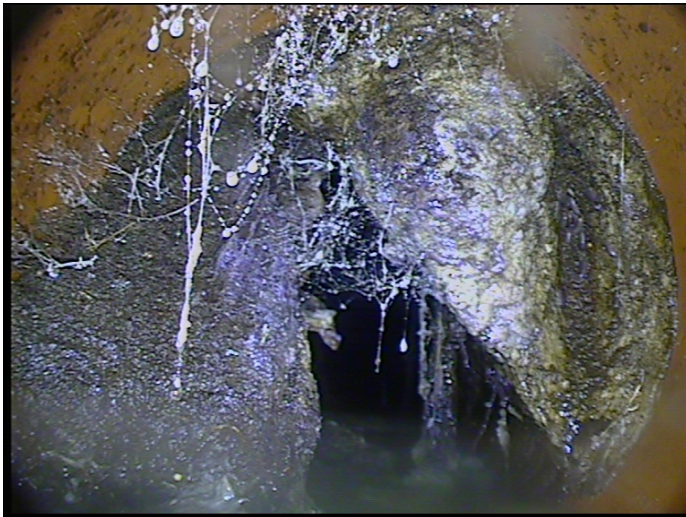
Code:	DAE
Description:	Deposits Attached Encrustation
Distance (ft):	200.9
Structural Grade:	0
O&M Grade:	4
Clock Start/From:	7
Clock To:	5
1st Value:	
2nd Value:	
Value Percent:	25.000
Continuous Index:	
Within 8" of Joint:	YES
Remarks:

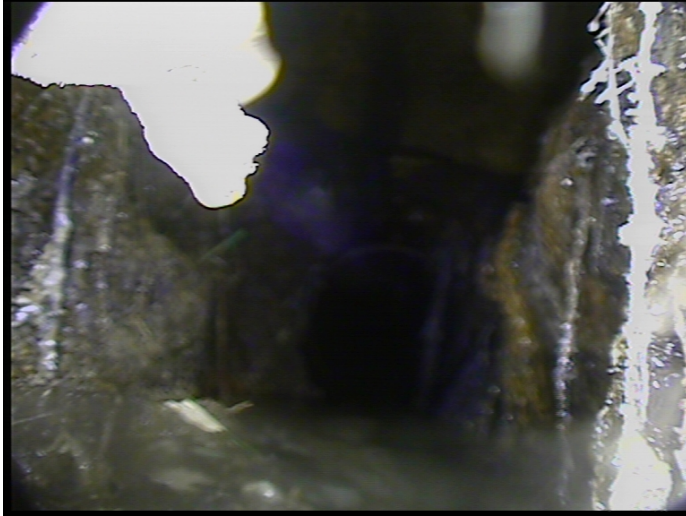
Code:	AMH
Description:	Manhole
Distance (ft):	202.5
Structural Grade:	0
O&M Grade:	0
Clock Start/From:	
Clock To:	
1st Value:	
2nd Value:	
Value Percent:	
Continuous Index:	
Within 8" of Joint:	NO
Remarks:	M-105-18
