## Profile/Photo Observation Report

| P.O.#: | <b>867_1</b> | Surveyor: | <b>M. Pielacha</b> | PSR: | <b>P-105-019-020</b> |

| Street: | <b>49th Avenue</b> | Flow Control: | |

| US MH: | <b>M-105-19</b> | DS MH: | <b>M-105-20</b> |

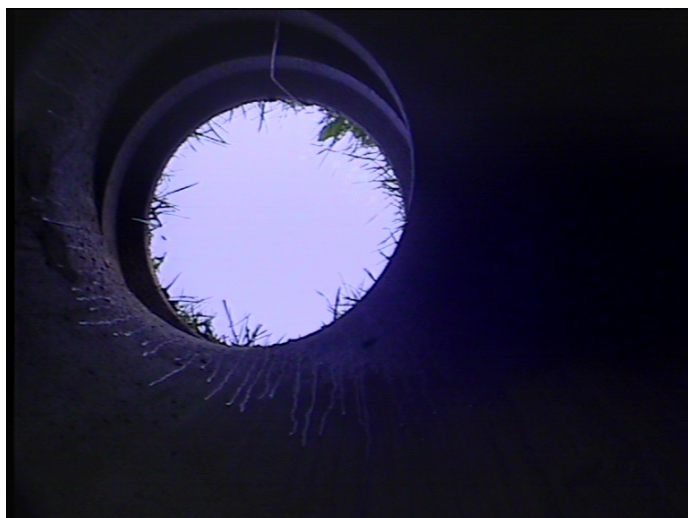
Code: **AMH**  
 Description: **Manhole**

Distance (ft): **.0**  
 Structural Grade: **0**  
 O&M Grade: **0**  
 Clock Start/From:  
 Clock To:  
 1st Value:  
 2nd Value:  
 Value Percent:  
 Continuous Index:  
 Within 8" of Joint: **NO**  
 Remarks: **M-105-20**

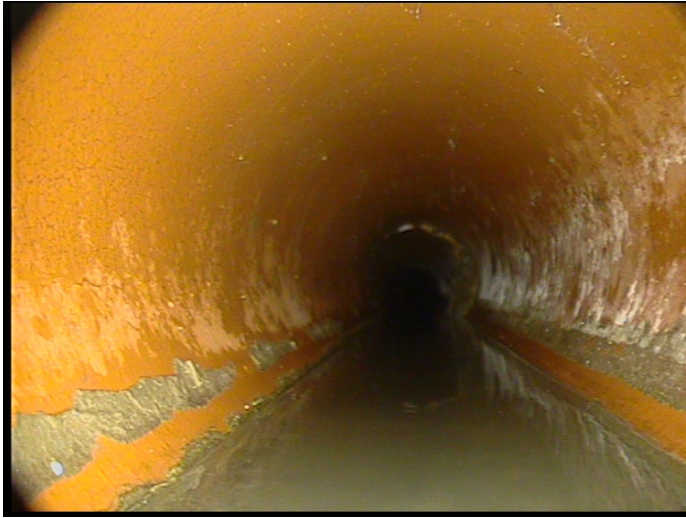
Code: **MWL**  
Description: **Water Level**

Distance (ft): **.0**  
Structural Grade: **0**  
O&M Grade: **0**  
Clock Start/From:  
Clock To:  
1st Value:  
2nd Value:  
Value Percent: **5.000**  
Continuous Index:  
Within 8" of Joint: **NO**  
Remarks:

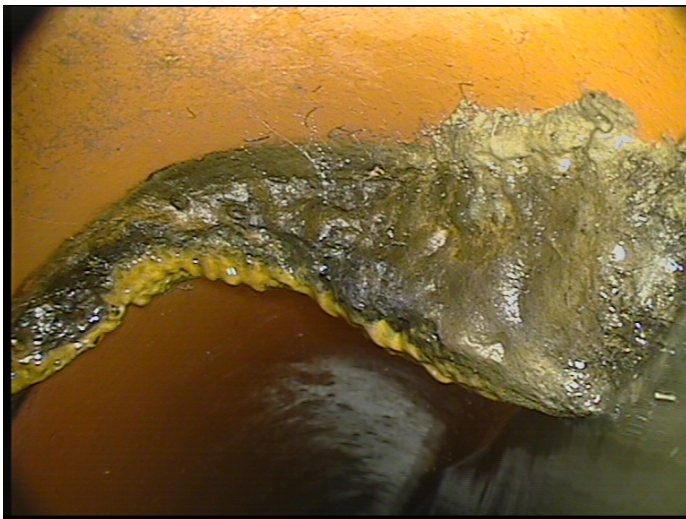
Code: **DAE**  
Description: **Deposits Attached Encrustation**

Distance (ft): **5.4**  
Structural Grade: **0**  
O&M Grade: **2**  
Clock Start/From: **12**  
Clock To: **5**  
1st Value:  
2nd Value:  
Value Percent: **10.000**  
Continuous Index:  
Within 8" of Joint: **YES**  
Remarks:

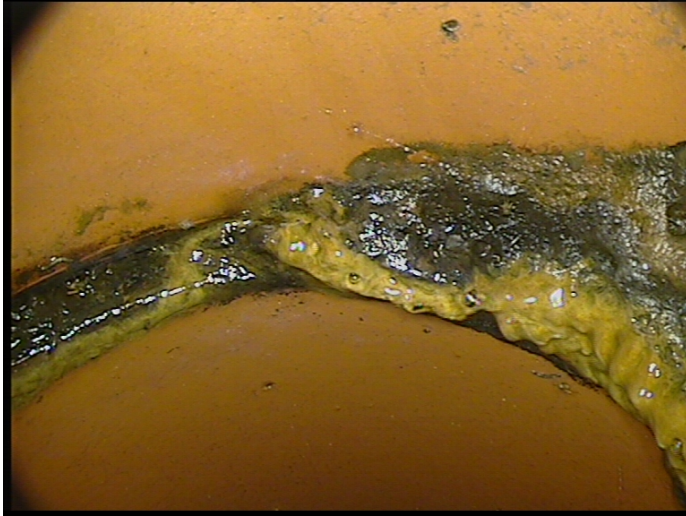
Code: **IR**  
Description: **Infil Runner**

Distance (ft): **5.9**  
Structural Grade: **0**  
O&M Grade: **4**  
Clock Start/From: **12**  
Clock To:  
1st Value:  
2nd Value:  
Value Percent:  
Continuous Index:  
Within 8" of Joint: **YES**  
Remarks:

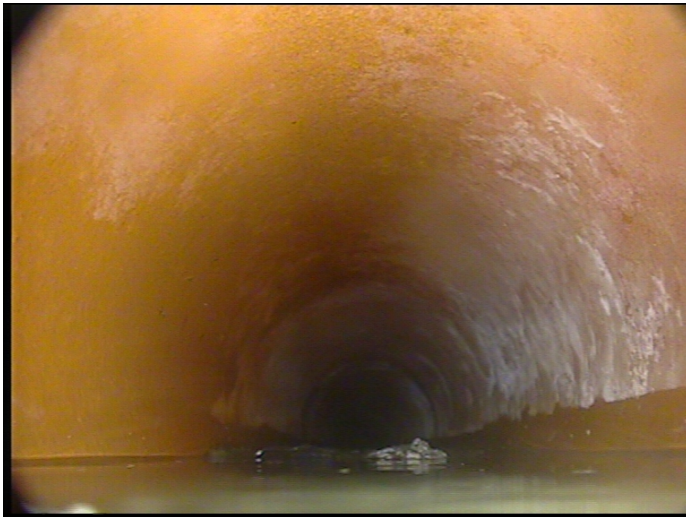
Code: **MWL**  
Description: **Water Level**

Distance (ft): **19.7**  
Structural Grade: **0**  
O&M Grade: **0**  
Clock Start/From:  
Clock To:  
1st Value:  
2nd Value:  
Value Percent: **20.000**  
Continuous Index:  
Within 8" of Joint: **NO**  
Remarks:

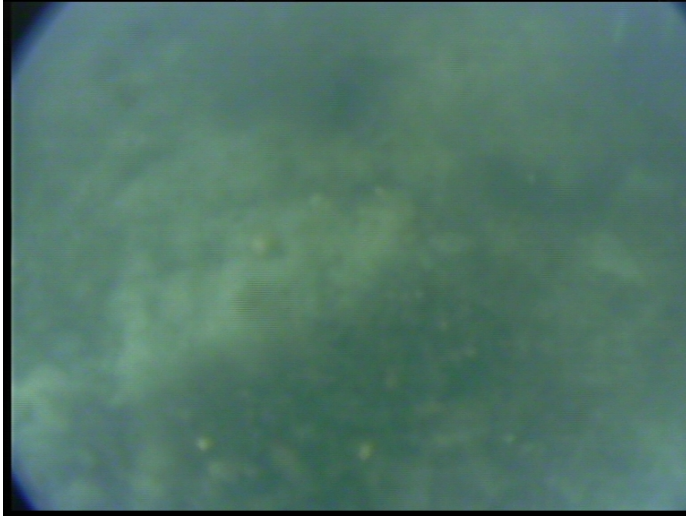
| Code: | <b>OBZ</b> |
| Description: | <b>Obstacle Other</b> |
| Distance (ft): | <b>32.5</b> |
| O&M Grade: | <b>2</b> |
| Remarks: | <b>Under water debris</b> |

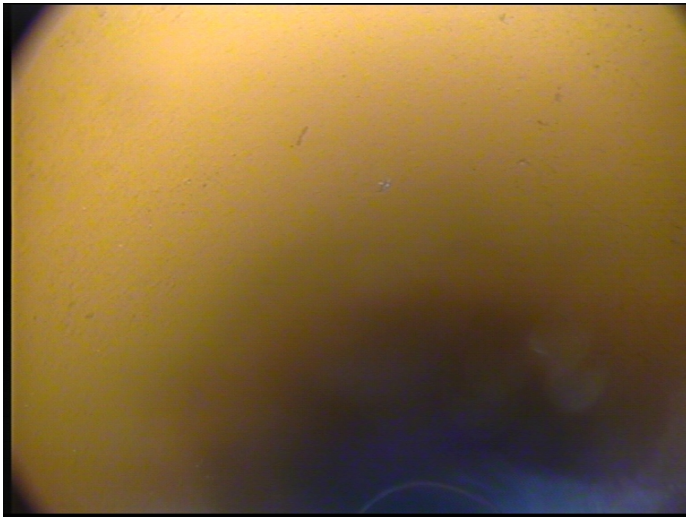
| Code: | <b>MSA</b> |
| Description: | <b>Abandoned Survey</b> |
| Distance (ft): | <b>32.5</b> |
| Remarks: | <b>Under water debris</b> |
