## Profile/Photo Observation Report

Date:	<b>10/17/2021</b>	Weather:		Coding:	<b>PACP 6.0</b>
Pipe Length (ft):		Owner:	<b>Hobart, IN</b>	Pre Clean:	<b>Not Known</b>
P.O.#:	<b>868_1</b>	Surveyor:	<b>M. Pielacha</b>	PSR:	<b>P-105-020-021</b>
Customer:	<b>Hobart, IN</b>	Clean Date:		Shape:	<b>C</b>

Street:	<b>49th Avenue</b>	Flow Control:	
City:	<b>Hobart, IN</b>	Year Renewed:	
Location:	<b>Light Highway</b>	Tape/Media #:	<b>868</b>
Purpose:	<b>Routine Assessment</b>	Dia/Height:	<b>12"</b>
Use:	<b>Sanitary</b>	Material:	<b>VCP</b>
Drain Area:		Lining:	
Category:	<b>NA</b>

US MH: **M-105-20** DS MH: **M-105-21** Total Length Surveyed (ft): **122.9**

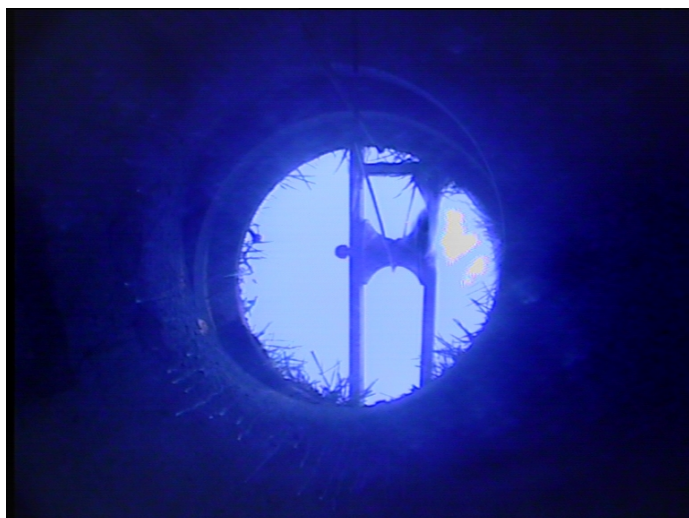
Code: **AMH**  
 Description: **Manhole**

Distance (ft): **.0**  
 Structural Grade: **0**  
 O&M Grade: **0**  
 Clock Start/From:  
 Clock To:  
 1st Value:  
 2nd Value:  
 Value Percent:  
 Continuous Index:  
 Within 8" of Joint: **NO**  
 Remarks: **M-105-20**

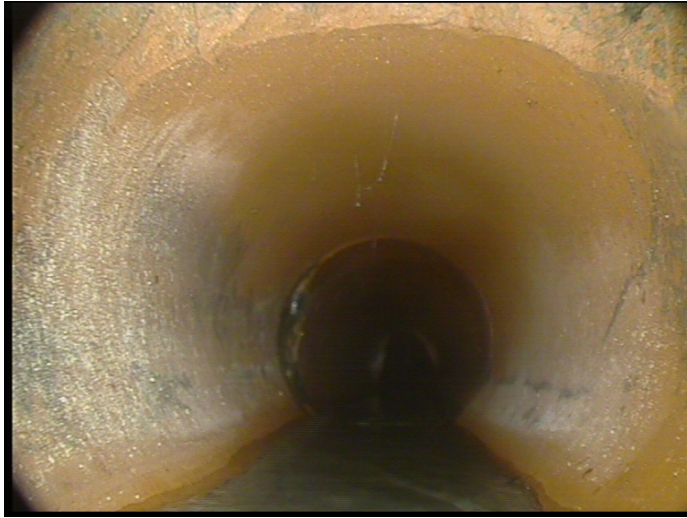
Code: **MWL**  
Description: **Water Level**

Distance (ft): **.0**  
Structural Grade: **0**  
O&M Grade: **0**  
Clock Start/From:  
Clock To:  
1st Value:  
2nd Value:  
Value Percent: **5.000**  
Continuous Index:  
Within 8" of Joint: **NO**  
Remarks:

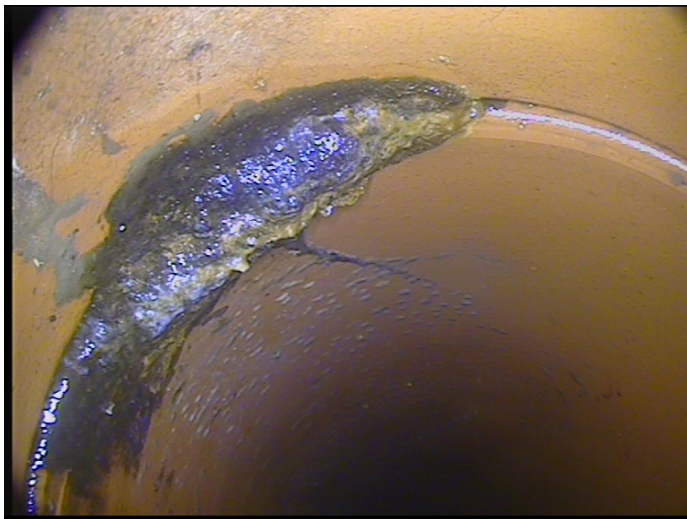
Code: **DAE**  
Description: **Deposits Attached Encrustation**

Distance (ft): **2.8**  
Structural Grade: **0**  
O&M Grade: **2**  
Clock Start/From: **8**  
Clock To: **10**  
1st Value:  
2nd Value:  
Value Percent: **5.000**  
Continuous Index: **S01**  
Within 8" of Joint: **YES**  
Remarks:

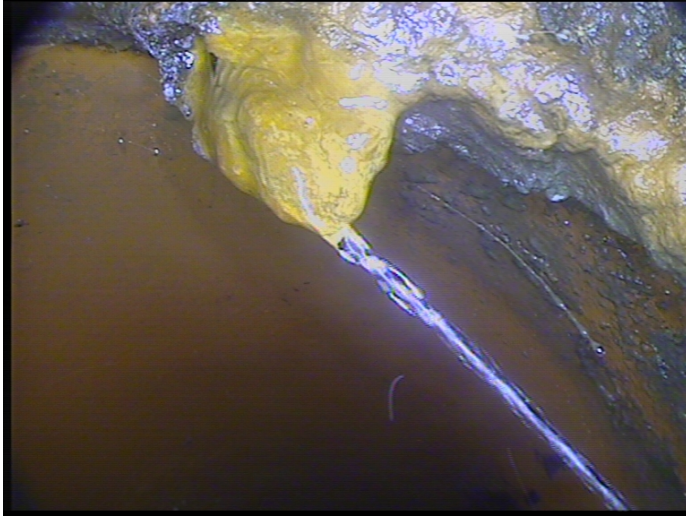
Code: **IR**  
Description: **Infil Runner**

Distance (ft): **21.1**  
Structural Grade: **0**  
O&M Grade: **4**  
Clock Start/From: **2**  
Clock To:  
1st Value:  
2nd Value:  
Value Percent:  
Continuous Index:  
Within 8" of Joint: **YES**  
Remarks:

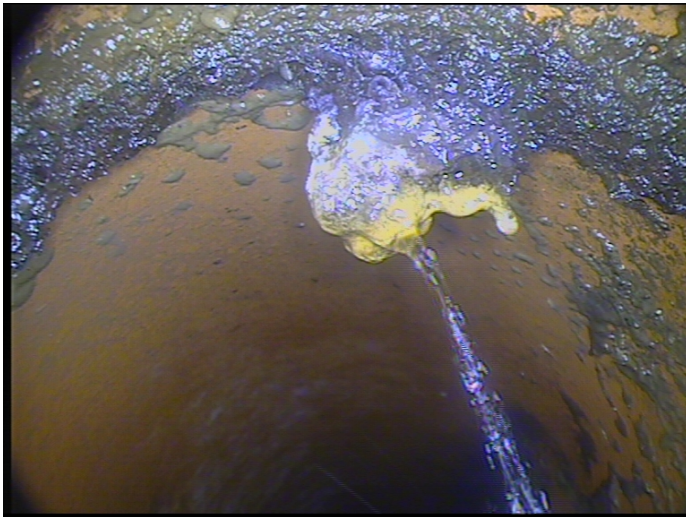
Code: **IR**  
Description: **Infil Runner**

Distance (ft): **44.9**  
Structural Grade: **0**  
O&M Grade: **4**  
Clock Start/From: **2**  
Clock To:  
1st Value:  
2nd Value:  
Value Percent:  
Continuous Index:  
Within 8" of Joint: **YES**  
Remarks:

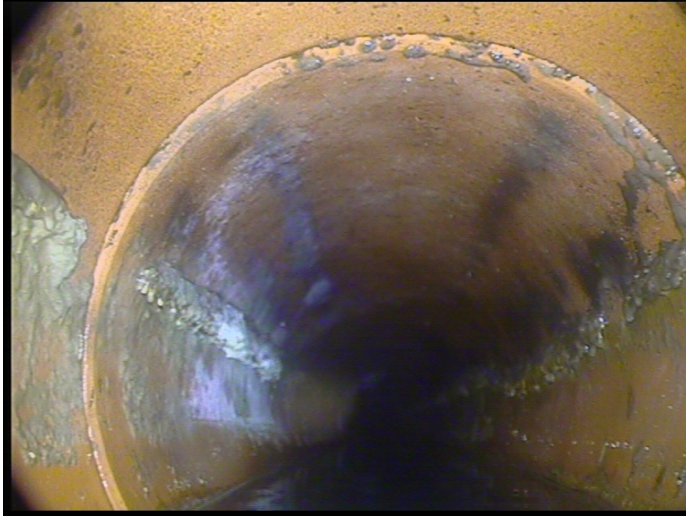
Code:	<b>DAE</b>
Description:	<b>Deposits Attached Encrustation</b>
Distance (ft):	<b>55.7</b>
Structural Grade:	<b>0</b>
O&M Grade:	<b>2</b>
Clock Start/From:	<b>8</b>
Clock To:	<b>10</b>
1st Value:	
2nd Value:	
Value Percent:	<b>5.000</b>
Continuous Index:	<b>F01</b>
Within 8" of Joint:	<b>NO</b>
Remarks:

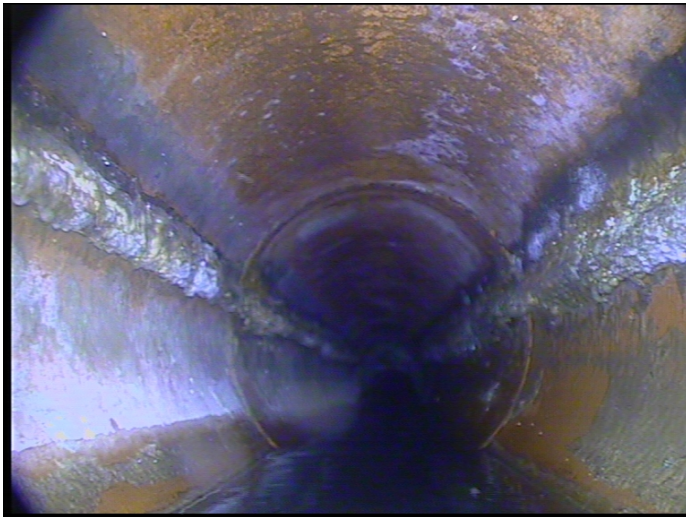
Code:	<b>DAGS</b>
Description:	<b>Deposits Attached Grease</b>
Distance (ft):	<b>84.7</b>
Structural Grade:	<b>0</b>
O&M Grade:	<b>2</b>
Clock Start/From:	<b>9</b>
Clock To:	<b>3</b>
1st Value:	
2nd Value:	
Value Percent:	<b>5.000</b>
Continuous Index:	<b>S02</b>
Within 8" of Joint:	<b>YES</b>
Remarks:

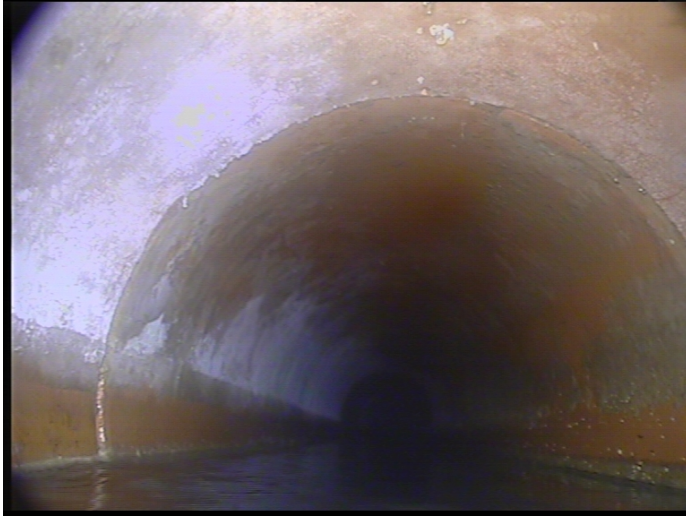
Code:	<b>DAGS</b>
Description:	<b>Deposits Attached Grease</b>
Distance (ft):	<b>122.9</b>
Structural Grade:	<b>0</b>
O&M Grade:	<b>2</b>
Clock Start/From:	<b>9</b>
Clock To:	<b>3</b>
1st Value:	
2nd Value:	
Value Percent:	<b>5.000</b>
Continuous Index:	<b>F02</b>
Within 8" of Joint:	<b>NO</b>
Remarks:

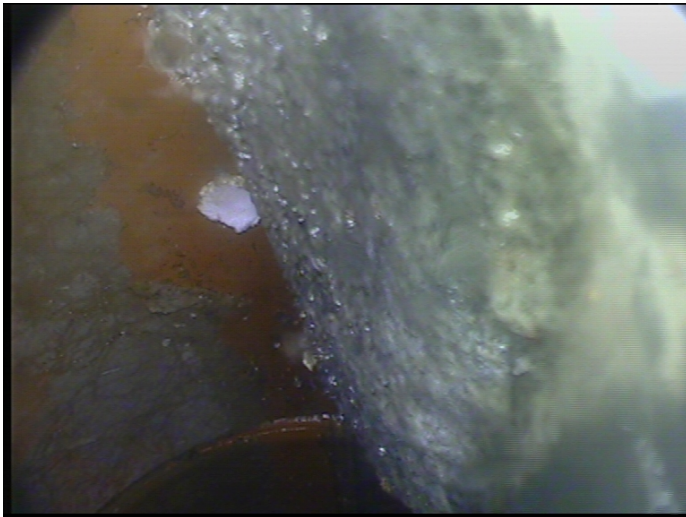
Code:	<b>OBZ</b>
Description:	<b>Obstacle Other</b>
Distance (ft):	<b>122.9</b>
Structural Grade:	<b>0</b>
O&M Grade:	<b>3</b>
Clock Start/From:	<b>4</b>
Clock To:	<b>6</b>
1st Value:	
2nd Value:	
Value Percent:	<b>15.000</b>
Continuous Index:	
Within 8" of Joint:	<b>NO</b>
Remarks:	<b>Debris</b>

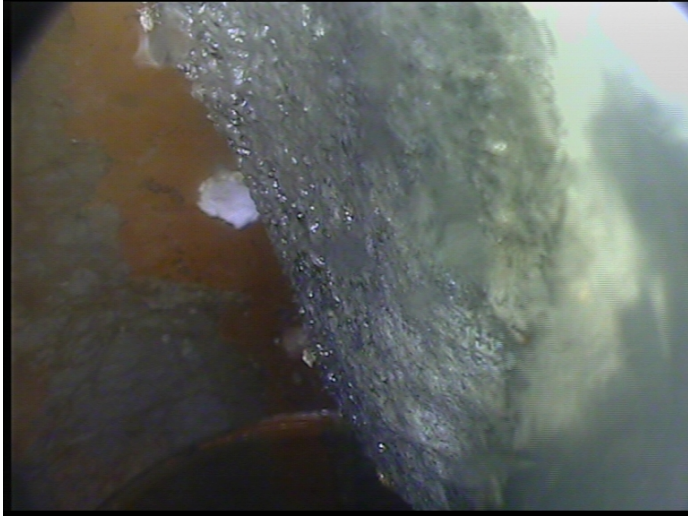
Code:	<b>MSA</b>
Description:	<b>Abandoned Survey</b>
Distance (ft):	<b>122.9</b>
Structural Grade:	<b>0</b>
O&M Grade:	<b>0</b>
Clock Start/From:	
Clock To:	
1st Value:	
2nd Value:	
Value Percent:	
Continuous Index:	
Within 8" of Joint:	<b>NO</b>
Remarks:	<b>heavy debris</b>
