Profile/Photo Observation Report

Date:	03/24/2018	Weather:		Coding:	PACP 6.0
Pipe Length (ft):	152.4	Owner:	NA	Pre Clean:	No Pre-Cleaning
P.O.#:		Surveyor:	Curtis Montgomery	PSR:	P-108-048-002
Customer:		Clean Date:	01/01/1900	Shape:	C

Street:	HOWARD CT	Flow Control:	Not Controlled
City:	Hobart, IN	Year Renewed:	
Location:	Light Highway	Tape/Media #:	
Purpose:	Routine Assessment	Dia/Height:	8"
Use:	Sanitary	Material:	PVC
Drain Area:	NA	Lining:	
Category:	NA		
Comment:	Flow direction Wrong		
Location Details:		Direction of Survey:	Upstream
US MH:	M-108-002	DS MH:	M-108-048
		Total Length Surveyed (ft):	187.2

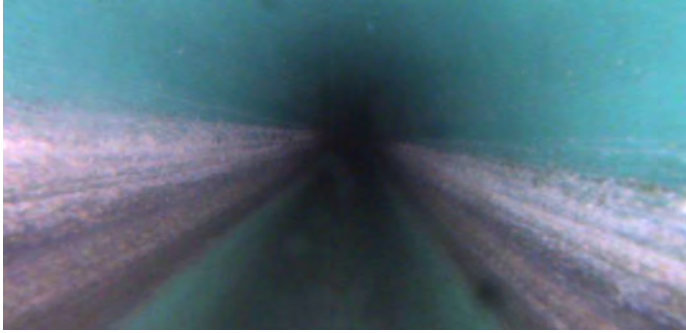
Code: **DAGS**
Description: **Deposits Attached Grease**

Distance (ft): **.0**
Structural Grade: **0**
O&M Grade: **2**
Clock Start/From: **8**
Clock To: **4**
1st Value:
2nd Value:
Value Percent: **5.000**
Continuous Index: **S01**
Within 8" of Joint: **NO**
Remarks:

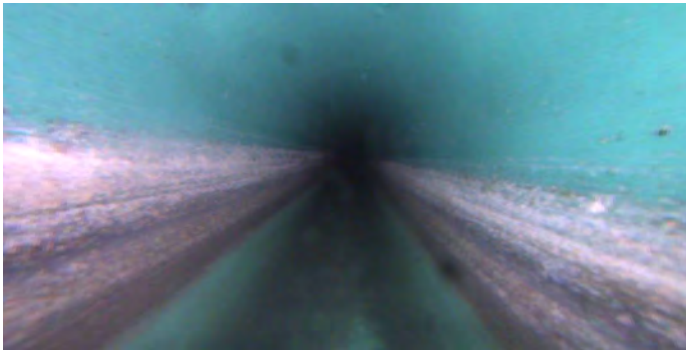
Code: **AMH**
Description: **Manhole**

Distance (ft): **.0**
Structural Grade: **0**
O&M Grade: **0**
Clock Start/From:
Clock To:
1st Value:
2nd Value:
Value Percent:
Continuous Index:
Within 8" of Joint: **NO**
Remarks: **M-108-048**

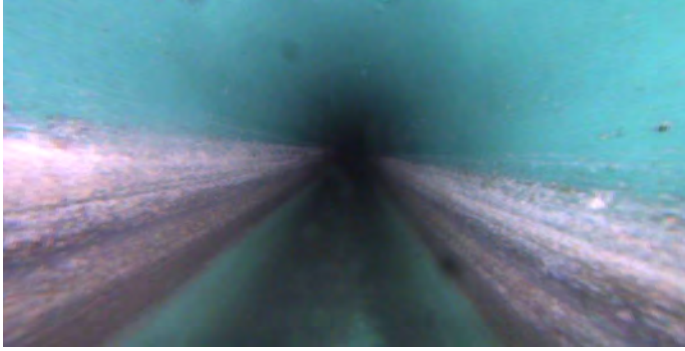
Code: **MWL**
Description: **Water Level**

Distance (ft): **.0**
Structural Grade: **0**
O&M Grade: **0**
Clock Start/From:
Clock To:
1st Value:
2nd Value:
Value Percent: **5.000**
Continuous Index:
Within 8" of Joint: **NO**
Remarks:

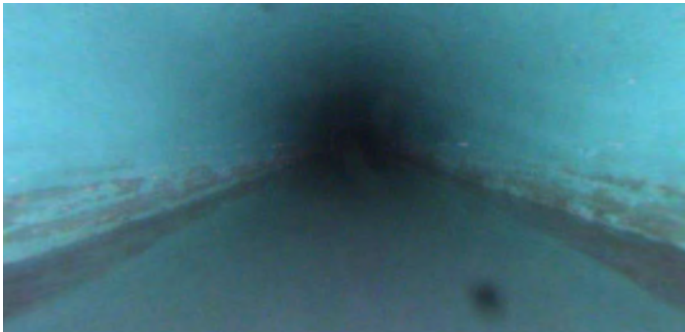
Code: **DAGS**
Description: **Deposits Attached Grease**

Distance (ft): **19.7**
Structural Grade: **0**
O&M Grade: **2**
Clock Start/From: **8**
Clock To: **4**
1st Value:
2nd Value:
Value Percent: **5.000**
Continuous Index: **F01**
Within 8" of Joint: **NO**
Remarks:

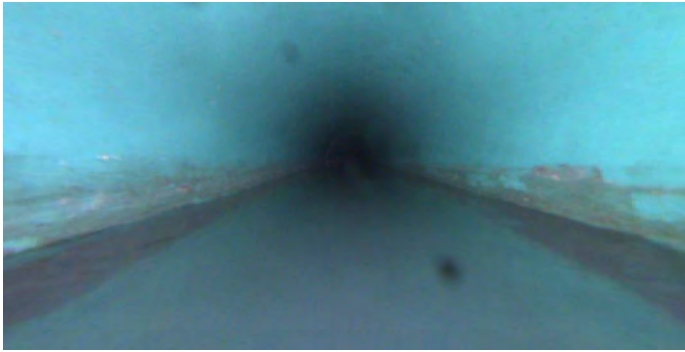
Code: **MWL**
Description: **Water Level**

Distance (ft): **20.8**
Structural Grade: **0**
O&M Grade: **0**
Clock Start/From:
Clock To:
1st Value:
2nd Value:
Value Percent: **20.000**
Continuous Index:
Within 8" of Joint: **NO**
Remarks:

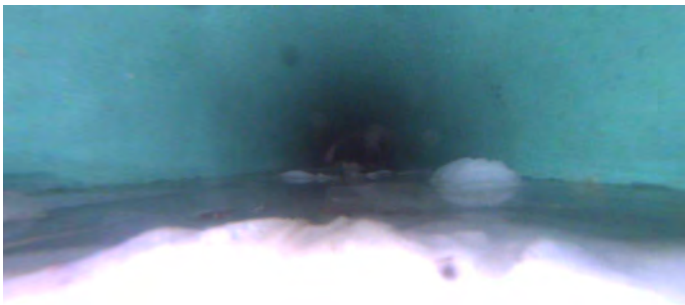
Code: **MWL**
Description: **Water Level**

Distance (ft): **33.0**
Structural Grade: **0**
O&M Grade: **0**
Clock Start/From:
Clock To:
1st Value:
2nd Value:
Value Percent: **40.000**
Continuous Index:
Within 8" of Joint: **NO**
Remarks:

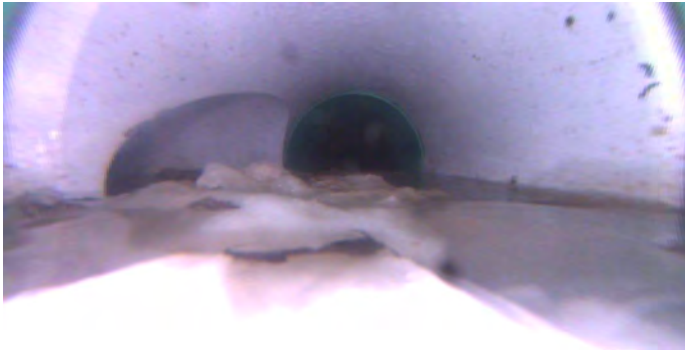
Code: **TF**
Description: **Tap Factory**

Distance (ft): **34.9**
Structural Grade: **0**
O&M Grade: **0**
Clock Start/From: **9**
Clock To:
1st Value: **6.000**
2nd Value:
Value Percent:
Continuous Index:
Within 8" of Joint:
Remarks:

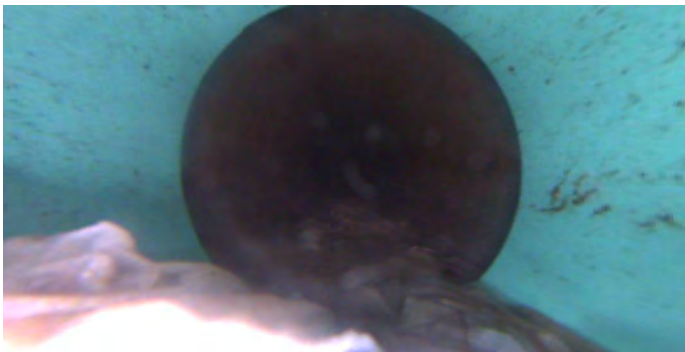
Code: **MMC**
Description: **Material Change**

Distance (ft): **37.5**
Structural Grade: **0**
O&M Grade: **0**
Clock Start/From:
Clock To:
1st Value:
2nd Value:
Value Percent:
Continuous Index:
Within 8" of Joint: **NO**
Remarks: **pvc to vcp**

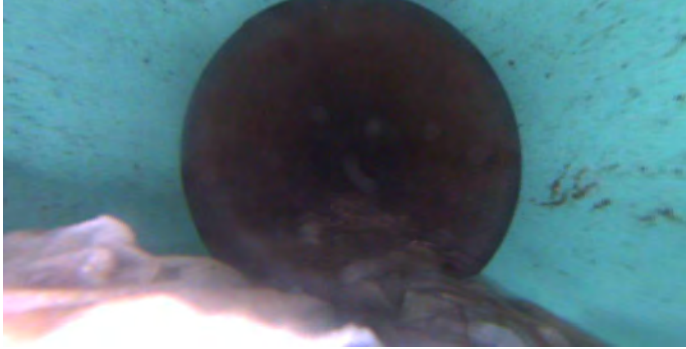
Code: **MWL**
Description: **Water Level**

Distance (ft): **37.5**
Structural Grade: **0**
O&M Grade: **0**
Clock Start/From:
Clock To:
1st Value:
2nd Value:
Value Percent: **10.000**
Continuous Index:
Within 8" of Joint: **NO**
Remarks:

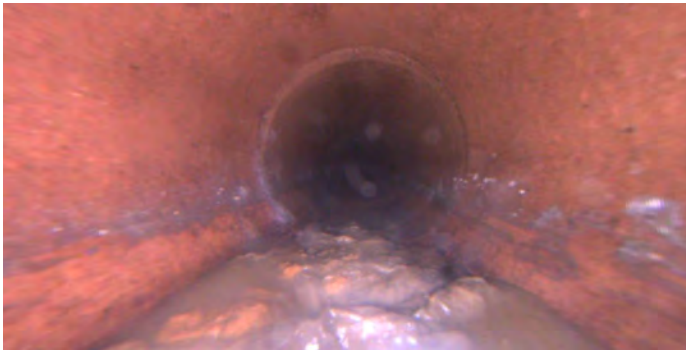
Code: **DSZ**
Description: **Deposits Settled Other**

Distance (ft): **40.8**
Structural Grade: **0**
O&M Grade: **2**
Clock Start/From: **5**
Clock To: **7**
1st Value:
2nd Value:
Value Percent: **10.000**
Continuous Index:
Within 8" of Joint: **NO**
Remarks: **debris**

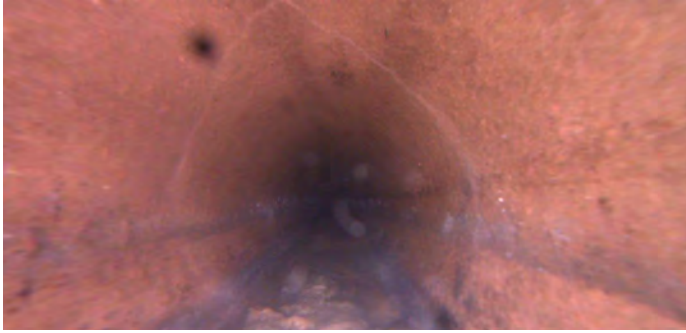
Code: **CC**
Description: **Crack Circumferential**

Distance (ft): **42.4**
Structural Grade: **1**
O&M Grade: **0**
Clock Start/From: **12**
Clock To: **12**
1st Value:
2nd Value:
Value Percent:
Continuous Index:
Within 8" of Joint:
Remarks:

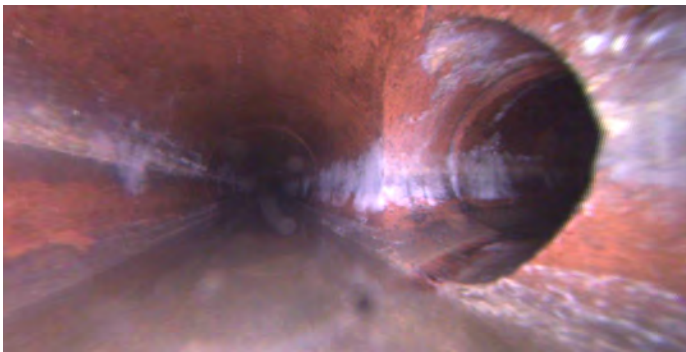
Code: **TF**
Description: **Tap Factory**

Distance (ft): **52.0**
Structural Grade: **0**
O&M Grade: **0**
Clock Start/From: **3**
Clock To:
1st Value: **6.000**
2nd Value:
Value Percent:
Continuous Index:
Within 8" of Joint:
Remarks:

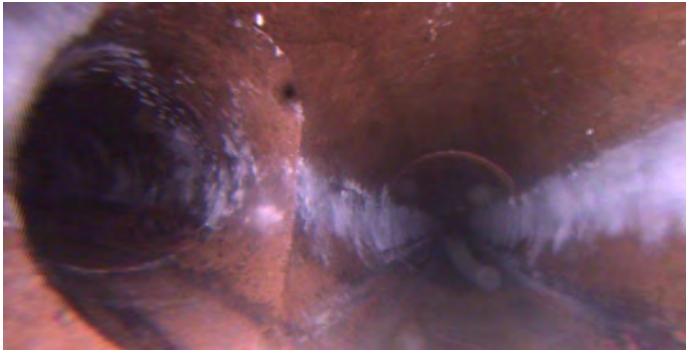
Code: **TF**
Description: **Tap Factory**

Distance (ft): **69.2**
Structural Grade: **0**
O&M Grade: **0**
Clock Start/From: **9**
Clock To:
1st Value: **6.000**
2nd Value:
Value Percent:
Continuous Index:
Within 8" of Joint:
Remarks:

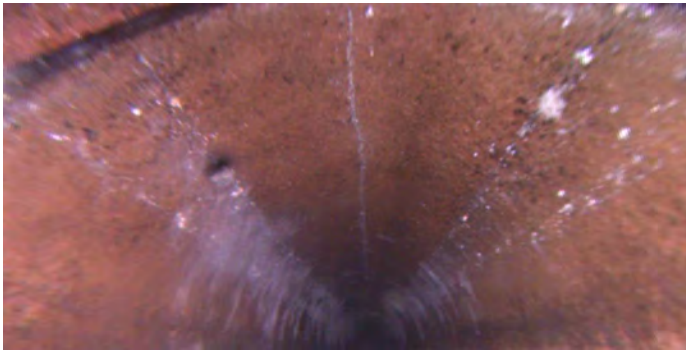
Code: **CL**
Description: **Crack Longitudinal**

Distance (ft): **101.1**
Structural Grade: **2**
O&M Grade: **0**
Clock Start/From: **12**
Clock To:
1st Value:
2nd Value:
Value Percent:
Continuous Index:
Within 8" of Joint:
Remarks:

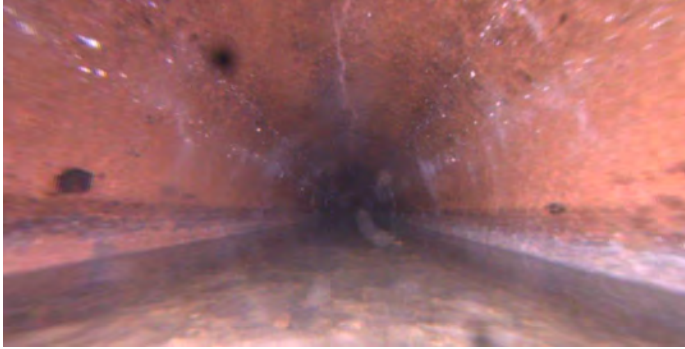
Code: **CL**
Description: **Crack Longitudinal**

Distance (ft): **109.2**
Structural Grade: **2**
O&M Grade: **0**
Clock Start/From: **12**
Clock To:
1st Value:
2nd Value:
Value Percent:
Continuous Index:
Within 8" of Joint: **NO**
Remarks:

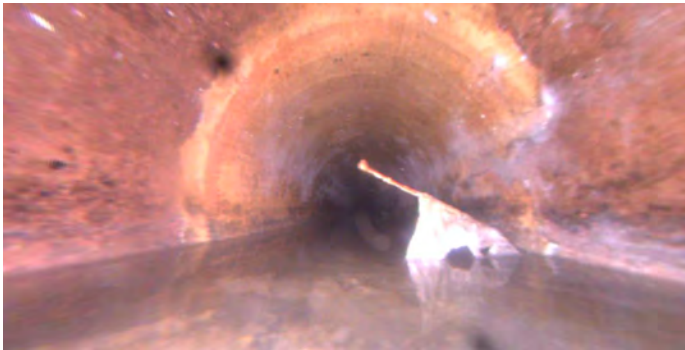
Code: **OBZ**
Description: **Obstacle Other**

Distance (ft): **114.0**
Structural Grade: **0**
O&M Grade: **2**
Clock Start/From: **3**
Clock To: **5**
1st Value:
2nd Value:
Value Percent: **5.000**
Continuous Index:
Within 8" of Joint: **NO**
Remarks: **unknown apparent stick**

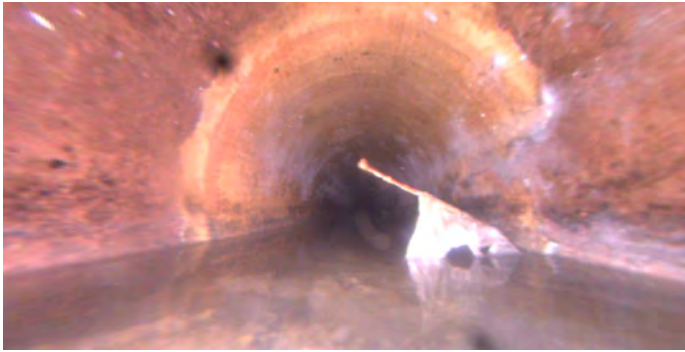
Code: **RPL**
Description: **Repair Localized Liner**

Distance (ft): **114.0**
Structural Grade: **0**
O&M Grade: **0**
Clock Start/From: **12**
Clock To: **12**
1st Value:
2nd Value:
Value Percent:
Continuous Index:
Within 8" of Joint: **NO**
Remarks: **spot liner**

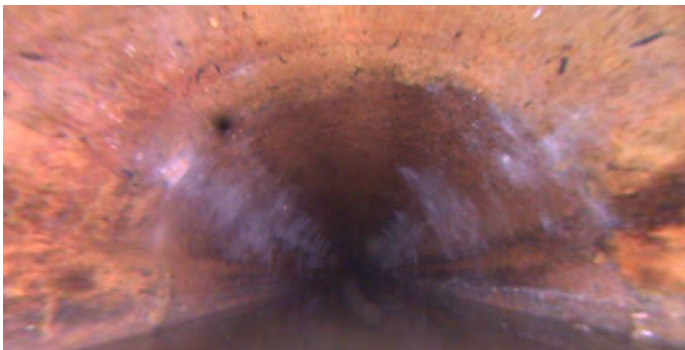
Code: **MGO**
Description: **General Observation**

Distance (ft): **118.2**
Structural Grade: **0**
O&M Grade: **0**
Clock Start/From:
Clock To:
1st Value:
2nd Value:
Value Percent:
Continuous Index:
Within 8" of Joint: **NO**
Remarks: **end of spot liner**

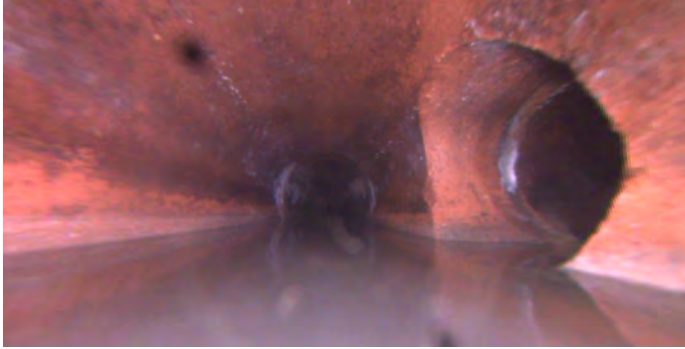
Code: **TF**
Description: **Tap Factory**

Distance (ft): **126.6**
Structural Grade: **0**
O&M Grade: **0**
Clock Start/From: **3**
Clock To:
1st Value: **6.000**
2nd Value:
Value Percent:
Continuous Index:
Within 8" of Joint:
Remarks:

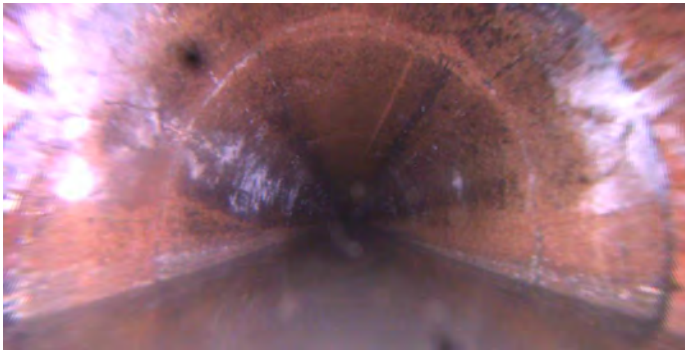
Code: **FC**
Description: **Fracture Circumferential**

Distance (ft): **128.3**
Structural Grade: **2**
O&M Grade: **0**
Clock Start/From: **8**
Clock To: **4**
1st Value:
2nd Value:
Value Percent:
Continuous Index:
Within 8" of Joint:
Remarks:

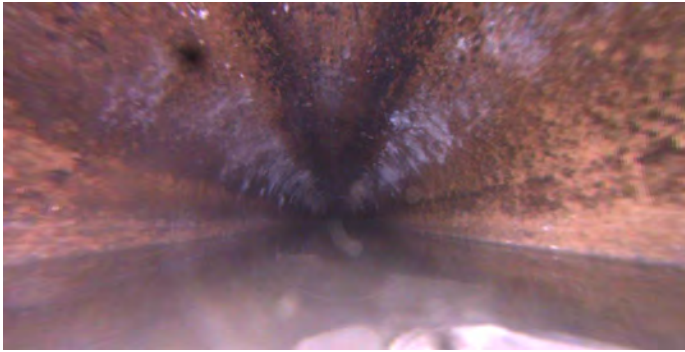
Code: **MWL**
Description: **Water Level**

Distance (ft): **134.1**
Structural Grade: **0**
O&M Grade: **0**
Clock Start/From:
Clock To:
1st Value:
2nd Value:
Value Percent: **25.000**
Continuous Index:
Within 8" of Joint: **NO**
Remarks:

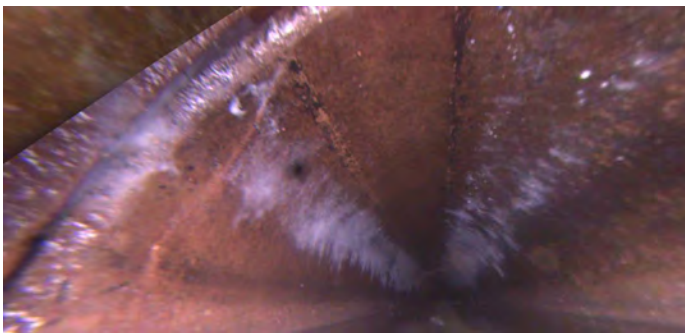
Code: **FC**
Description: **Fracture Circumferential**

Distance (ft): **143.6**
Structural Grade: **2**
O&M Grade: **0**
Clock Start/From: **8**
Clock To: **11**
1st Value:
2nd Value:
Value Percent:
Continuous Index:
Within 8" of Joint: **YES**
Remarks:

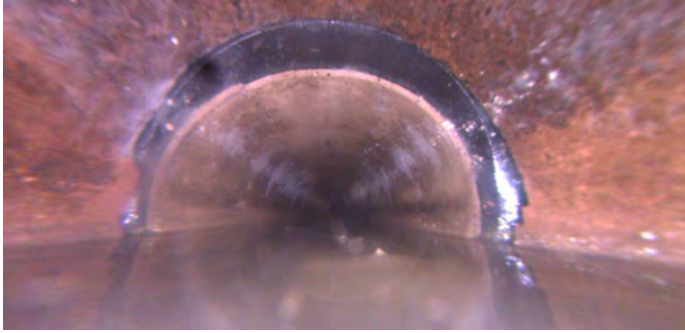
Code: **JSL**
Description: **Joint Separated Large**

Distance (ft): **156.0**
Structural Grade: **2**
O&M Grade: **0**
Clock Start/From:
Clock To:
1st Value:
2nd Value:
Value Percent:
Continuous Index:
Within 8" of Joint: **NO**
Remarks:

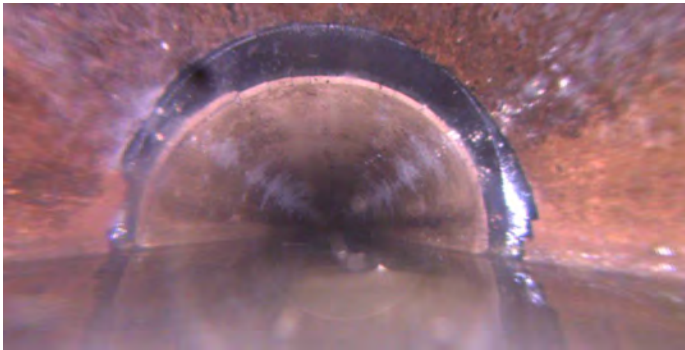
Code: **MMC**
Description: **Material Change**

Distance (ft): **156.0**
Structural Grade: **0**
O&M Grade: **0**
Clock Start/From:
Clock To:
1st Value:
2nd Value:
Value Percent:
Continuous Index:
Within 8" of Joint: **NO**
Remarks: **vcp to pvc**

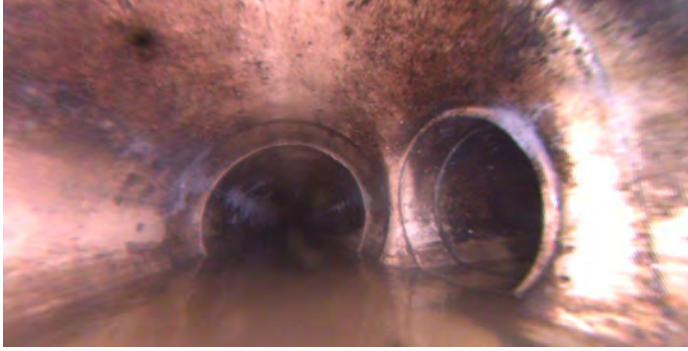
Code: **TF**
Description: **Tap Factory**

Distance (ft): **164.1**
Structural Grade: **0**
O&M Grade: **0**
Clock Start/From: **3**
Clock To:
1st Value: **6.000**
2nd Value:
Value Percent:
Continuous Index:
Within 8" of Joint:
Remarks:

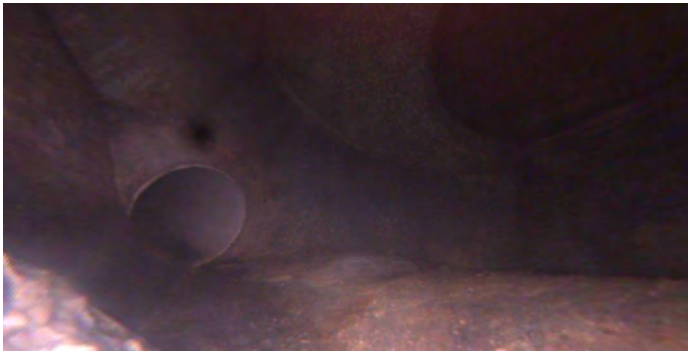
Code: **AMH**
Description: **Manhole**

Distance (ft): **187.2**
Structural Grade: **0**
O&M Grade: **0**
Clock Start/From:
Clock To:
1st Value:
2nd Value:
Value Percent:
Continuous Index:
Within 8" of Joint: **NO**
Remarks: **M-108-002**
