Profile/Photo Observation Report

Street:	FOXCROFT STREET	Flow Control:	Not Controlled
City:	Hobart, IN	Year Renewed:	
Location:	Light Highway	Tape/Media #:	
Purpose:	Routine Assessment	Dia/Height:	8"
Use:	Sanitary	Material:	PVC
Drain Area:	NA	Lining:	
Category:	NA		
Comment:	Flow direction Wrong

Location Details:		Direction of Survey:	Upstream
US MH:	M-108-002	DS MH:	M-108-048
		Total Length Surveyed (ft):	187.2

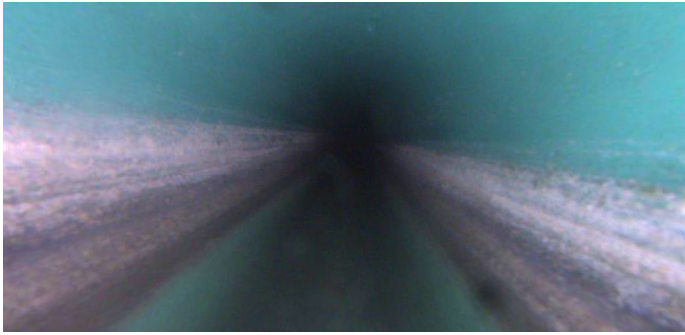
Code: **DAGS**
Description: **Deposits Attached Grease**

Distance (ft): **.0**
Structural Grade: **0**
O&M Grade: **2**
Clock Start/From: **8**
Clock To: **4**
1st Value:
2nd Value:
Value Percent: **5.000**
Continuous Index: **S01**
Within 8" of Joint: **NO**
Remarks:

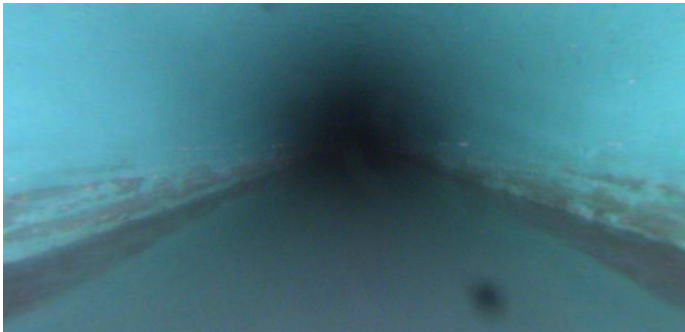
Code: **DAGS**
Description: **Deposits Attached Grease**

Distance (ft): **19.7**
Structural Grade: **0**
O&M Grade: **2**
Clock Start/From: **8**
Clock To: **4**
1st Value:
2nd Value:
Value Percent: **5.000**
Continuous Index: **F01**
Within 8" of Joint: **NO**
Remarks:

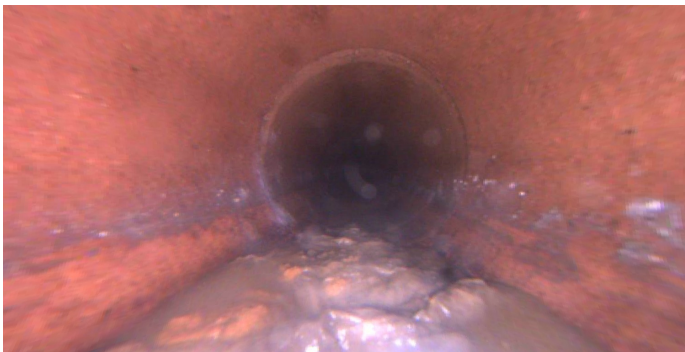
Code: **DSZ**
Description: **Deposits Settled Other**

Distance (ft): **40.8**
Structural Grade: **0**
O&M Grade: **2**
Clock Start/From: **5**
Clock To: **7**
1st Value:
2nd Value:
Value Percent: **10.000**
Continuous Index:
Within 8" of Joint: **NO**
Remarks: **debris**

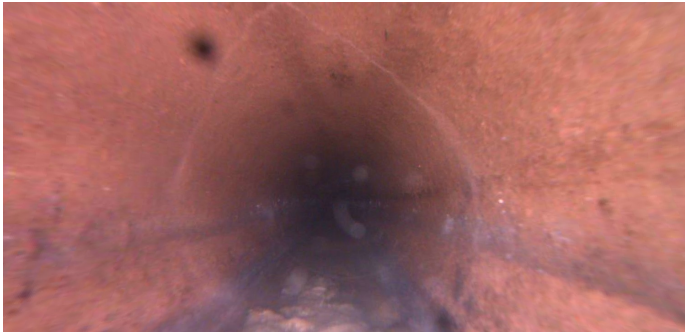
Code: **CC**
Description: **Crack Circumferential**

Distance (ft): **42.4**
Structural Grade: **1**
O&M Grade: **0**
Clock Start/From: **12**
Clock To: **12**
1st Value:
2nd Value:
Value Percent:
Continuous Index:
Within 8" of Joint:
Remarks:

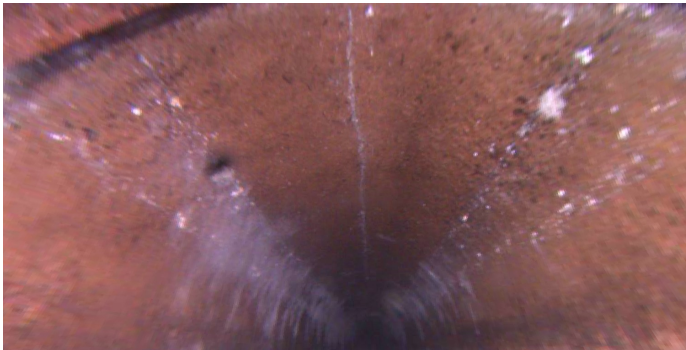
Code: **CL**
Description: **Crack Longitudinal**

Distance (ft): **101.1**
Structural Grade: **2**
O&M Grade: **0**
Clock Start/From: **12**
Clock To:
1st Value:
2nd Value:
Value Percent:
Continuous Index:
Within 8" of Joint:
Remarks:

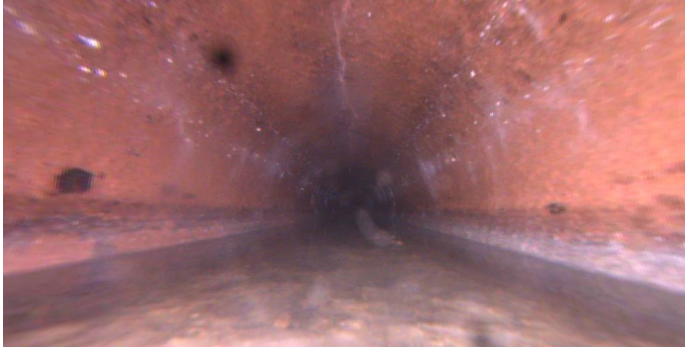
Code: **CL**
Description: **Crack Longitudinal**

Distance (ft): **109.2**
Structural Grade: **2**
O&M Grade: **0**
Clock Start/From: **12**
Clock To:
1st Value:
2nd Value:
Value Percent:
Continuous Index:
Within 8" of Joint: **NO**
Remarks:

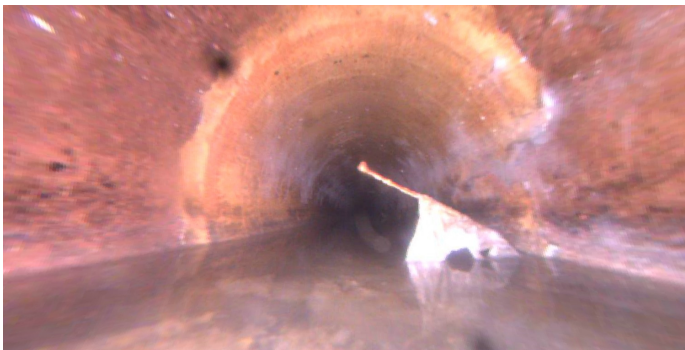
Code: **OBZ**
Description: **Obstacle Other**

Distance (ft): **114.0**
Structural Grade: **0**
O&M Grade: **2**
Clock Start/From: **3**
Clock To: **5**
1st Value:
2nd Value:
Value Percent: **5.000**
Continuous Index:
Within 8" of Joint: **NO**
Remarks: **unknown apparent stick**

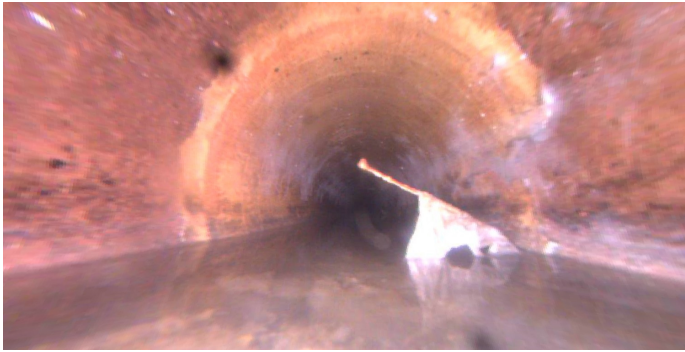
Code: **RPL**
Description: **Repair Localized Liner**

Distance (ft): **114.0**
Structural Grade: **0**
O&M Grade: **0**
Clock Start/From: **12**
Clock To: **12**
1st Value:
2nd Value:
Value Percent:
Continuous Index:
Within 8" of Joint: **NO**
Remarks: **spot liner**

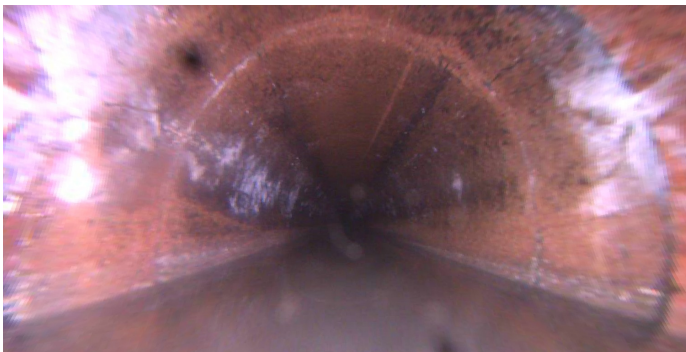
Code: **FC**
Description: **Fracture Circumferential**

Distance (ft): **128.3**
Structural Grade: **2**
O&M Grade: **0**
Clock Start/From: **8**
Clock To: **4**
1st Value:
2nd Value:
Value Percent:
Continuous Index:
Within 8" of Joint:
Remarks:

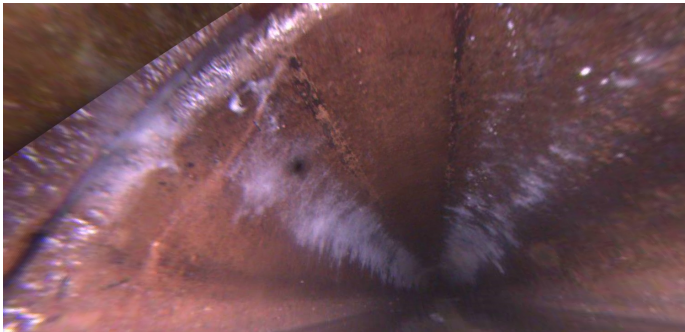
Code: **FC**
Description: **Fracture Circumferential**

Distance (ft): **143.6**
Structural Grade: **2**
O&M Grade: **0**
Clock Start/From: **8**
Clock To: **11**
1st Value:
2nd Value:
Value Percent:
Continuous Index:
Within 8" of Joint: **YES**
Remarks:

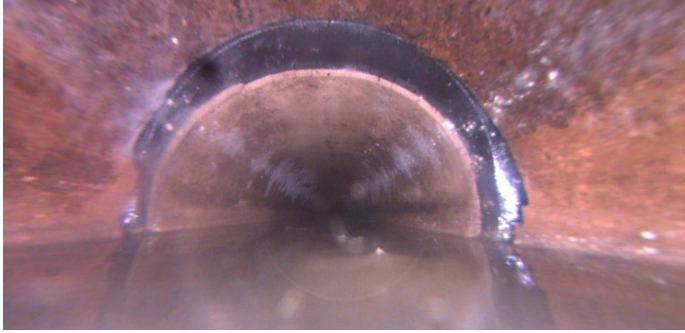
Code: **JSL**
Description: **Joint Separated Large**

Distance (ft): **156.0**
Structural Grade: **2**
O&M Grade: **0**
Clock Start/From:
Clock To:
1st Value:
2nd Value:
Value Percent:
Continuous Index:
Within 8" of Joint: **NO**
Remarks:
