Profile/Photo Observation Report

Date:	03/24/2018	Weather:		Coding:	PACP 6.0
Pipe Length (ft):	304.4	Owner:	NA	Pre Clean:	No Pre-Cleaning
P.O.#:		Surveyor:	Justin Gonzales	PSR:	P-108-002-004
Customer:		Clean Date:	01/01/1900	Shape:	C

Street:	HOWARD CT & 14TH LN	Flow Control:	Not Controlled
City:	Hobart, IN	Year Renewed:	
Location:	Light Highway	Tape/Media #:	
Purpose:	Routine Assessment	Dia/Height:	10"
Use:	Sanitary	Material:	VCP
Drain Area:	NA	Lining:	
Category:	NA		
Comment:	Flow direction wrong		
Location Details:		Direction of Survey:	Downstream
US MH:	M-108-004	DS MH:	M-108-002
		Total Length Surveyed (ft):	314.1

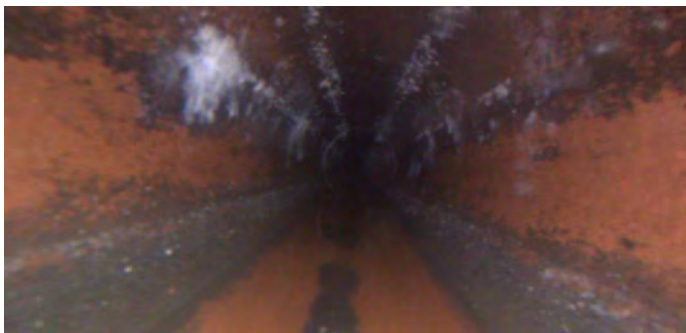
Code: **AMH**
Description: **Manhole**

Distance (ft): **.0**
Structural Grade: **0**
O&M Grade: **0**
Clock Start/From:
Clock To:
1st Value:
2nd Value:
Value Percent:
Continuous Index:
Within 8" of Joint: **NO**
Remarks: **M-108-004**

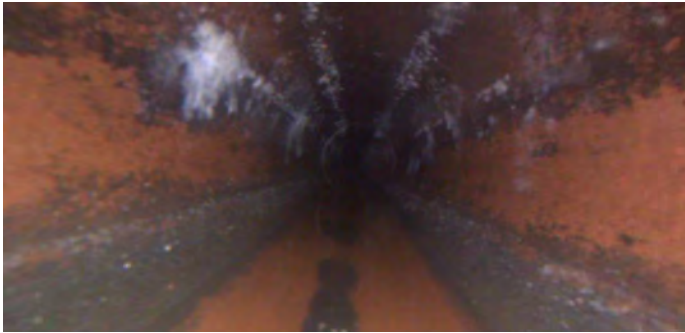
Code:	MWL
Description:	Water Level

Distance (ft):	.0
Structural Grade:	0
O&M Grade:	0
Clock Start/From:	
Clock To:	
1st Value:	
2nd Value:	
Value Percent:	5.000
Continuous Index:	
Within 8" of Joint:	NO
Remarks:

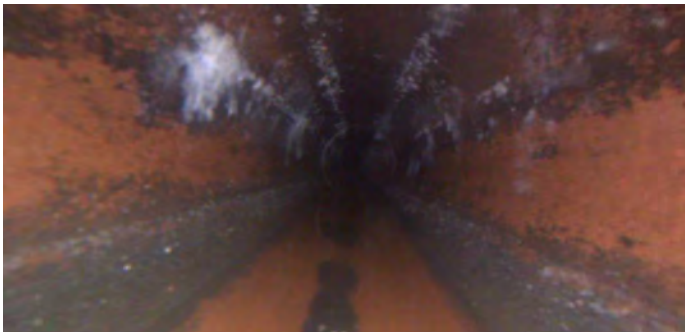
Code:	DAGS
Description:	Deposits Attached Grease

Distance (ft):	.0
Structural Grade:	0
O&M Grade:	2
Clock Start/From:	7
Clock To:	5
1st Value:	
2nd Value:	
Value Percent:	5.000
Continuous Index:	S01
Within 8" of Joint:	YES
Remarks:	WANDER

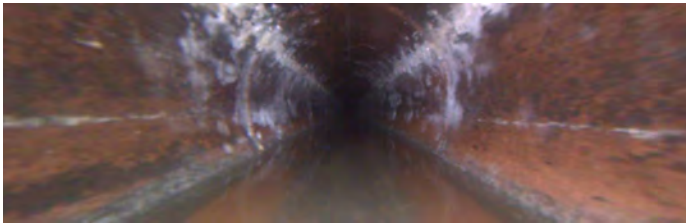
Code: **DSF**
Description: **Deposits Settled Fine**

Distance (ft): **44.2**
Structural Grade: **0**
O&M Grade: **2**
Clock Start/From: **6**
Clock To:
1st Value:
2nd Value:
Value Percent: **5.000**
Continuous Index:
Within 8" of Joint: **NO**
Remarks:

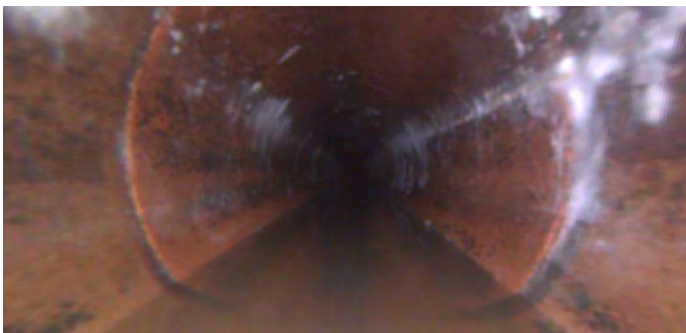
Code: **DSF**
Description: **Deposits Settled Fine**

Distance (ft): **54.9**
Structural Grade: **0**
O&M Grade: **2**
Clock Start/From: **6**
Clock To:
1st Value:
2nd Value:
Value Percent: **5.000**
Continuous Index:
Within 8" of Joint:
Remarks:

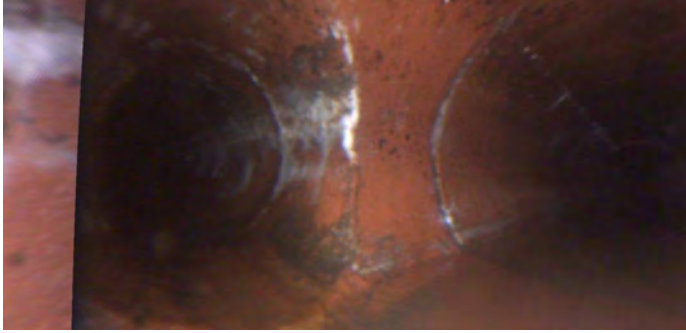
Code: **TF**
Description: **Tap Factory**

Distance (ft): **77.9**
Structural Grade: **0**
O&M Grade: **0**
Clock Start/From: **9**
Clock To:
1st Value: **4.000**
2nd Value:
Value Percent:
Continuous Index:
Within 8" of Joint:
Remarks:

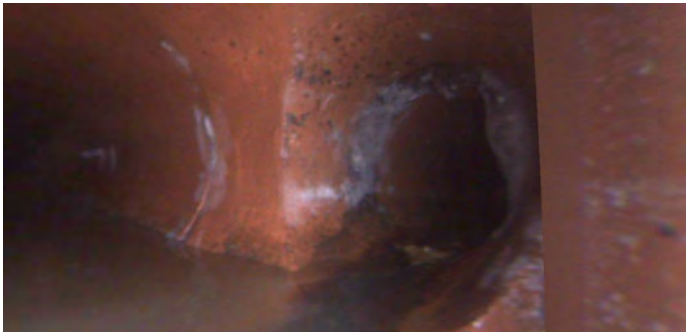
Code: **TF**
Description: **Tap Factory**

Distance (ft): **111.9**
Structural Grade: **0**
O&M Grade: **0**
Clock Start/From: **3**
Clock To:
1st Value: **4.000**
2nd Value:
Value Percent:
Continuous Index:
Within 8" of Joint:
Remarks:

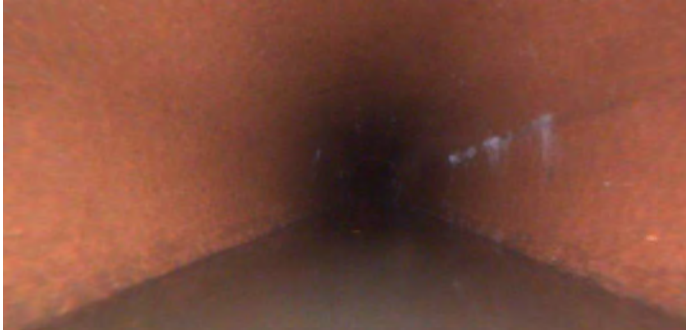
Code: **CL**
Description: **Crack Longitudinal**

Distance (ft): **113.5**
Structural Grade: **2**
O&M Grade: **0**
Clock Start/From: **3**
Clock To:
1st Value:
2nd Value:
Value Percent:
Continuous Index:
Within 8" of Joint:
Remarks:

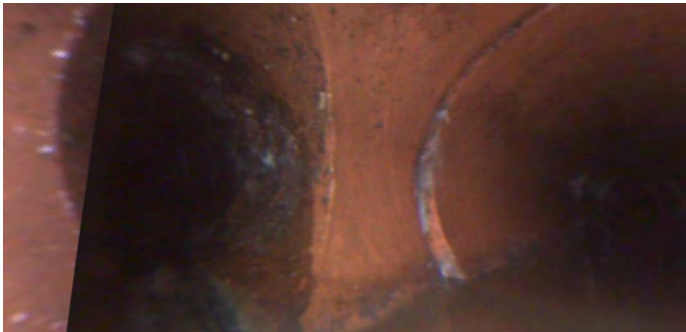
Code: **TF**
Description: **Tap Factory**

Distance (ft): **140.7**
Structural Grade: **0**
O&M Grade: **0**
Clock Start/From: **9**
Clock To:
1st Value: **4.000**
2nd Value:
Value Percent:
Continuous Index:
Within 8" of Joint:
Remarks:

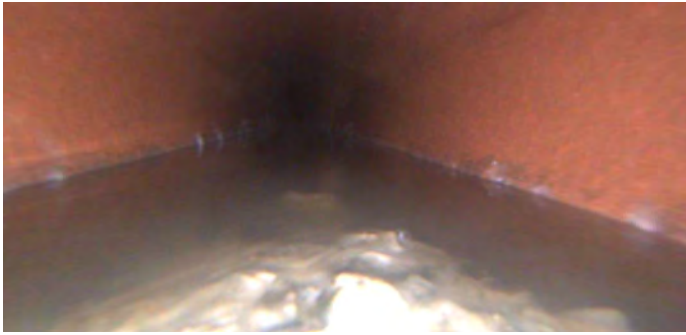
Code: **MGO**
Description: **General Observation**

Distance (ft): **164.0**
Structural Grade: **0**
O&M Grade: **0**
Clock Start/From:
Clock To:
1st Value:
2nd Value:
Value Percent:
Continuous Index:
Within 8" of Joint: **NO**
Remarks: **TOILET TISSUE**

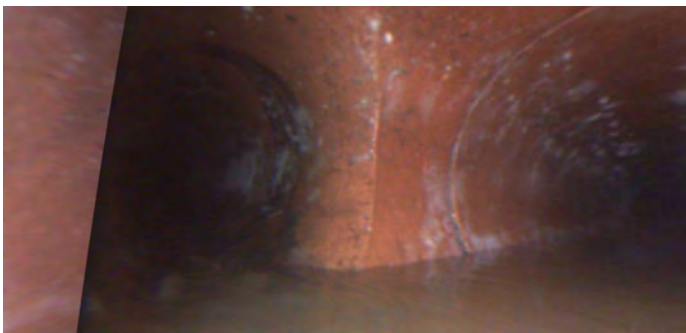
Code: **TF**
Description: **Tap Factory**

Distance (ft): **195.4**
Structural Grade: **0**
O&M Grade: **0**
Clock Start/From: **9**
Clock To:
1st Value: **4.000**
2nd Value:
Value Percent:
Continuous Index:
Within 8" of Joint:
Remarks:

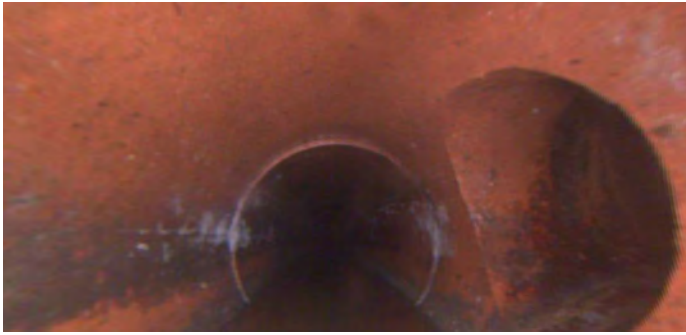
Code: **TF**
Description: **Tap Factory**

Distance (ft): **249.8**
Structural Grade: **0**
O&M Grade: **0**
Clock Start/From: **3**
Clock To:
1st Value: **4.000**
2nd Value:
Value Percent:
Continuous Index:
Within 8" of Joint:
Remarks:

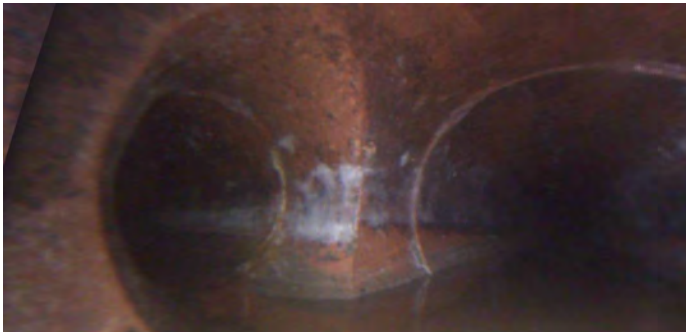
Code: **TF**
Description: **Tap Factory**

Distance (ft): **262.7**
Structural Grade: **0**
O&M Grade: **0**
Clock Start/From: **9**
Clock To:
1st Value: **4.000**
2nd Value:
Value Percent:
Continuous Index:
Within 8" of Joint:
Remarks:

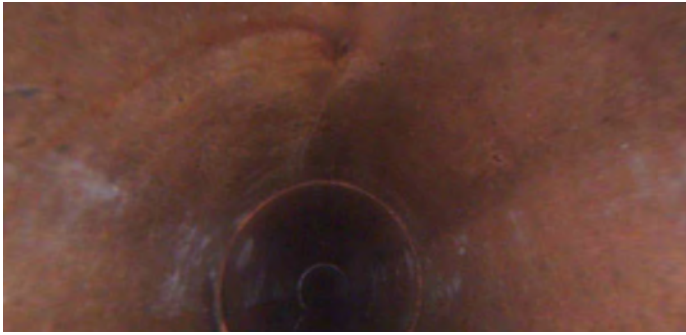
Code: **FL**
Description: **Fracture Longitudinal**

Distance (ft): **294.0**
Structural Grade: **3**
O&M Grade: **0**
Clock Start/From: **12**
Clock To:
1st Value:
2nd Value:
Value Percent:
Continuous Index:
Within 8" of Joint: **YES**
Remarks:

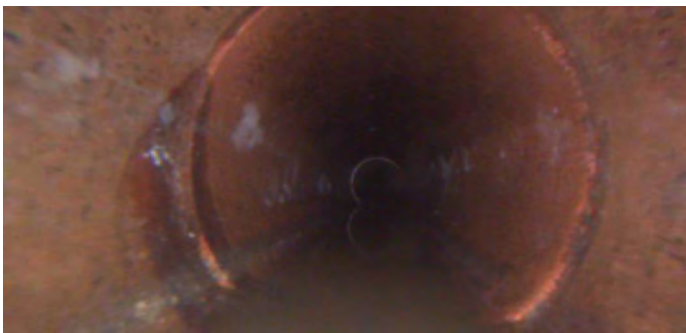
Code: **IS**
Description: **Infil Stain**

Distance (ft): **294.7**
Structural Grade: **0**
O&M Grade: **0**
Clock Start/From: **7**
Clock To: **10**
1st Value:
2nd Value:
Value Percent:
Continuous Index:
Within 8" of Joint: **YES**
Remarks:

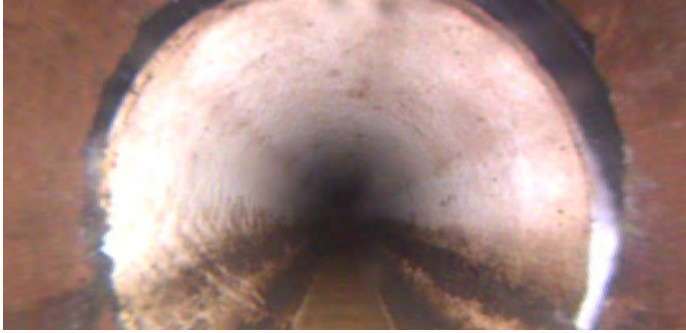
Code: **RPR**
Description: **Repair Point Pipe Replaced**

Distance (ft): **299.0**
Structural Grade: **0**
O&M Grade: **0**
Clock Start/From:
Clock To:
1st Value:
2nd Value:
Value Percent:
Continuous Index:
Within 8" of Joint: **NO**
Remarks: **VCP TO PVC**

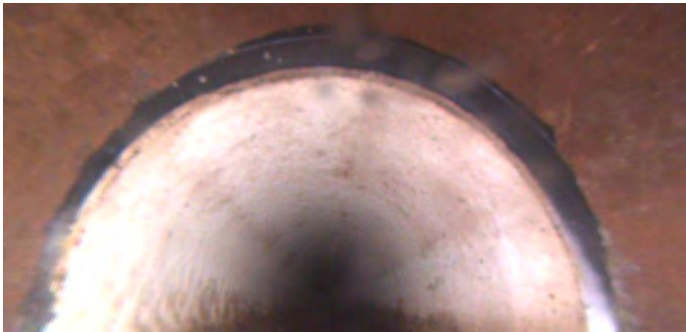
Code: **JOM**
Description: **Joint Offset Medium**

Distance (ft): **299.0**
Structural Grade: **1**
O&M Grade: **0**
Clock Start/From:
Clock To:
1st Value:
2nd Value:
Value Percent:
Continuous Index:
Within 8" of Joint: **NO**
Remarks:

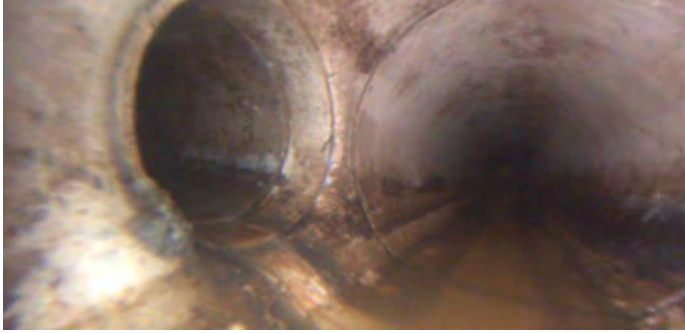
Code: **TF**
Description: **Tap Factory**

Distance (ft): **306.6**
Structural Grade: **0**
O&M Grade: **0**
Clock Start/From: **9**
Clock To:
1st Value: **4.000**
2nd Value:
Value Percent:
Continuous Index:
Within 8" of Joint:
Remarks:

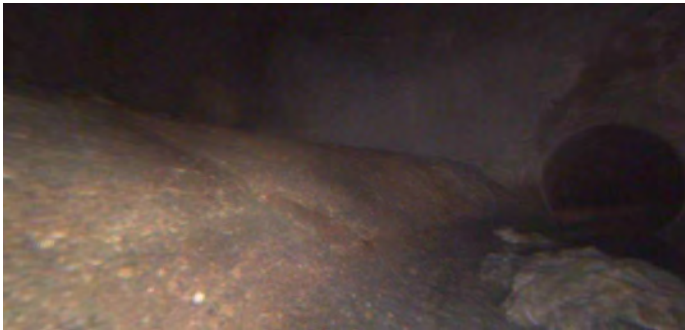
Code: **RPR**
Description: **Repair Point Pipe Replaced**

Distance (ft): **314.1**
Structural Grade: **0**
O&M Grade: **0**
Clock Start/From:
Clock To:
1st Value:
2nd Value:
Value Percent:
Continuous Index:
Within 8" of Joint: **NO**
Remarks: **RPR END**

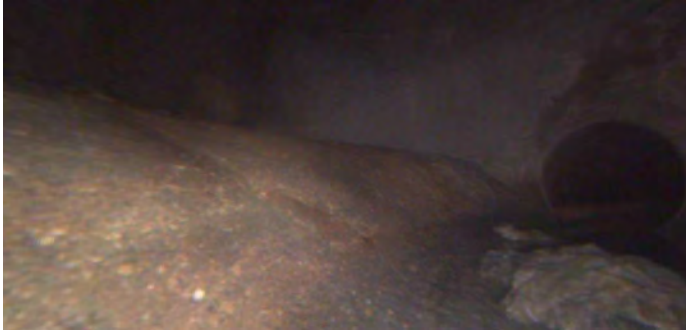
Code: **DAGS**
Description: **Deposits Attached Grease**

Distance (ft): **314.1**
Structural Grade: **0**
O&M Grade: **2**
Clock Start/From: **7**
Clock To: **5**
1st Value:
2nd Value:
Value Percent: **5.000**
Continuous Index: **F01**
Within 8" of Joint: **YES**
Remarks: **WANDER**

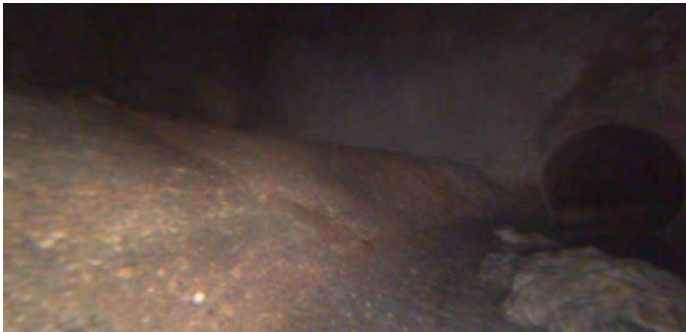
Code: **AMH**
Description: **Manhole**

Distance (ft): **314.1**
Structural Grade: **0**
O&M Grade: **0**
Clock Start/From:
Clock To:
1st Value:
2nd Value:
Value Percent:
Continuous Index:
Within 8" of Joint: **NO**
Remarks: **M-108-002**
