## Profile/Photo Observation Report

Date:	<b>03/24/2018</b>	Weather:		Coding:	<b>PACP 6.0</b>
Pipe Length (ft):	<b>304.4</b>	Owner:	<b>NA</b>	Pre Clean:	<b>No Pre-Cleaning</b>
P.O.#:		Surveyor:	<b>Justin Gonzales</b>	PSR:	<b>P-108-002-004</b>
Customer:		Clean Date:	<b>01/01/1900</b>	Shape:	<b>C</b>

Street:	<b>FOXCROFT STREET</b>	Flow Control:	<b>Not Controlled</b>
City:	<b>Hobart, IN</b>	Year Renewed:	
Location:	<b>Light Highway</b>	Tape/Media #:	
Purpose:	<b>Routine Assessment</b>	Dia/Height:	<b>10"</b>
Use:	<b>Sanitary</b>	Material:	<b>VCP</b>
Drain Area:	<b>NA</b>	Lining:	
Category:	<b>NA</b>		
Comment:	<b>Flow direction wrong</b>

Location Details:		Direction of Survey:	<b>Downstream</b>
US MH:	<b>M-108-004</b>	DS MH:	<b>M-108-002</b>
		Total Length Surveyed (ft):	<b>314.1</b>

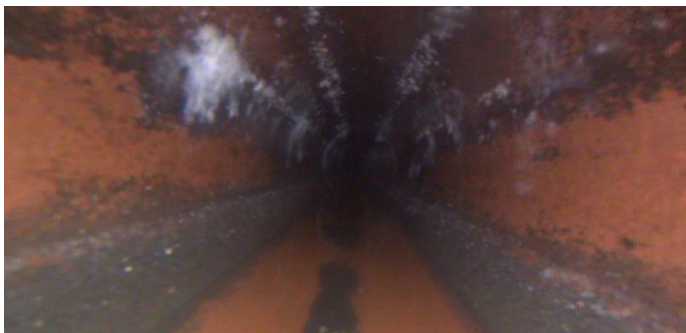
Code: **AMH**  
Description: **Manhole**

Distance (ft): **.0**  
Structural Grade: **0**  
O&M Grade: **0**  
Clock Start/From:  
Clock To:  
1st Value:  
2nd Value:  
Value Percent:  
Continuous Index:  
Within 8" of Joint: **NO**  
Remarks: **M-108-004**

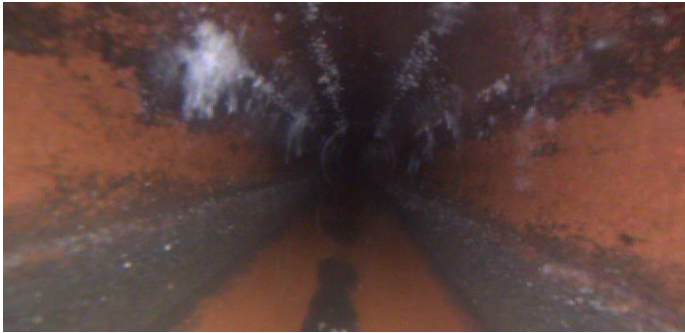
Code:	<b>MWL</b>
Description:	<b>Water Level</b>

Distance (ft):	<b>.0</b>
Structural Grade:	<b>0</b>
O&M Grade:	<b>0</b>
Clock Start/From:	
Clock To:	
1st Value:	
2nd Value:	
Value Percent:	<b>5.000</b>
Continuous Index:	
Within 8" of Joint:	<b>NO</b>
Remarks:

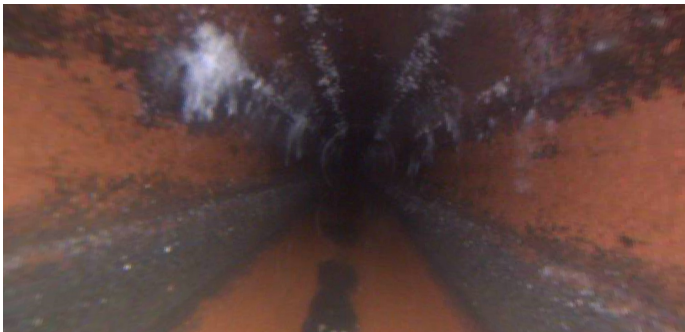
Code:	<b>DAGS</b>
Description:	<b>Deposits Attached Grease</b>

Distance (ft):	<b>.0</b>
Structural Grade:	<b>0</b>
O&M Grade:	<b>2</b>
Clock Start/From:	<b>7</b>
Clock To:	<b>5</b>
1st Value:	
2nd Value:	
Value Percent:	<b>5.000</b>
Continuous Index:	<b>S01</b>
Within 8" of Joint:	<b>YES</b>
Remarks:	<b>WANDER</b>

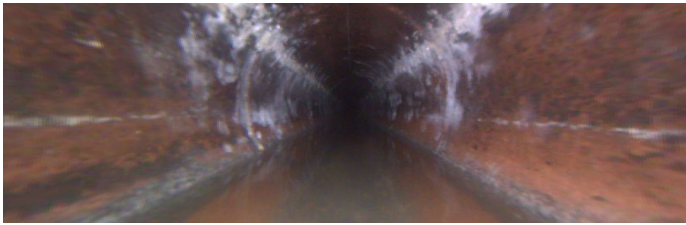
Code: **DSF**  
Description: **Deposits Settled Fine**

Distance (ft): **44.2**  
Structural Grade: **0**  
O&M Grade: **2**  
Clock Start/From: **6**  
Clock To:  
1st Value:  
2nd Value:  
Value Percent: **5.000**  
Continuous Index:  
Within 8" of Joint: **NO**  
Remarks:

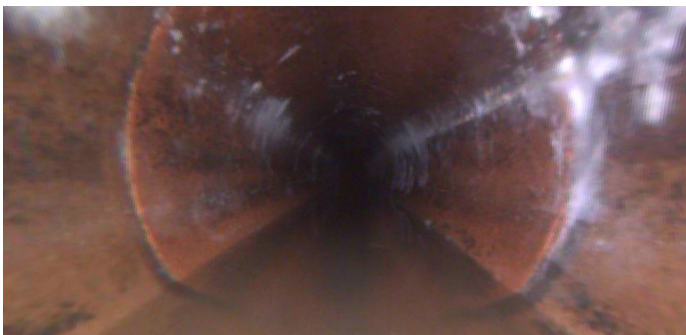
Code: **DSF**  
Description: **Deposits Settled Fine**

Distance (ft): **54.9**  
Structural Grade: **0**  
O&M Grade: **2**  
Clock Start/From: **6**  
Clock To:  
1st Value:  
2nd Value:  
Value Percent: **5.000**  
Continuous Index:  
Within 8" of Joint:  
Remarks:

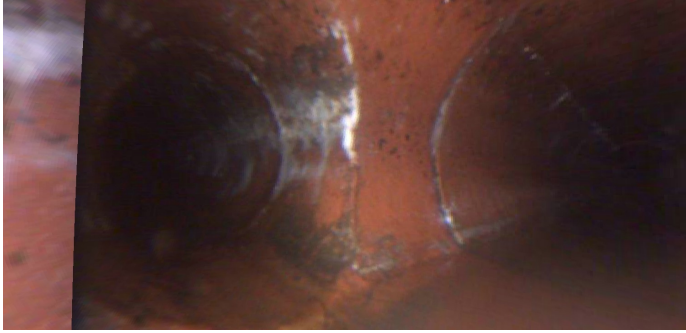
Code: **TF**  
Description: **Tap Factory**

Distance (ft): **77.9**  
Structural Grade: **0**  
O&M Grade: **0**  
Clock Start/From: **9**  
Clock To:  
1st Value: **4.000**  
2nd Value:  
Value Percent:  
Continuous Index:  
Within 8" of Joint:  
Remarks:

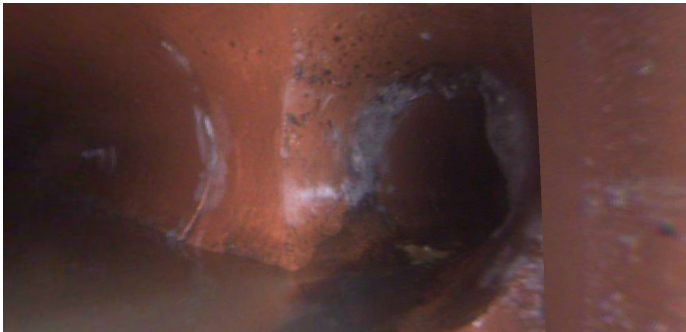
Code: **TF**  
Description: **Tap Factory**

Distance (ft): **111.9**  
Structural Grade: **0**  
O&M Grade: **0**  
Clock Start/From: **3**  
Clock To:  
1st Value: **4.000**  
2nd Value:  
Value Percent:  
Continuous Index:  
Within 8" of Joint:  
Remarks:

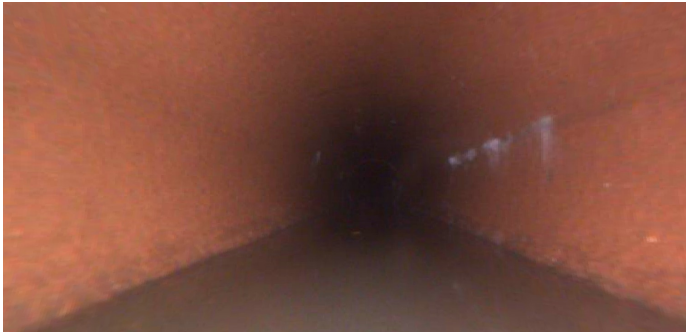
Code: **CL**  
Description: **Crack Longitudinal**

Distance (ft): **113.5**  
Structural Grade: **2**  
O&M Grade: **0**  
Clock Start/From: **3**  
Clock To:  
1st Value:  
2nd Value:  
Value Percent:  
Continuous Index:  
Within 8" of Joint:  
Remarks:

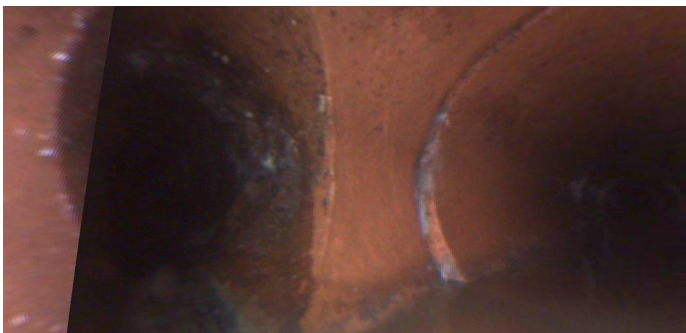
Code: **TF**  
Description: **Tap Factory**

Distance (ft): **140.7**  
Structural Grade: **0**  
O&M Grade: **0**  
Clock Start/From: **9**  
Clock To:  
1st Value: **4.000**  
2nd Value:  
Value Percent:  
Continuous Index:  
Within 8" of Joint:  
Remarks:

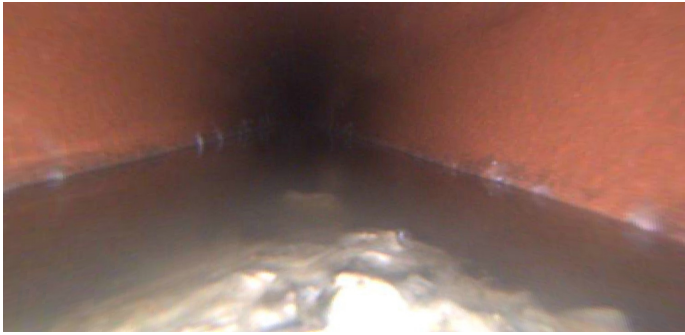
Code: **MGO**  
Description: **General Observation**

Distance (ft): **164.0**  
Structural Grade: **0**  
O&M Grade: **0**  
Clock Start/From:  
Clock To:  
1st Value:  
2nd Value:  
Value Percent:  
Continuous Index:  
Within 8" of Joint: **NO**  
Remarks: **TOILET TISSUE**

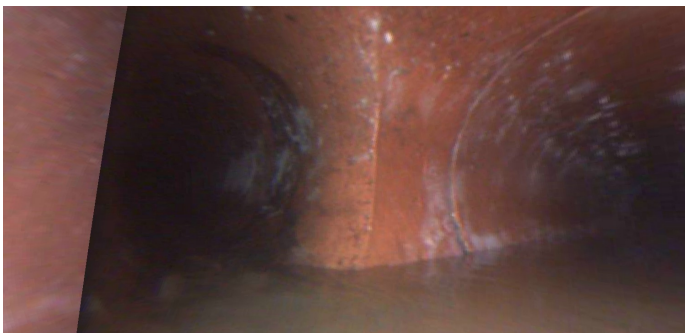
Code: **TF**  
Description: **Tap Factory**

Distance (ft): **195.4**  
Structural Grade: **0**  
O&M Grade: **0**  
Clock Start/From: **9**  
Clock To:  
1st Value: **4.000**  
2nd Value:  
Value Percent:  
Continuous Index:  
Within 8" of Joint:  
Remarks:

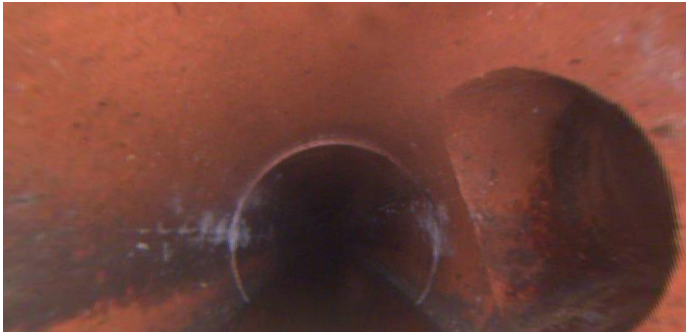
Code: **TF**  
Description: **Tap Factory**

Distance (ft): **249.8**  
Structural Grade: **0**  
O&M Grade: **0**  
Clock Start/From: **3**  
Clock To:  
1st Value: **4.000**  
2nd Value:  
Value Percent:  
Continuous Index:  
Within 8" of Joint:  
Remarks:

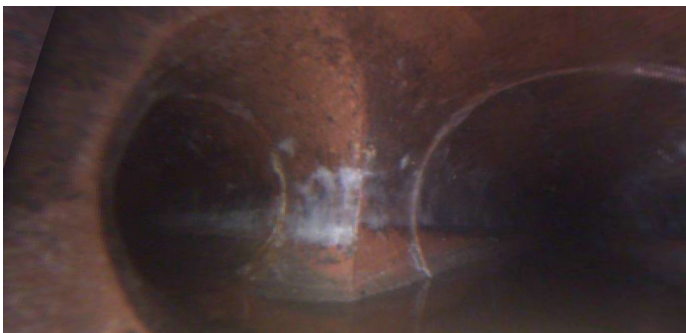
Code: **TF**  
Description: **Tap Factory**

Distance (ft): **262.7**  
Structural Grade: **0**  
O&M Grade: **0**  
Clock Start/From: **9**  
Clock To:  
1st Value: **4.000**  
2nd Value:  
Value Percent:  
Continuous Index:  
Within 8" of Joint:  
Remarks:

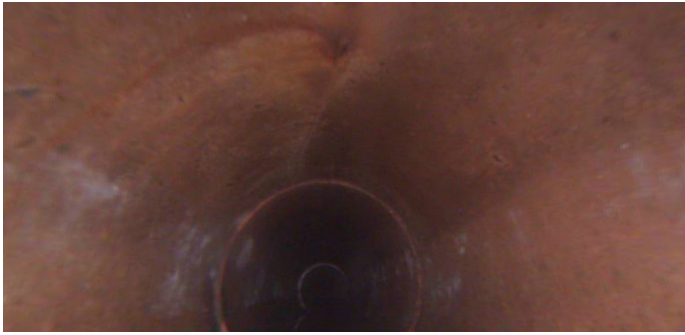
Code: **FL**  
Description: **Fracture Longitudinal**

Distance (ft): **294.0**  
Structural Grade: **3**  
O&M Grade: **0**  
Clock Start/From: **12**  
Clock To:  
1st Value:  
2nd Value:  
Value Percent:  
Continuous Index:  
Within 8" of Joint: **YES**  
Remarks:

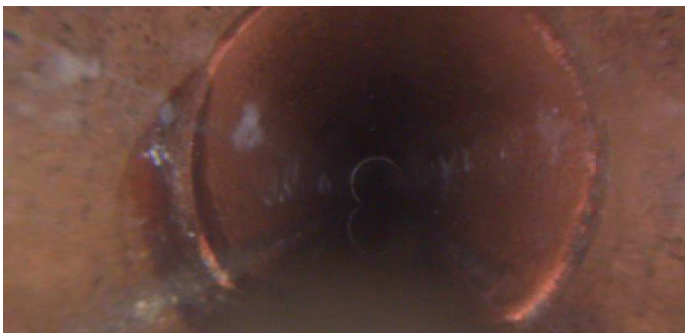
Code: **IS**  
Description: **Infil Stain**

Distance (ft): **294.7**  
Structural Grade: **0**  
O&M Grade: **0**  
Clock Start/From: **7**  
Clock To: **10**  
1st Value:  
2nd Value:  
Value Percent:  
Continuous Index:  
Within 8" of Joint: **YES**  
Remarks:

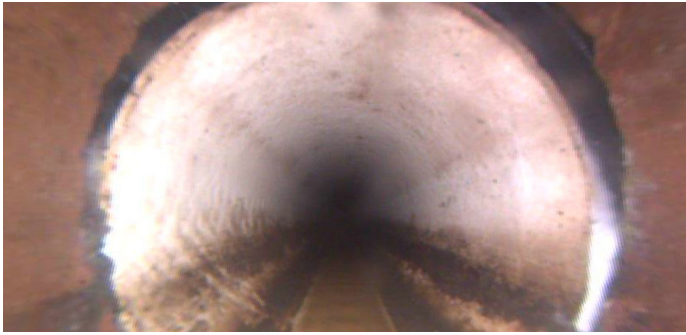
Code: **RPR**  
Description: **Repair Point Pipe Replaced**

Distance (ft): **299.0**  
Structural Grade: **0**  
O&M Grade: **0**  
Clock Start/From:  
Clock To:  
1st Value:  
2nd Value:  
Value Percent:  
Continuous Index:  
Within 8" of Joint: **NO**  
Remarks: **VCP TO PVC**

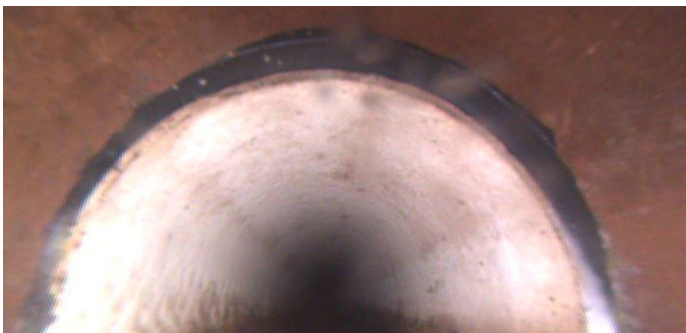
Code: **JOM**  
Description: **Joint Offset Medium**

Distance (ft): **299.0**  
Structural Grade: **1**  
O&M Grade: **0**  
Clock Start/From:  
Clock To:  
1st Value:  
2nd Value:  
Value Percent:  
Continuous Index:  
Within 8" of Joint: **NO**  
Remarks:

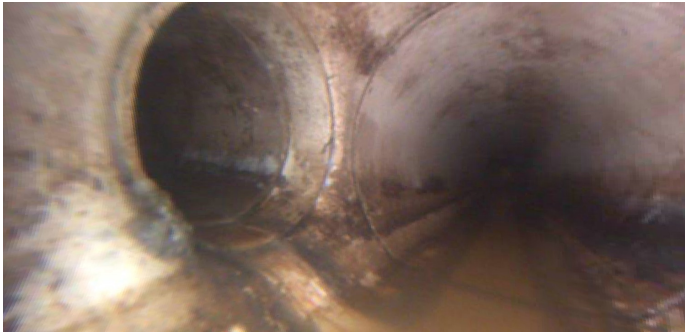
Code: **TF**  
Description: **Tap Factory**

Distance (ft): **306.6**  
Structural Grade: **0**  
O&M Grade: **0**  
Clock Start/From: **9**  
Clock To:  
1st Value: **4.000**  
2nd Value:  
Value Percent:  
Continuous Index:  
Within 8" of Joint:  
Remarks:

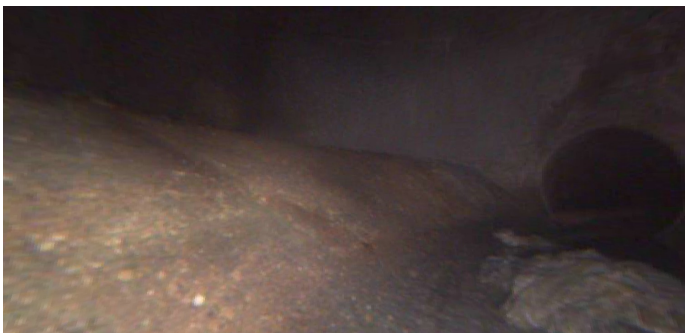
Code: **RPR**  
Description: **Repair Point Pipe Replaced**

Distance (ft): **314.1**  
Structural Grade: **0**  
O&M Grade: **0**  
Clock Start/From:  
Clock To:  
1st Value:  
2nd Value:  
Value Percent:  
Continuous Index:  
Within 8" of Joint: **NO**  
Remarks: **RPR END**

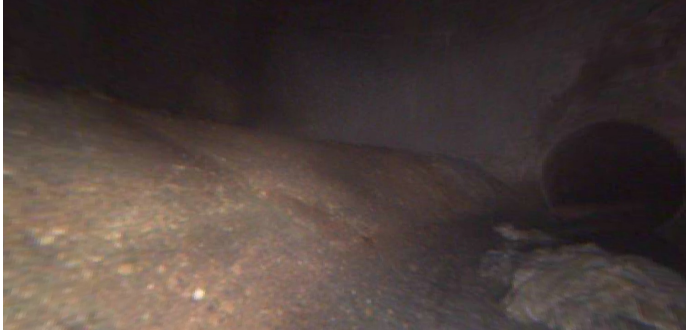
Code: **DAGS**  
Description: **Deposits Attached Grease**

Distance (ft): **314.1**  
Structural Grade: **0**  
O&M Grade: **2**  
Clock Start/From: **7**  
Clock To: **5**  
1st Value:  
2nd Value:  
Value Percent: **5.000**  
Continuous Index: **F01**  
Within 8" of Joint: **YES**  
Remarks: **WANDER**

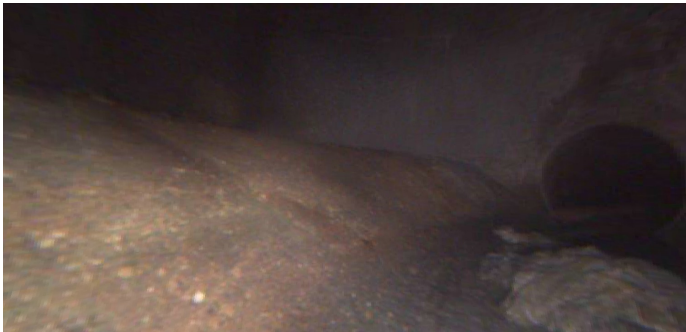
Code: **AMH**  
Description: **Manhole**

Distance (ft): **314.1**  
Structural Grade: **0**  
O&M Grade: **0**  
Clock Start/From:  
Clock To:  
1st Value:  
2nd Value:  
Value Percent:  
Continuous Index:  
Within 8" of Joint: **NO**  
Remarks: **M-108-002**
