Profile/Photo Observation Report

Street:	HOWARD CT & 14TH LN	Flow Control:	Not Controlled
City:	Hobart, IN	Year Renewed:	
Location:	Light Highway	Tape/Media #:	
Purpose:	Routine Assessment	Dia/Height:	12"
Use:	Sanitary	Material:	VCP
Drain Area:	NA	Lining:	
Category:	NA		
Comment:	P_C at 146 ft in O_C . Flow direction wrong		
Location Details:		Direction of Survey:	Downstream
US MH:	M-108-004	DS MH:	M-108-003
		Total Length Surveyed (ft):	147.4

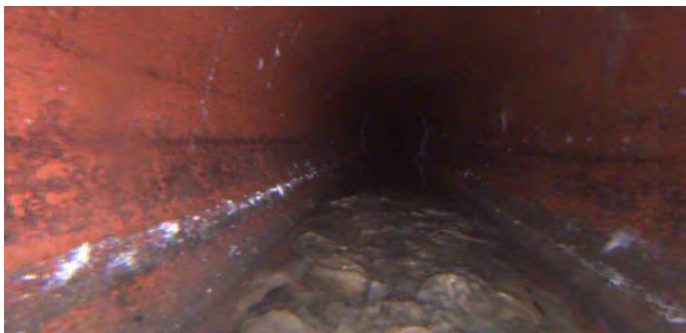
Code: **AMH**
Description: **Manhole**

Distance (ft): **.0**
Structural Grade: **0**
O&M Grade: **0**
Clock Start/From:
Clock To:
1st Value:
2nd Value:
Value Percent:
Continuous Index:
Within 8" of Joint: **NO**
Remarks: **M-108-004**

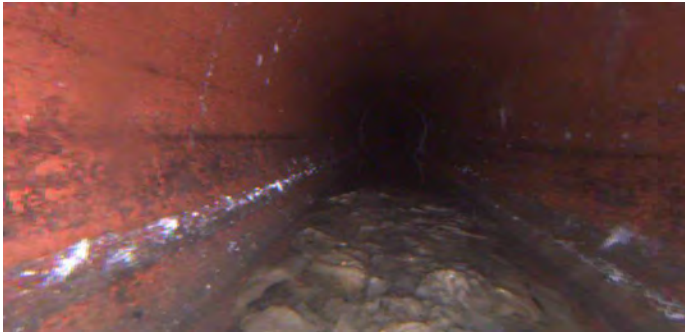
Code:	MWL
Description:	Water Level

Distance (ft):	.0
Structural Grade:	0
O&M Grade:	0
Clock Start/From:	
Clock To:	
1st Value:	
2nd Value:	
Value Percent:	10.000
Continuous Index:	
Within 8" of Joint:	NO
Remarks:

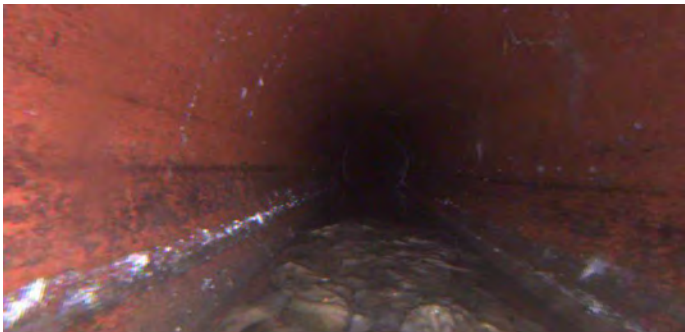
Code:	DAZ
Description:	Deposits Attached Other

Distance (ft):	.0
Structural Grade:	0
O&M Grade:	2
Clock Start/From:	7
Clock To:	5
1st Value:	
2nd Value:	
Value Percent:	5.000
Continuous Index:	S01
Within 8" of Joint:	YES
Remarks:	WANDER

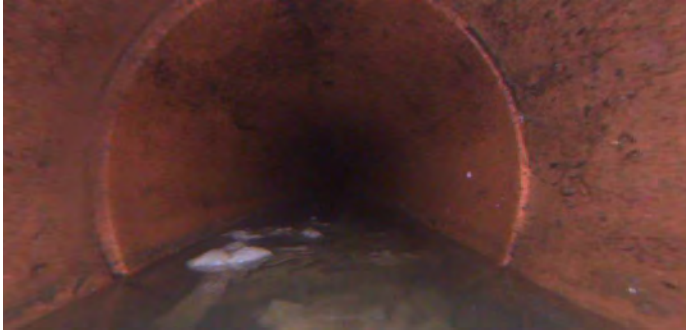
Code: **MGO**
Description: **General Observation**

Distance (ft): **22.5**
Structural Grade: **0**
O&M Grade: **0**
Clock Start/From:
Clock To:
1st Value:
2nd Value:
Value Percent:
Continuous Index:
Within 8" of Joint: **NO**
Remarks: **TOILET TISSUE**

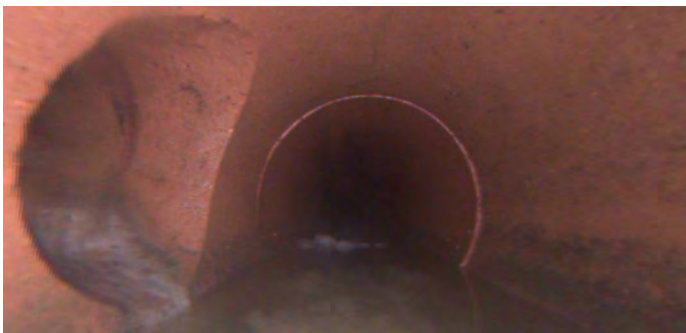
Code: **TF**
Description: **Tap Factory**

Distance (ft): **54.0**
Structural Grade: **0**
O&M Grade: **0**
Clock Start/From: **9**
Clock To:
1st Value: **4.000**
2nd Value:
Value Percent:
Continuous Index:
Within 8" of Joint:
Remarks:

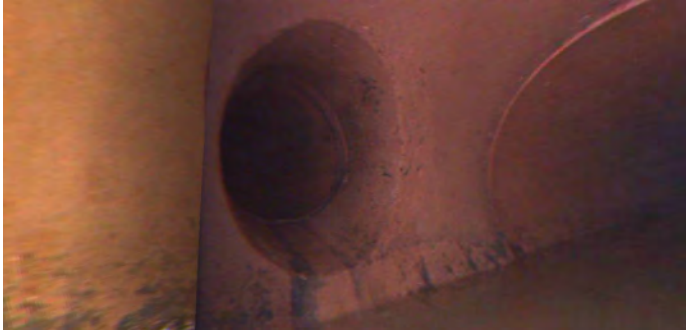
Code: **TF**
Description: **Tap Factory**

Distance (ft): **104.3**
Structural Grade: **0**
O&M Grade: **0**
Clock Start/From: **9**
Clock To:
1st Value: **4.000**
2nd Value:
Value Percent:
Continuous Index:
Within 8" of Joint:
Remarks:

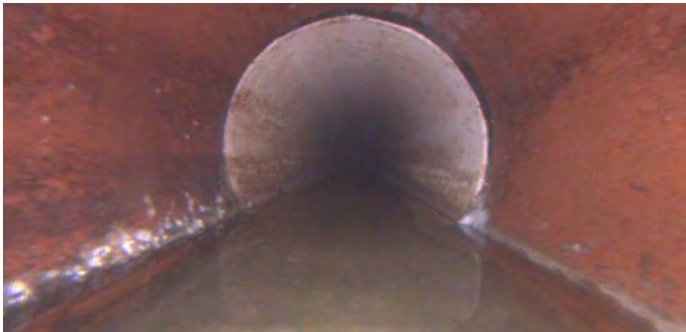
Code: **RPR**
Description: **Repair Point Pipe Replaced**

Distance (ft): **127.7**
Structural Grade: **0**
O&M Grade: **0**
Clock Start/From:
Clock To:
1st Value:
2nd Value:
Value Percent:
Continuous Index:
Within 8" of Joint: **NO**
Remarks: **PVC**

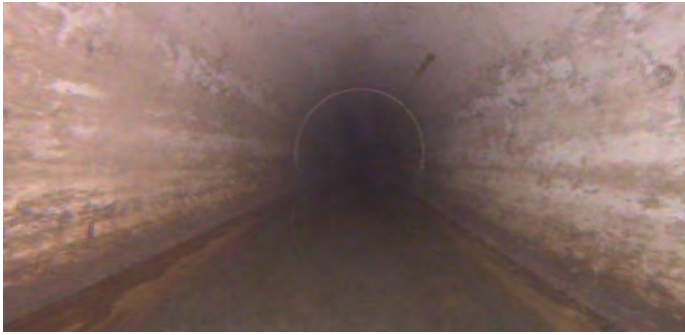
Code: **MGO**
Description: **General Observation**

Distance (ft): **132.5**
Structural Grade: **0**
O&M Grade: **0**
Clock Start/From:
Clock To:
1st Value:
2nd Value:
Value Percent:
Continuous Index:
Within 8" of Joint: **NO**
Remarks: **SLIGHT FOG**

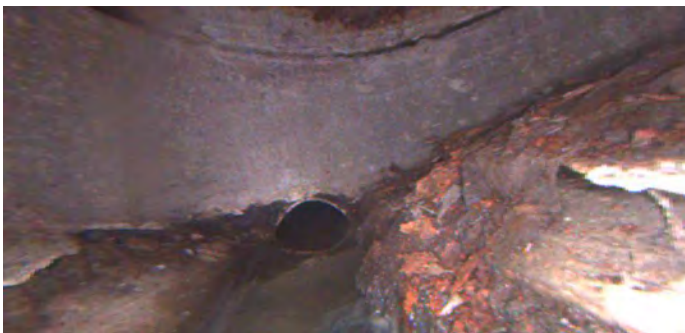
Code: **AMH**
Description: **Manhole**

Distance (ft): **147.4**
Structural Grade: **0**
O&M Grade: **0**
Clock Start/From:
Clock To:
1st Value:
2nd Value:
Value Percent:
Continuous Index:
Within 8" of Joint: **NO**
Remarks: **M-108-003**

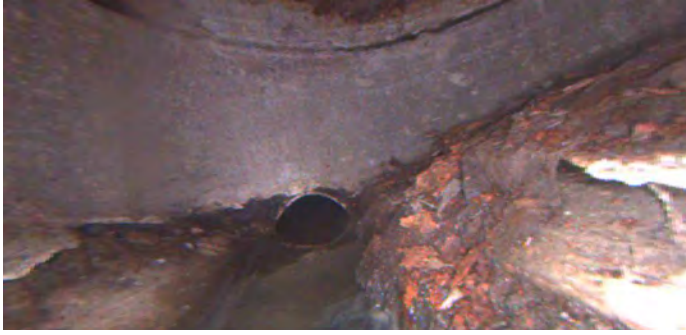
Code:	DAZ
Description:	Deposits Attached Other
Distance (ft):	147.4
Structural Grade:	0
O&M Grade:	2
Clock Start/From:	7
Clock To:	5
1st Value:	
2nd Value:	
Value Percent:	5.000
Continuous Index:	F01
Within 8" of Joint:	YES
Remarks:	WANDER
