Profile/Photo Observation Report

| Street: | FOXCROFT STREET | Flow Control: | Not Controlled |
| City: | Hobart, IN | Year Renewed: | |
| US MH: | M-108-004 | DS MH: | M-108-003 |

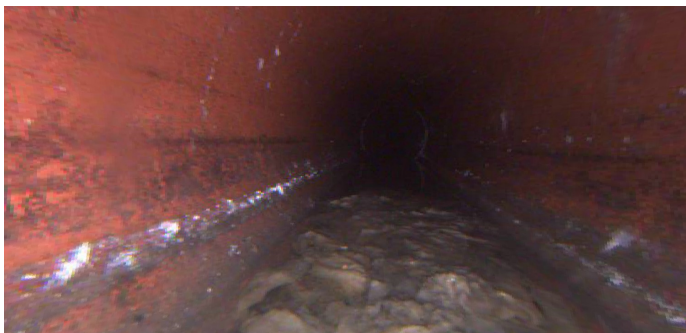
Code: **AMH**
Description: **Manhole**

Distance (ft): **.0**
Structural Grade: **0**
O&M Grade: **0**
Clock Start/From:
Clock To:
1st Value:
2nd Value:
Value Percent:
Continuous Index:
Within 8" of Joint: **NO**
Remarks: **M-108-004**

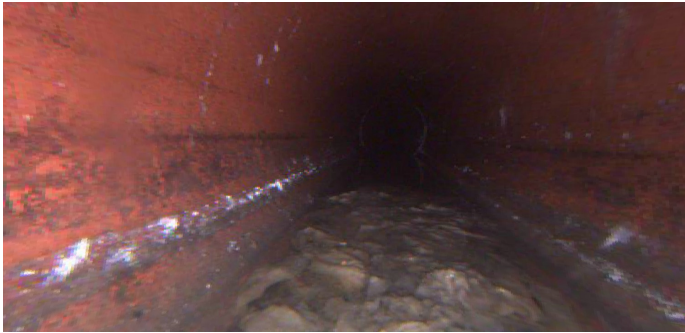
| Description: | Water Level |

| Value Percent: | 10.000 |

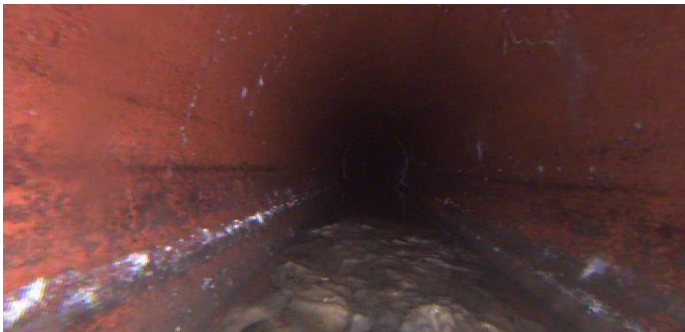
| Description: | Deposits Attached Other |

| O&M Grade: | 2 |
| Value Percent: | 5.000 |
| Remarks: | WANDER |

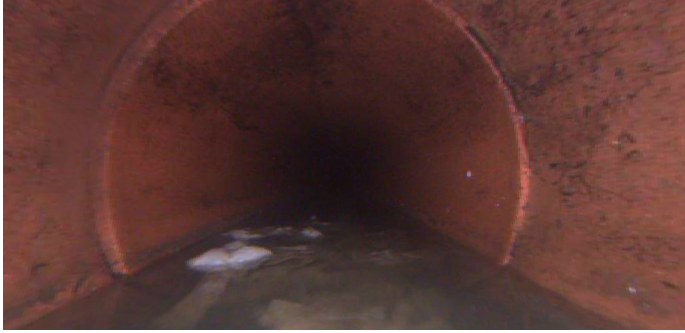
Code: **MGO**
Description: **General Observation**

Distance (ft): **22.5**
Structural Grade: **0**
O&M Grade: **0**
Clock Start/From:
Clock To:
1st Value:
2nd Value:
Value Percent:
Continuous Index:
Within 8" of Joint: **NO**
Remarks: **TOILET TISSUE**

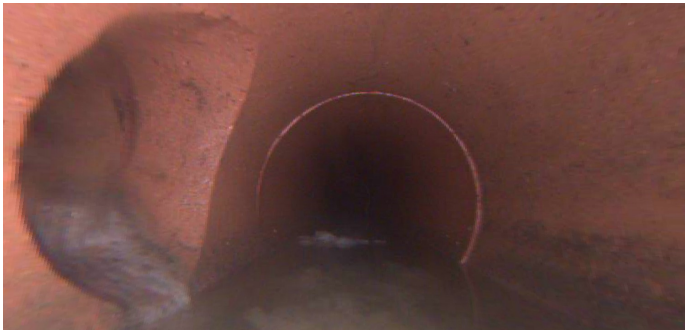
Code: **TF**
Description: **Tap Factory**

Distance (ft): **54.0**
Structural Grade: **0**
O&M Grade: **0**
Clock Start/From: **9**
Clock To:
1st Value: **4.000**
2nd Value:
Value Percent:
Continuous Index:
Within 8" of Joint:
Remarks:

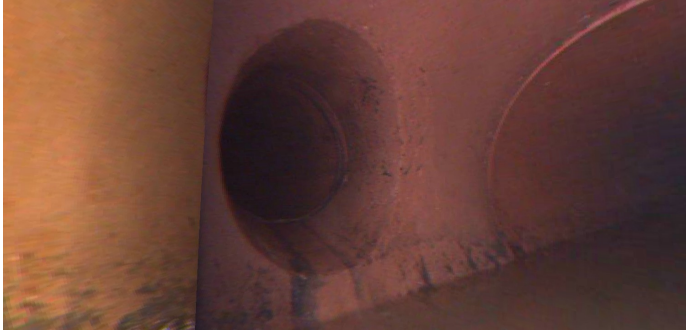
Code: **TF**
Description: **Tap Factory**

Distance (ft): **104.3**
Structural Grade: **0**
O&M Grade: **0**
Clock Start/From: **9**
Clock To:
1st Value: **4.000**
2nd Value:
Value Percent:
Continuous Index:
Within 8" of Joint:
Remarks:

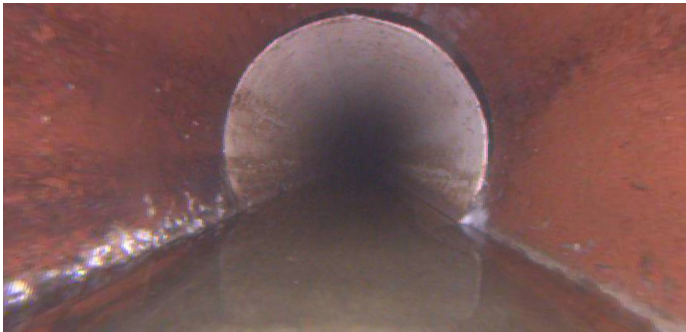
Code: **RPR**
Description: **Repair Point Pipe Replaced**

Distance (ft): **127.7**
Structural Grade: **0**
O&M Grade: **0**
Clock Start/From:
Clock To:
1st Value:
2nd Value:
Value Percent:
Continuous Index:
Within 8" of Joint: **NO**
Remarks: **PVC**

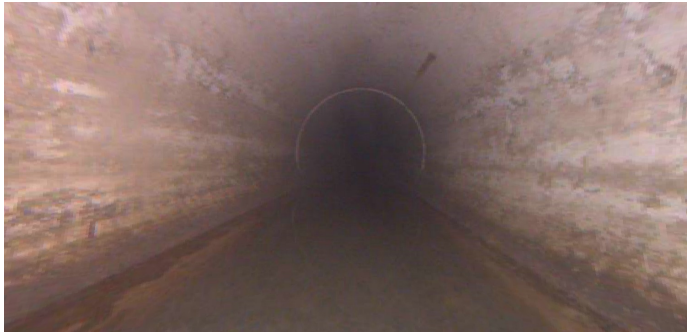
Code: **MGO**
Description: **General Observation**

Distance (ft): **132.5**
Structural Grade: **0**
O&M Grade: **0**
Clock Start/From:
Clock To:
1st Value:
2nd Value:
Value Percent:
Continuous Index:
Within 8" of Joint: **NO**
Remarks: **SLIGHT FOG**

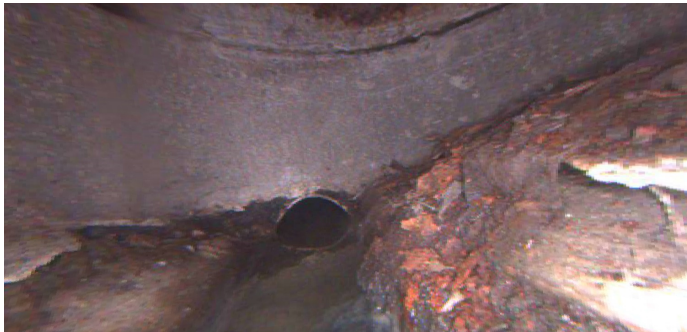
Code: **AMH**
Description: **Manhole**

Distance (ft): **147.4**
Structural Grade: **0**
O&M Grade: **0**
Clock Start/From:
Clock To:
1st Value:
2nd Value:
Value Percent:
Continuous Index:
Within 8" of Joint: **NO**
Remarks: **M-108-003**

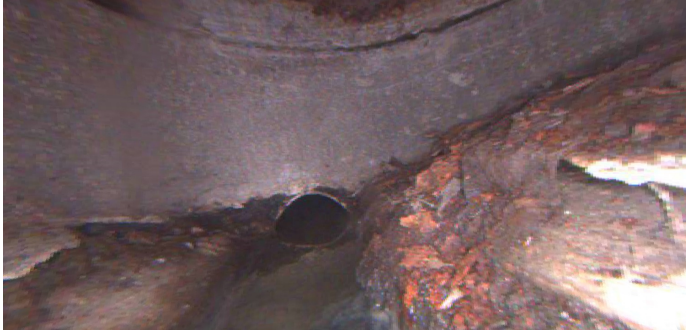
| Description: | Deposits Attached Other |
| O&M Grade: | 2 |
| Value Percent: | 5.000 |
| Remarks: | WANDER |
