## Profile/Photo Observation Report

Date:	<b>03/24/2018</b>	Weather:		Coding:	<b>PACP 6.0</b>
Pipe Length (ft):	<b>178.7</b>	Owner:	<b>NA</b>	Pre Clean:	<b>No Pre-Cleaning</b>
P.O.#:		Surveyor:	<b>Byrd Fitzgerald</b>	PSR:	<b>P-108-004-005</b>
Customer:		Clean Date:	<b>01/01/1900</b>	Shape:	<b>C</b>

Street:	<b>HOWARD CT &amp; 14TH LN</b>	Flow Control:	<b>Not Controlled</b>
City:	<b>Hobart, IN</b>	Year Renewed:	
Location:	<b>Light Highway</b>	Tape/Media #:	
Purpose:	<b>Routine Assessment</b>	Dia/Height:	<b>12"</b>
Use:	<b>Sanitary</b>	Material:	<b>VCP</b>
Drain Area:	<b>NA</b>	Lining:	
Category:	<b>NA</b>		
Comment:	<b>Flow direction wrong</b>		
Location Details:		Direction of Survey:	<b>Upstream</b>
US MH:	<b>M-108-005</b>	DS MH:	<b>M-108-004</b>
		Total Length Surveyed (ft):	<b>176.3</b>

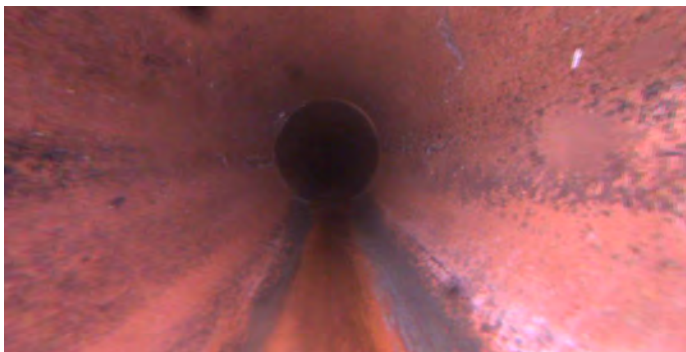
Code: **AMH**  
Description: **Manhole**

Distance (ft): **.0**  
Structural Grade: **0**  
O&M Grade: **0**  
Clock Start/From:  
Clock To:  
1st Value:  
2nd Value:  
Value Percent:  
Continuous Index:  
Within 8" of Joint: **NO**  
Remarks: **M-108-004**

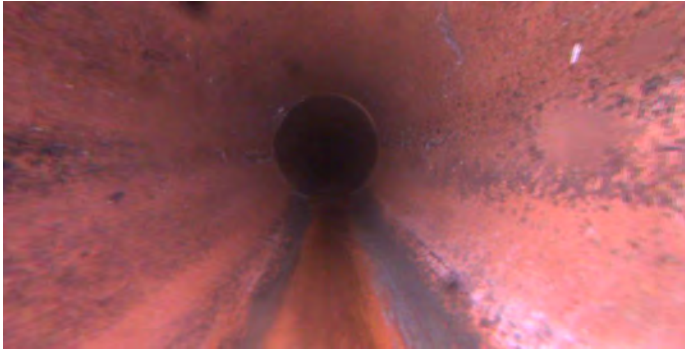
Code:	<b>MWL</b>
Description:	<b>Water Level</b>

Distance (ft):	<b>.0</b>
Structural Grade:	<b>0</b>
O&M Grade:	<b>0</b>
Clock Start/From:	
Clock To:	
1st Value:	
2nd Value:	
Value Percent:	<b>5.000</b>
Continuous Index:	
Within 8" of Joint:	<b>NO</b>
Remarks:

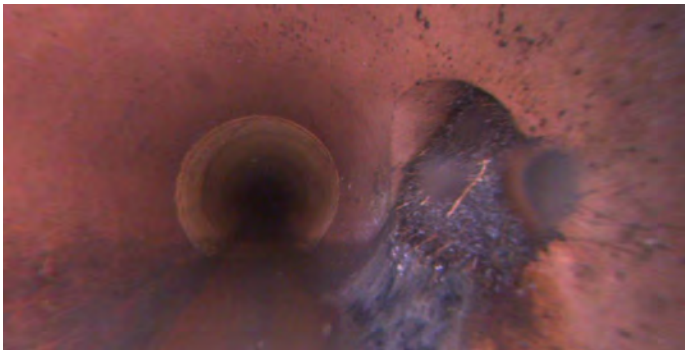
Code:	<b>TFD</b>
Description:	<b>Tap Factory Defective</b>

Distance (ft):	<b>9.2</b>
Structural Grade:	<b>0</b>
O&M Grade:	<b>2</b>
Clock Start/From:	<b>3</b>
Clock To:	
1st Value:	<b>6.000</b>
2nd Value:	
Value Percent:	
Continuous Index:	
Within 8" of Joint:	
Remarks:	<b>RBL in the tap 100%</b>

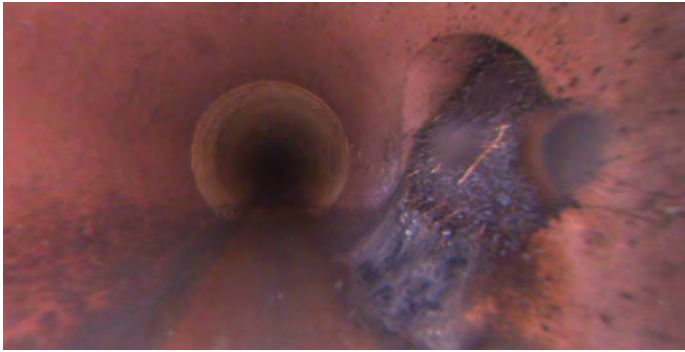
Code: **RFL**  
Description: **Roots Fine Lateral**

Distance (ft): **9.2**  
Structural Grade: **0**  
O&M Grade: **1**  
Clock Start/From: **3**  
Clock To:  
1st Value:  
2nd Value:  
Value Percent:  
Continuous Index:  
Within 8" of Joint: **NO**  
Remarks:

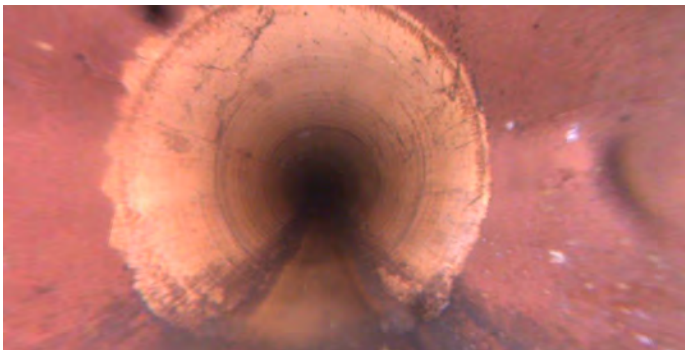
Code: **RPL**  
Description: **Repair Localized Liner**

Distance (ft): **10.1**  
Structural Grade: **0**  
O&M Grade: **0**  
Clock Start/From: **12**  
Clock To: **12**  
1st Value:  
2nd Value:  
Value Percent:  
Continuous Index:  
Within 8" of Joint: **NO**  
Remarks: **Spot liner**

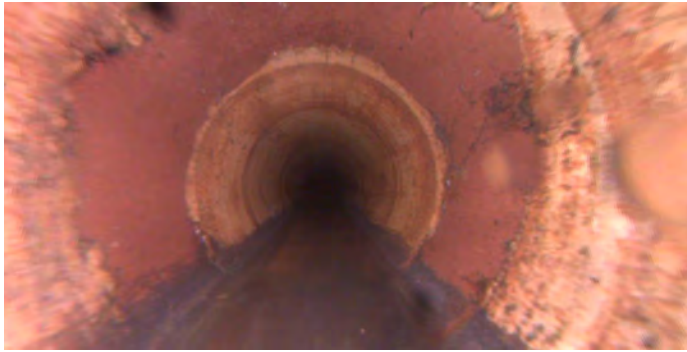
Code:	<b>MGO</b>
Description:	<b>General Observation</b>
Distance (ft):	<b>14.3</b>
Structural Grade:	<b>0</b>
O&M Grade:	<b>0</b>
Clock Start/From:	
Clock To:	
1st Value:	
2nd Value:	
Value Percent:	
Continuous Index:	
Within 8" of Joint:	<b>NO</b>
Remarks:	<b>end of spot liner</b>

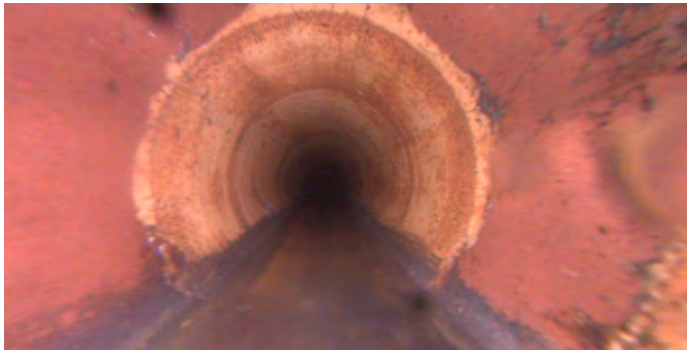
Code:	<b>RPL</b>
Description:	<b>Repair Localized Liner</b>
Distance (ft):	<b>14.5</b>
Structural Grade:	<b>0</b>
O&M Grade:	<b>0</b>
Clock Start/From:	<b>12</b>
Clock To:	<b>12</b>
1st Value:	
2nd Value:	
Value Percent:	
Continuous Index:	
Within 8" of Joint:	<b>NO</b>
Remarks:	<b>spot liner</b>

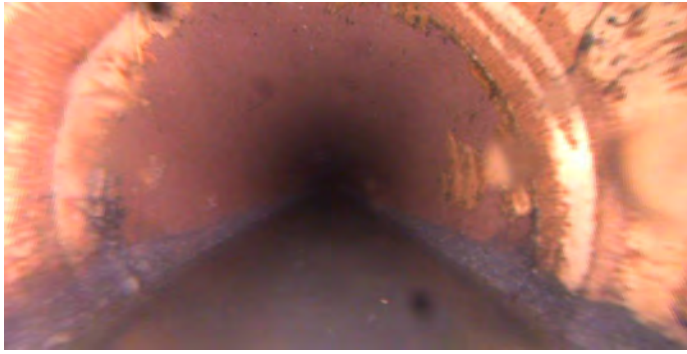
Code:	<b>MGO</b>
Description:	<b>General Observation</b>
Distance (ft):	<b>18.7</b>
Structural Grade:	<b>0</b>
O&M Grade:	<b>0</b>
Clock Start/From:	
Clock To:	
1st Value:	
2nd Value:	
Value Percent:	
Continuous Index:	
Within 8" of Joint:	<b>NO</b>
Remarks:	<b>end of spot liner</b>

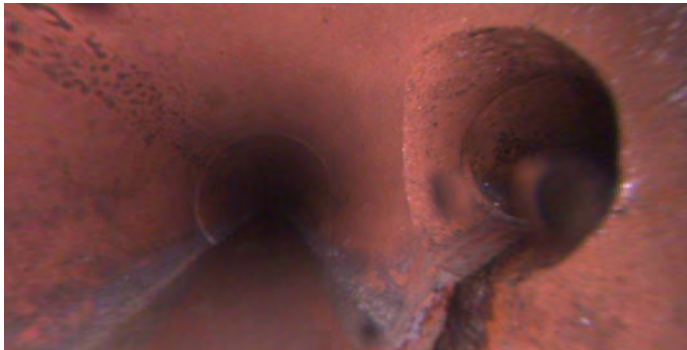
Code:	<b>TF</b>
Description:	<b>Tap Factory</b>
Distance (ft):	<b>59.5</b>
Structural Grade:	<b>0</b>
O&M Grade:	<b>0</b>
Clock Start/From:	<b>3</b>
Clock To:	
1st Value:	<b>6.000</b>
2nd Value:	
Value Percent:	
Continuous Index:	
Within 8" of Joint:	
Remarks:

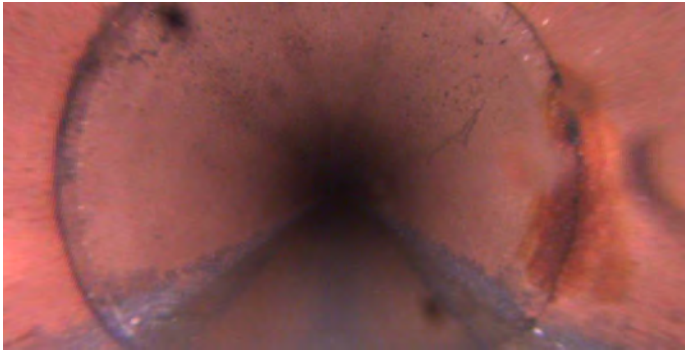
Code: **IS**  
Description: **Infil Stain**

Distance (ft): **90.9**  
Structural Grade: **0**  
O&M Grade: **0**  
Clock Start/From: **2**  
Clock To: **4**  
1st Value:  
2nd Value:  
Value Percent:  
Continuous Index:  
Within 8" of Joint: **YES**  
Remarks:

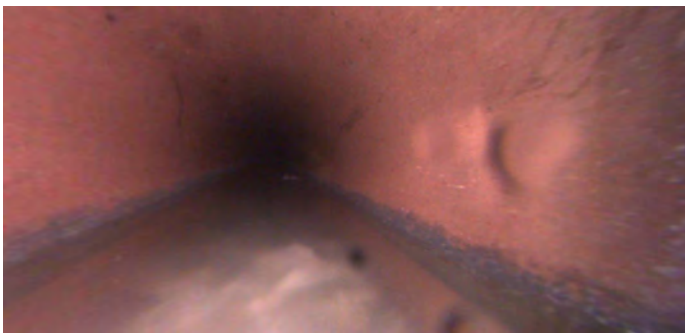
Code: **DSZ**  
Description: **Deposits Settled Other**

Distance (ft): **98.9**  
Structural Grade: **0**  
O&M Grade: **2**  
Clock Start/From: **6**  
Clock To:  
1st Value:  
2nd Value:  
Value Percent: **5.000**  
Continuous Index: **S01**  
Within 8" of Joint: **NO**  
Remarks: **tissue**

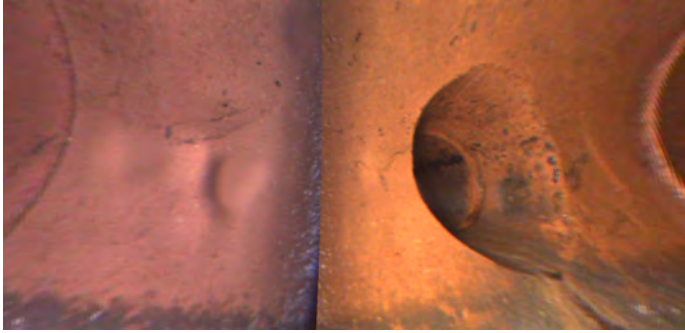
Code: **TF**  
Description: **Tap Factory**

Distance (ft): **122.5**  
Structural Grade: **0**  
O&M Grade: **0**  
Clock Start/From: **2**  
Clock To:  
1st Value: **4.000**  
2nd Value:  
Value Percent:  
Continuous Index:  
Within 8" of Joint: **YES**  
Remarks:

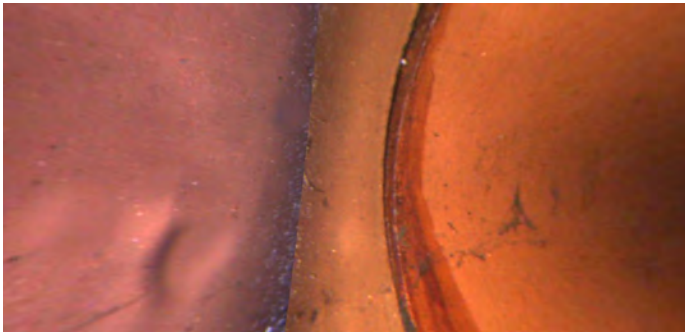
Code: **IS**  
Description: **Infil Stain**

Distance (ft): **129.6**  
Structural Grade: **0**  
O&M Grade: **0**  
Clock Start/From: **2**  
Clock To: **5**  
1st Value:  
2nd Value:  
Value Percent:  
Continuous Index: **S02**  
Within 8" of Joint: **YES**  
Remarks: **wandering**

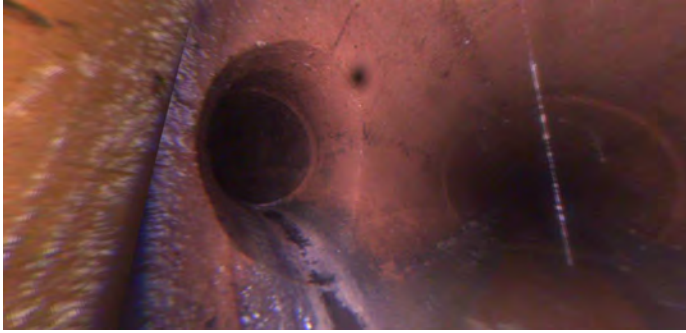
Code: **TF**  
Description: **Tap Factory**

Distance (ft): **147.8**  
Structural Grade: **0**  
O&M Grade: **0**  
Clock Start/From: **10**  
Clock To:  
1st Value: **4.000**  
2nd Value:  
Value Percent:  
Continuous Index:  
Within 8" of Joint: **YES**  
Remarks:

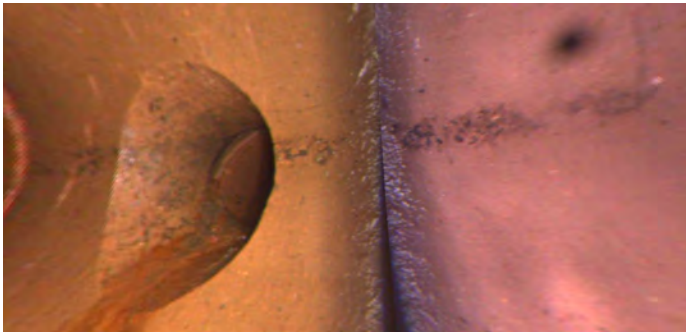
Code: **TF**  
Description: **Tap Factory**

Distance (ft): **168.9**  
Structural Grade: **0**  
O&M Grade: **0**  
Clock Start/From: **10**  
Clock To:  
1st Value: **4.000**  
2nd Value:  
Value Percent:  
Continuous Index:  
Within 8" of Joint: **YES**  
Remarks:

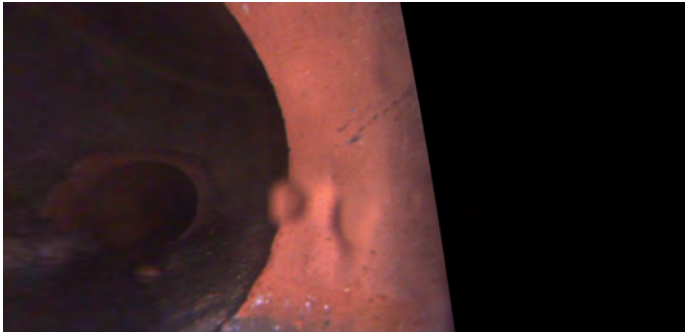
Code: **DSZ**  
Description: **Deposits Settled Other**

Distance (ft): **175.2**  
Structural Grade: **0**  
O&M Grade: **2**  
Clock Start/From: **6**  
Clock To:  
1st Value:  
2nd Value:  
Value Percent: **5.000**  
Continuous Index: **F01**  
Within 8" of Joint: **NO**  
Remarks: **tissue**

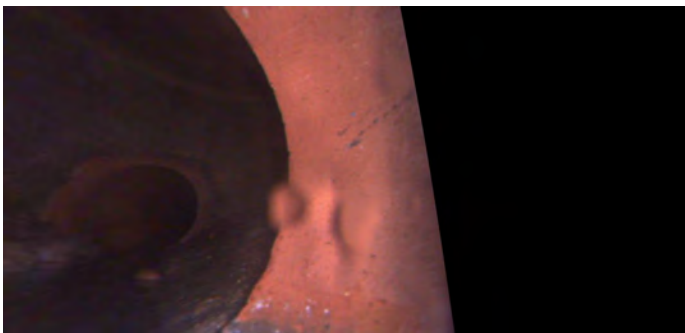
Code: **IS**  
Description: **Infil Stain**

Distance (ft): **175.2**  
Structural Grade: **0**  
O&M Grade: **0**  
Clock Start/From: **2**  
Clock To: **5**  
1st Value:  
2nd Value:  
Value Percent:  
Continuous Index: **F02**  
Within 8" of Joint: **YES**  
Remarks: **wandering**

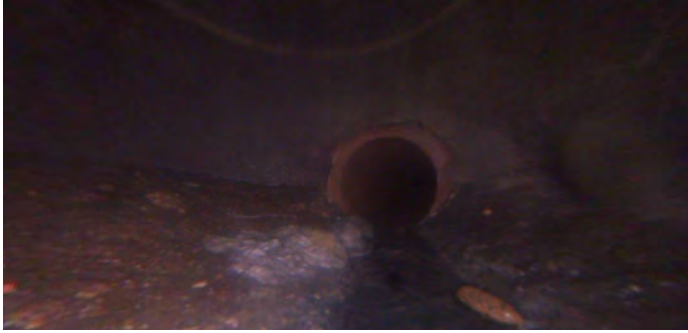
Code:	<b>AMH</b>
Description:	<b>Manhole</b>
Distance (ft):	<b>176.3</b>
Structural Grade:	<b>0</b>
O&M Grade:	<b>0</b>
Clock Start/From:	
Clock To:	
1st Value:	
2nd Value:	
Value Percent:	
Continuous Index:	
Within 8" of Joint:	<b>NO</b>
Remarks:	<b>M-108-005</b>
