Profile/Photo Observation Report

Date:	03/24/2018	Weather:		Coding:	PACP 6.0
Pipe Length (ft):	178.7	Owner:	NA	Pre Clean:	No Pre-Cleaning
P.O.#:		Surveyor:	Byrd Fitzgerald	PSR:	P-108-004-005
Customer:		Clean Date:	01/01/1900	Shape:	C

Street:	FOXCROFT STREET	Flow Control:	Not Controlled
City:	Hobart, IN	Year Renewed:	
Location:	Light Highway	Tape/Media #:	
Purpose:	Routine Assessment	Dia/Height:	12"
Use:	Sanitary	Material:	VCP
Drain Area:	NA	Lining:	
Category:	NA		
Comment:	Flow direction wrong		
Location Details:		Direction of Survey:	Upstream
US MH:	M-108-005	DS MH:	M-108-004
		Total Length Surveyed (ft):	176.3

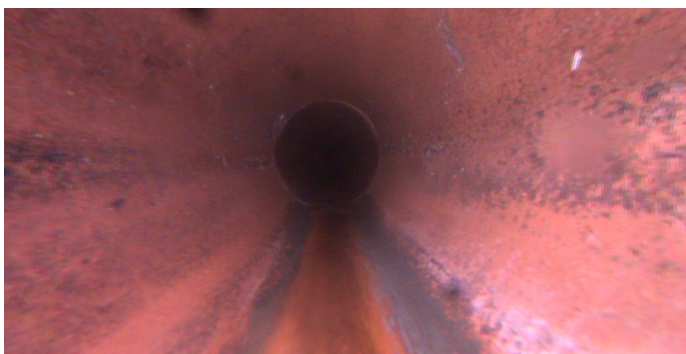
Code: **AMH**
Description: **Manhole**

Distance (ft): **.0**
Structural Grade: **0**
O&M Grade: **0**
Clock Start/From:
Clock To:
1st Value:
2nd Value:
Value Percent:
Continuous Index:
Within 8" of Joint: **NO**
Remarks: **M-108-004**

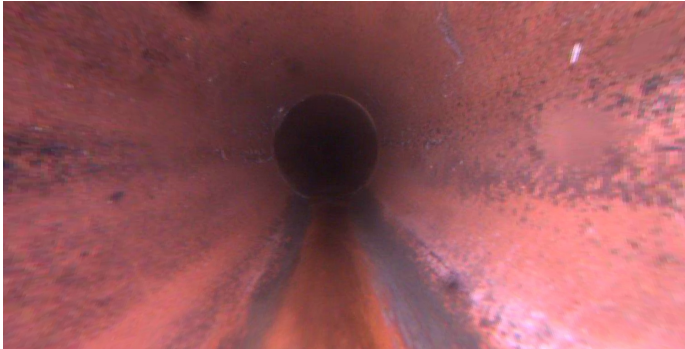
Code:	MWL
Description:	Water Level

Distance (ft):	.0
Structural Grade:	0
O&M Grade:	0
Clock Start/From:	
Clock To:	
1st Value:	
2nd Value:	
Value Percent:	5.000
Continuous Index:	
Within 8" of Joint:	NO
Remarks:

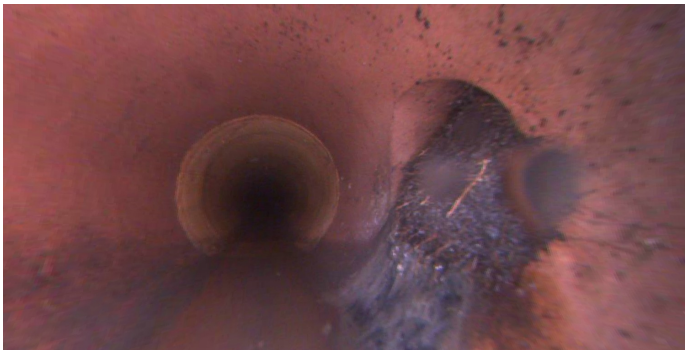
Code:	TFD
Description:	Tap Factory Defective

Distance (ft):	9.2
Structural Grade:	0
O&M Grade:	2
Clock Start/From:	3
Clock To:	
1st Value:	6.000
2nd Value:	
Value Percent:	
Continuous Index:	
Within 8" of Joint:	
Remarks:	RBL in the tap 100%

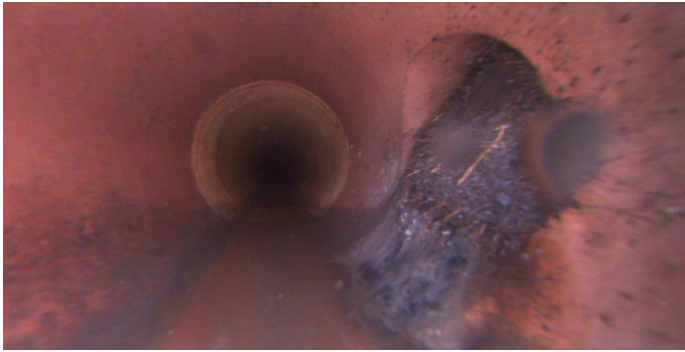
Code: **RFL**
Description: **Roots Fine Lateral**

Distance (ft): **9.2**
Structural Grade: **0**
O&M Grade: **1**
Clock Start/From: **3**
Clock To:
1st Value:
2nd Value:
Value Percent:
Continuous Index:
Within 8" of Joint: **NO**
Remarks:

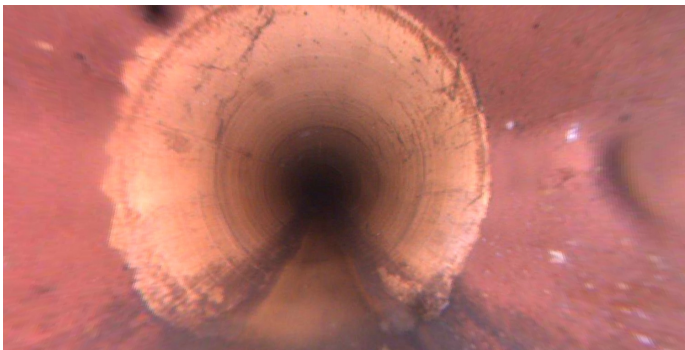
Code: **RPL**
Description: **Repair Localized Liner**

Distance (ft): **10.1**
Structural Grade: **0**
O&M Grade: **0**
Clock Start/From: **12**
Clock To: **12**
1st Value:
2nd Value:
Value Percent:
Continuous Index:
Within 8" of Joint: **NO**
Remarks: **Spot liner**

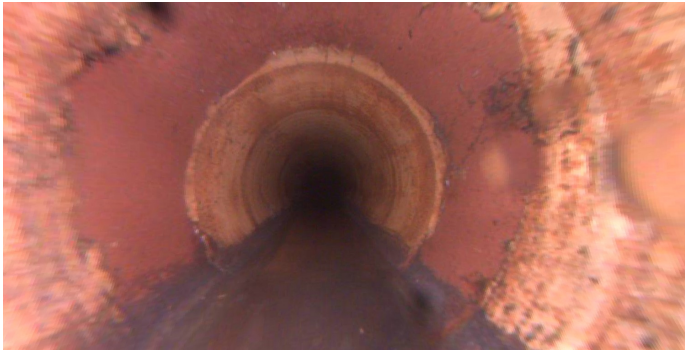
Code: **MGO**
Description: **General Observation**

Distance (ft): **14.3**
Structural Grade: **0**
O&M Grade: **0**
Clock Start/From:
Clock To:
1st Value:
2nd Value:
Value Percent:
Continuous Index:
Within 8" of Joint: **NO**
Remarks: **end of spot liner**

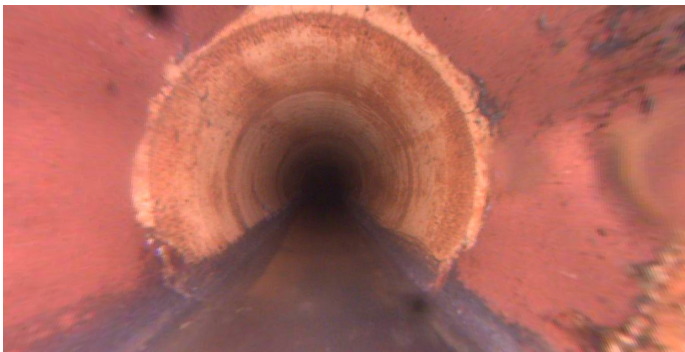
Code: **RPL**
Description: **Repair Localized Liner**

Distance (ft): **14.5**
Structural Grade: **0**
O&M Grade: **0**
Clock Start/From: **12**
Clock To: **12**
1st Value:
2nd Value:
Value Percent:
Continuous Index:
Within 8" of Joint: **NO**
Remarks: **spot liner**

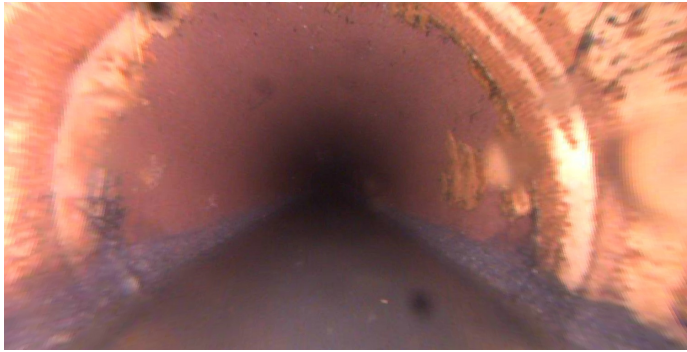
Code:	MGO
Description:	General Observation
Distance (ft):	18.7
Structural Grade:	0
O&M Grade:	0
Clock Start/From:	
Clock To:	
1st Value:	
2nd Value:	
Value Percent:	
Continuous Index:	
Within 8" of Joint:	NO
Remarks:	end of spot liner

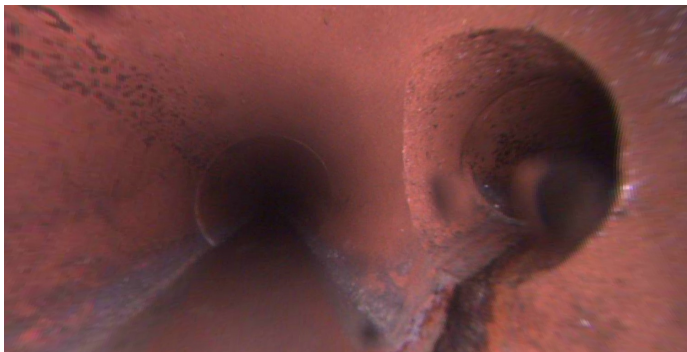
Code:	TF
Description:	Tap Factory
Distance (ft):	59.5
Structural Grade:	0
O&M Grade:	0
Clock Start/From:	3
Clock To:	
1st Value:	6.000
2nd Value:	
Value Percent:	
Continuous Index:	
Within 8" of Joint:	
Remarks:

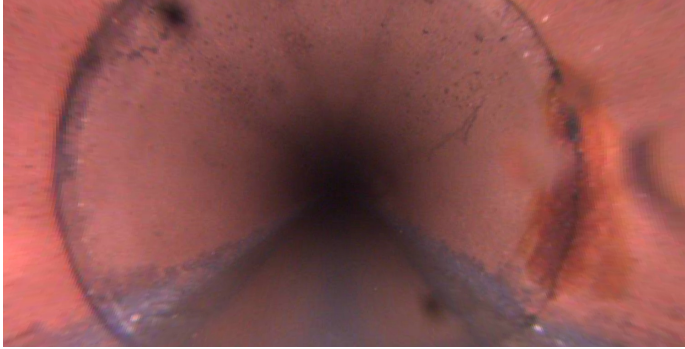
Code: **IS**
Description: **Infil Stain**

Distance (ft): **90.9**
Structural Grade: **0**
O&M Grade: **0**
Clock Start/From: **2**
Clock To: **4**
1st Value:
2nd Value:
Value Percent:
Continuous Index:
Within 8" of Joint: **YES**
Remarks:

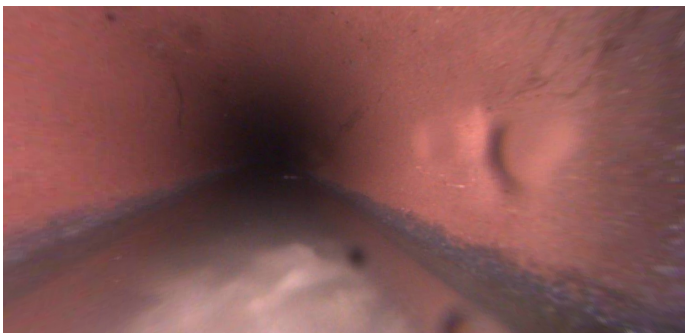
Code: **DSZ**
Description: **Deposits Settled Other**

Distance (ft): **98.9**
Structural Grade: **0**
O&M Grade: **2**
Clock Start/From: **6**
Clock To:
1st Value:
2nd Value:
Value Percent: **5.000**
Continuous Index: **S01**
Within 8" of Joint: **NO**
Remarks: **tissue**

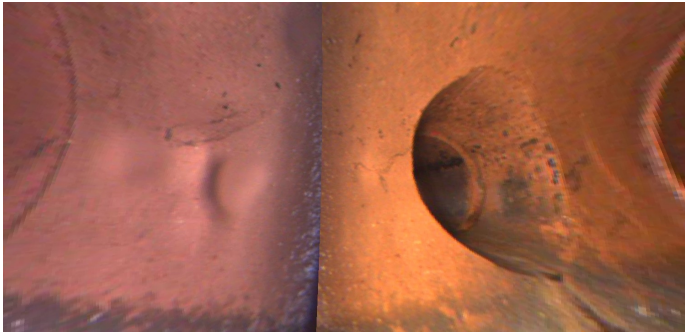
Code: **TF**
Description: **Tap Factory**

Distance (ft): **122.5**
Structural Grade: **0**
O&M Grade: **0**
Clock Start/From: **2**
Clock To:
1st Value: **4.000**
2nd Value:
Value Percent:
Continuous Index:
Within 8" of Joint: **YES**
Remarks:

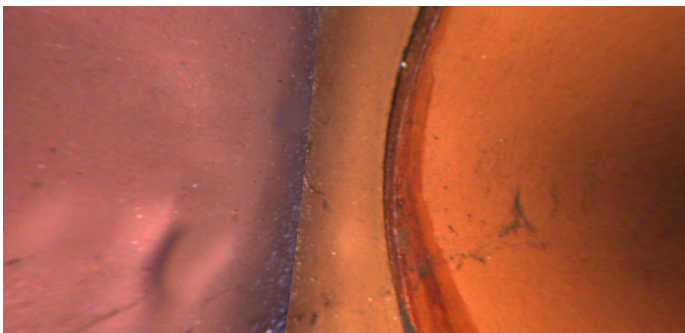
Code: **IS**
Description: **Infil Stain**

Distance (ft): **129.6**
Structural Grade: **0**
O&M Grade: **0**
Clock Start/From: **2**
Clock To: **5**
1st Value:
2nd Value:
Value Percent:
Continuous Index: **S02**
Within 8" of Joint: **YES**
Remarks: **wandering**

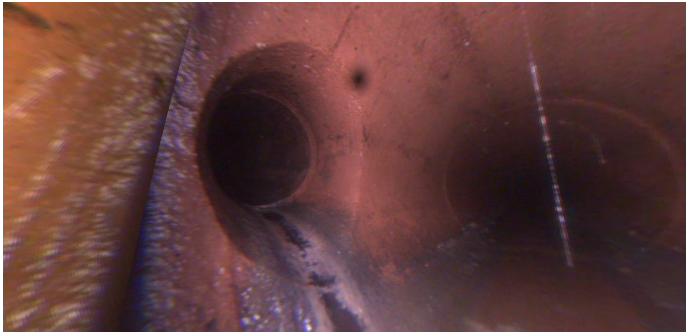
Code: **TF**
Description: **Tap Factory**

Distance (ft): **147.8**
Structural Grade: **0**
O&M Grade: **0**
Clock Start/From: **10**
Clock To:
1st Value: **4.000**
2nd Value:
Value Percent:
Continuous Index:
Within 8" of Joint: **YES**
Remarks:

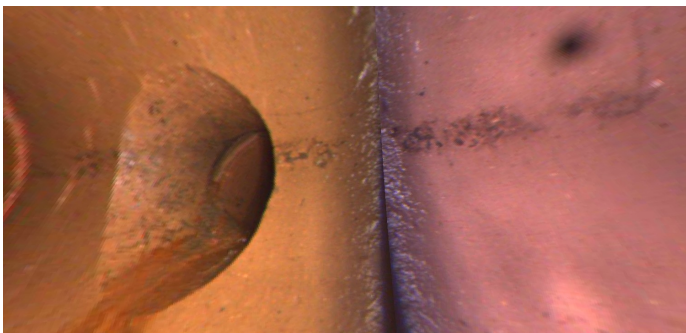
Code: **TF**
Description: **Tap Factory**

Distance (ft): **168.9**
Structural Grade: **0**
O&M Grade: **0**
Clock Start/From: **10**
Clock To:
1st Value: **4.000**
2nd Value:
Value Percent:
Continuous Index:
Within 8" of Joint: **YES**
Remarks:

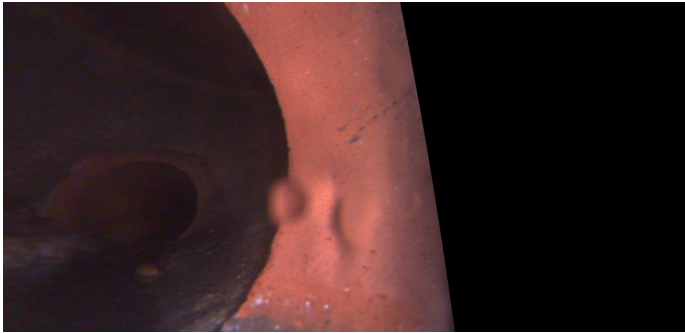
Code: **DSZ**
Description: **Deposits Settled Other**

Distance (ft): **175.2**
Structural Grade: **0**
O&M Grade: **2**
Clock Start/From: **6**
Clock To:
1st Value:
2nd Value:
Value Percent: **5.000**
Continuous Index: **F01**
Within 8" of Joint: **NO**
Remarks: **tissue**

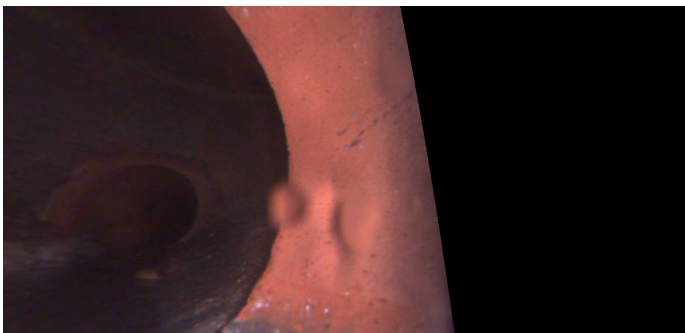
Code: **IS**
Description: **Infil Stain**

Distance (ft): **175.2**
Structural Grade: **0**
O&M Grade: **0**
Clock Start/From: **2**
Clock To: **5**
1st Value:
2nd Value:
Value Percent:
Continuous Index: **F02**
Within 8" of Joint: **YES**
Remarks: **wandering**

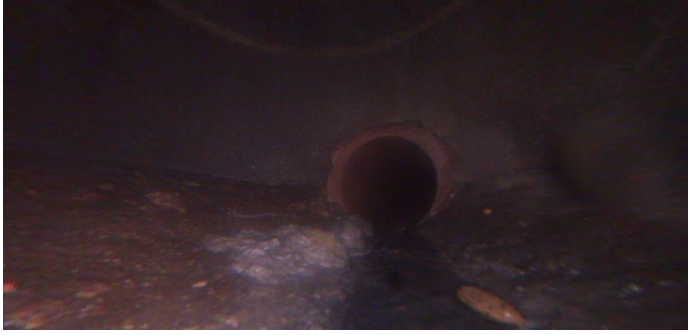
Code:	AMH
Description:	Manhole
Distance (ft):	176.3
Structural Grade:	0
O&M Grade:	0
Clock Start/From:	
Clock To:	
1st Value:	
2nd Value:	
Value Percent:	
Continuous Index:	
Within 8" of Joint:	NO
Remarks:	M-108-005
