Profile/Photo Observation Report

Date:	03/24/2018	Weather:		Coding:	PACP 6.0
Pipe Length (ft):	203.5	Owner:	NA	Pre Clean:	No Pre-Cleaning
P.O.#:		Surveyor:	Byrd Fitzgerald	PSR:	P-108-005-006
Customer:		Clean Date:	01/01/1900	Shape:	C

Street:	14TH LN	Flow Control:	Not Controlled
City:	Hobart, IN	Year Renewed:	
Location:	Light Highway	Tape/Media #:	
Purpose:	Routine Assessment	Dia/Height:	8"
Use:	Sanitary	Material:	VCP
Drain Area:	NA	Lining:	
Category:	NA		
Comment:	Flow direction wrong		
Location Details:		Direction of Survey:	Upstream
US MH:	M-108-006	DS MH:	M-108-005
		Total Length Surveyed (ft):	193.5

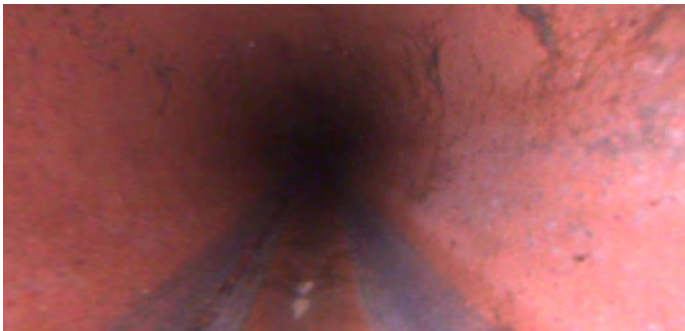
Code: **AMH**
Description: **Manhole**

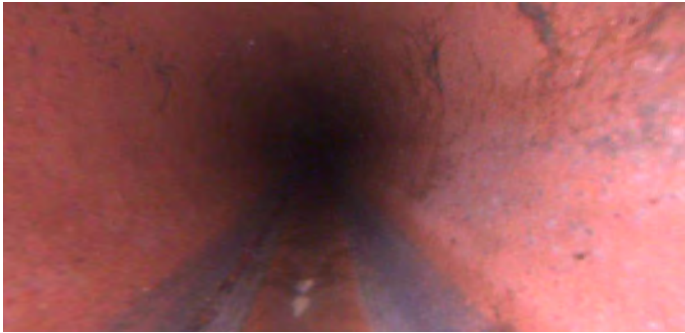
Code:	MWL
Description:	Water Level

Distance (ft):	.0
Structural Grade:	0
O&M Grade:	0
Clock Start/From:	
Clock To:	
1st Value:	
2nd Value:	
Value Percent:	5.000
Continuous Index:	
Within 8" of Joint:	NO
Remarks:

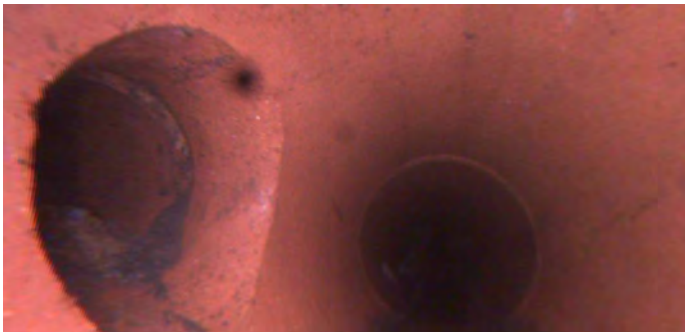
Code:	TF
Description:	Tap Factory

Distance (ft):	22.0
Structural Grade:	0
O&M Grade:	0
Clock Start/From:	9
Clock To:	
1st Value:	4.000
2nd Value:	
Value Percent:	
Continuous Index:	
Within 8" of Joint:	
Remarks:

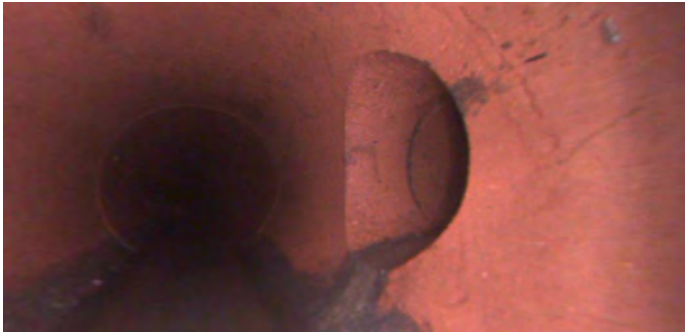
Code: **TF**
Description: **Tap Factory**

Distance (ft): **58.8**
Structural Grade: **0**
O&M Grade: **0**
Clock Start/From: **3**
Clock To:
1st Value: **4.000**
2nd Value:
Value Percent:
Continuous Index:
Within 8" of Joint: **YES**
Remarks:

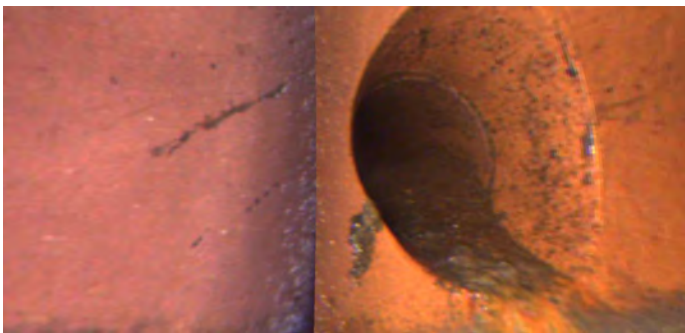
Code: **TFD**
Description: **Tap Factory Defective**

Distance (ft): **114.2**
Structural Grade: **0**
O&M Grade: **2**
Clock Start/From: **3**
Clock To:
1st Value: **4.000**
2nd Value:
Value Percent:
Continuous Index:
Within 8" of Joint: **YES**
Remarks: **blocked**

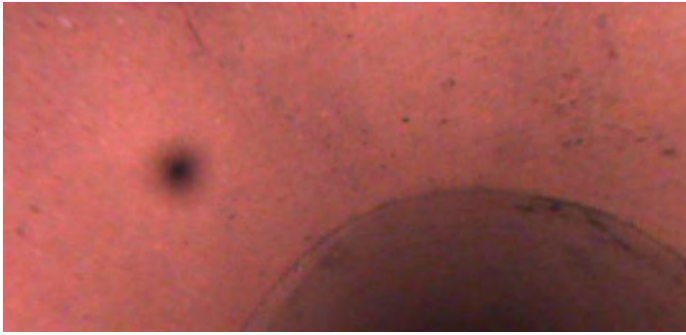
Code: **CM**
Description: **Crack Multiple**

Distance (ft): **125.9**
Structural Grade: **3**
O&M Grade: **0**
Clock Start/From: **9**
Clock To: **11**
1st Value:
2nd Value:
Value Percent:
Continuous Index: **S01**
Within 8" of Joint: **YES**
Remarks: **fine cracks/wandering**

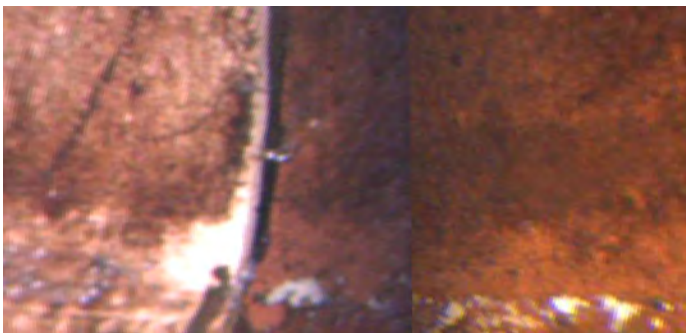
Code: **MMC**
Description: **Material Change**

Distance (ft): **160.3**
Structural Grade: **0**
O&M Grade: **0**
Clock Start/From:
Clock To:
1st Value:
2nd Value:
Value Percent:
Continuous Index:
Within 8" of Joint: **NO**
Remarks: **pvc**

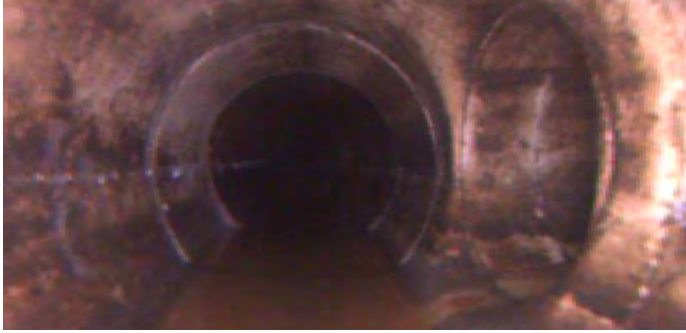
Code: **TF**
Description: **Tap Factory**

Distance (ft): **163.6**
Structural Grade: **0**
O&M Grade: **0**
Clock Start/From: **3**
Clock To:
1st Value: **4.000**
2nd Value:
Value Percent:
Continuous Index:
Within 8" of Joint: **YES**
Remarks:

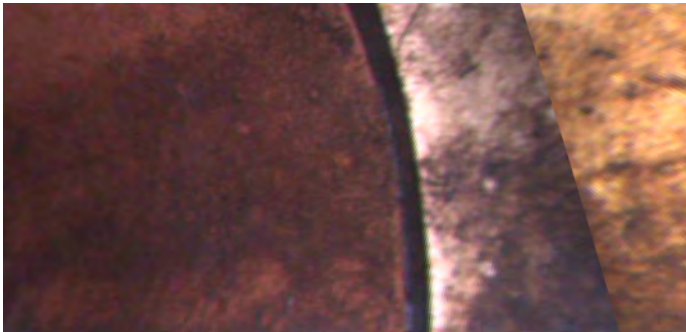
Code: **MMC**
Description: **Material Change**

Distance (ft): **165.8**
Structural Grade: **0**
O&M Grade: **0**
Clock Start/From:
Clock To:
1st Value:
2nd Value:
Value Percent:
Continuous Index:
Within 8" of Joint: **NO**
Remarks: **vcp**

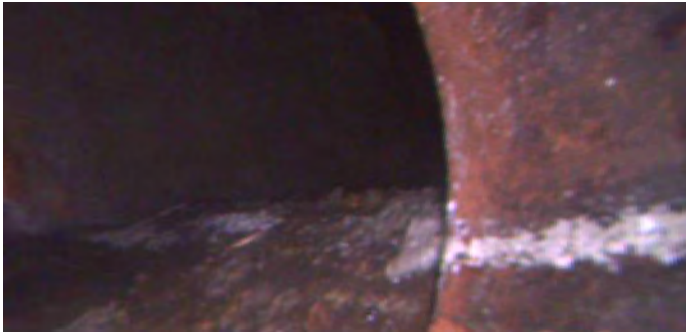
Code: **CM**
Description: **Crack Multiple**

Distance (ft): **192.4**
Structural Grade: **3**
O&M Grade: **0**
Clock Start/From: **9**
Clock To: **11**
1st Value:
2nd Value:
Value Percent:
Continuous Index: **F01**
Within 8" of Joint: **YES**
Remarks: **fine cracks/wandering**

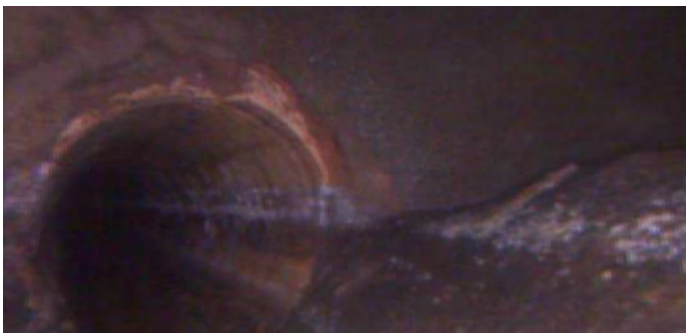
Code: **AMH**
Description: **Manhole**

Distance (ft): **193.5**
Structural Grade: **0**
O&M Grade: **0**
Clock Start/From:
Clock To:
1st Value:
2nd Value:
Value Percent:
Continuous Index:
Within 8" of Joint: **NO**
Remarks: **M-108-006**
