Profile/Photo Observation Report

Date:	03/24/2018	Weather:		Coding:	PACP 6.0
Pipe Length (ft):	203.5	Owner:	NA	Pre Clean:	No Pre-Cleaning
P.O.#:		Surveyor:	Byrd Fitzgerald	PSR:	P-108-005-006
Customer:		Clean Date:	01/01/1900	Shape:	C

Street:	FOXCROFT STREET	Flow Control:	Not Controlled
City:	Hobart, IN	Year Renewed:	
Location:	Light Highway	Tape/Media #:	
Purpose:	Routine Assessment	Dia/Height:	8"
Use:	Sanitary	Material:	VCP
Drain Area:	NA	Lining:	
Category:	NA		
Comment:	Flow direction wrong

Location Details:		Direction of Survey:	Upstream
US MH:	M-108-006	DS MH:	M-108-005
		Total Length Surveyed (ft):	193.5

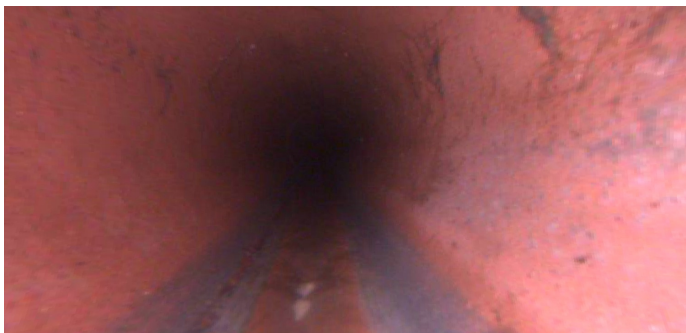
Code: **AMH**
Description: **Manhole**

Distance (ft): **.0**
Structural Grade: **0**
O&M Grade: **0**
Clock Start/From:
Clock To:
1st Value:
2nd Value:
Value Percent:
Continuous Index:
Within 8" of Joint: **NO**
Remarks: **M-108-005**

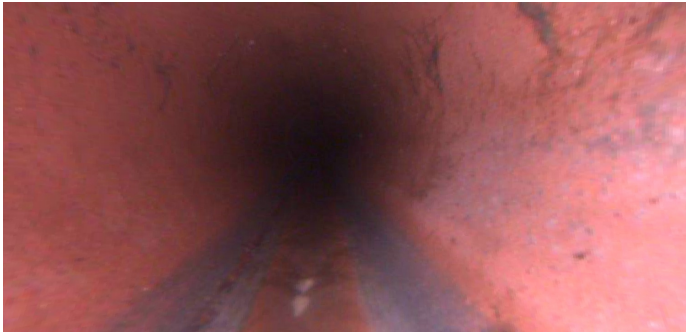
Code:	MWL
Description:	Water Level

Distance (ft):	.0
Structural Grade:	0
O&M Grade:	0
Clock Start/From:	
Clock To:	
1st Value:	
2nd Value:	
Value Percent:	5.000
Continuous Index:	
Within 8" of Joint:	NO
Remarks:

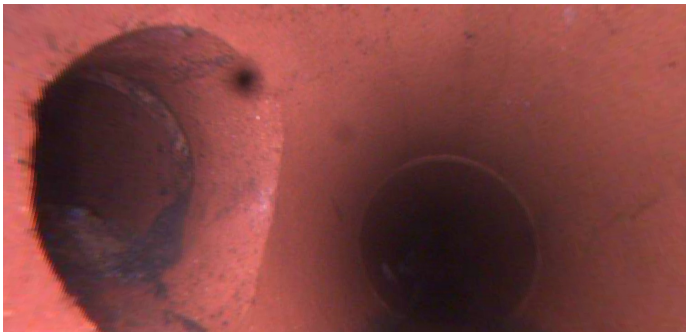
Code:	TF
Description:	Tap Factory

Distance (ft):	22.0
Structural Grade:	0
O&M Grade:	0
Clock Start/From:	9
Clock To:	
1st Value:	4.000
2nd Value:	
Value Percent:	
Continuous Index:	
Within 8" of Joint:	
Remarks:

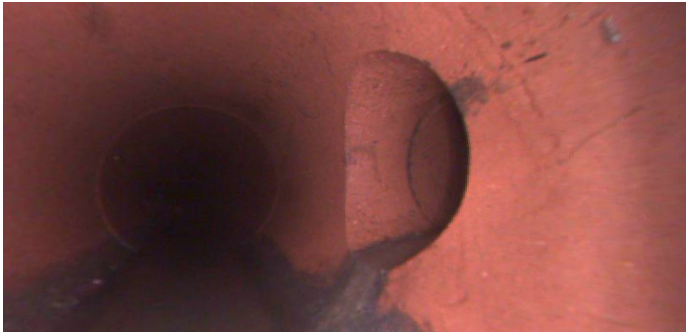
Code: **TF**
Description: **Tap Factory**

Distance (ft): **58.8**
Structural Grade: **0**
O&M Grade: **0**
Clock Start/From: **3**
Clock To:
1st Value: **4.000**
2nd Value:
Value Percent:
Continuous Index:
Within 8" of Joint: **YES**
Remarks:

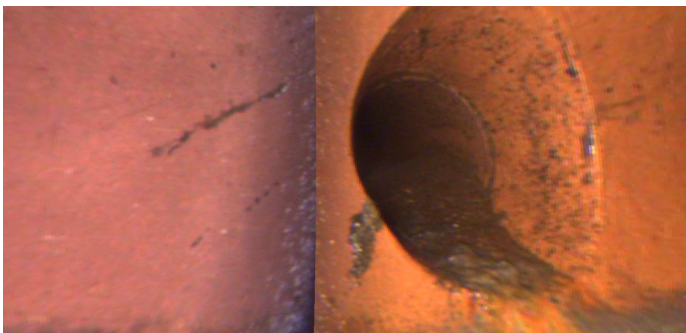
Code: **TFD**
Description: **Tap Factory Defective**

Distance (ft): **114.2**
Structural Grade: **0**
O&M Grade: **2**
Clock Start/From: **3**
Clock To:
1st Value: **4.000**
2nd Value:
Value Percent:
Continuous Index:
Within 8" of Joint: **YES**
Remarks: **blocked**

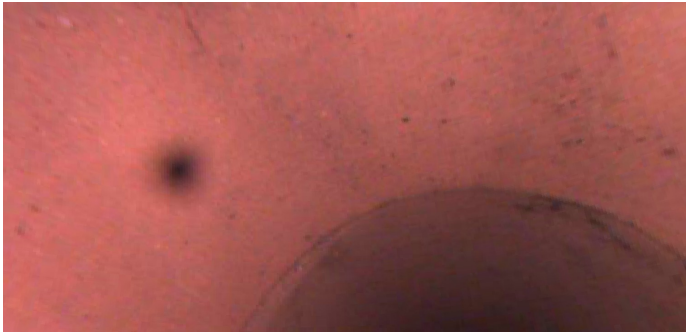
Code: **CM**
Description: **Crack Multiple**

Distance (ft): **125.9**
Structural Grade: **3**
O&M Grade: **0**
Clock Start/From: **9**
Clock To: **11**
1st Value:
2nd Value:
Value Percent:
Continuous Index: **S01**
Within 8" of Joint: **YES**
Remarks: **fine cracks/wandering**

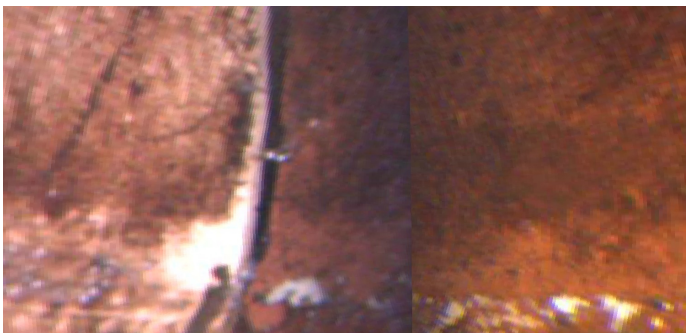
Code: **MMC**
Description: **Material Change**

Distance (ft): **160.3**
Structural Grade: **0**
O&M Grade: **0**
Clock Start/From:
Clock To:
1st Value:
2nd Value:
Value Percent:
Continuous Index:
Within 8" of Joint: **NO**
Remarks: **pvc**

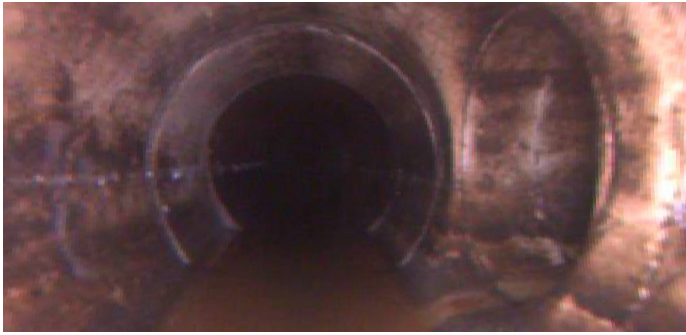
Code: **TF**
Description: **Tap Factory**

Distance (ft): **163.6**
Structural Grade: **0**
O&M Grade: **0**
Clock Start/From: **3**
Clock To:
1st Value: **4.000**
2nd Value:
Value Percent:
Continuous Index:
Within 8" of Joint: **YES**
Remarks:

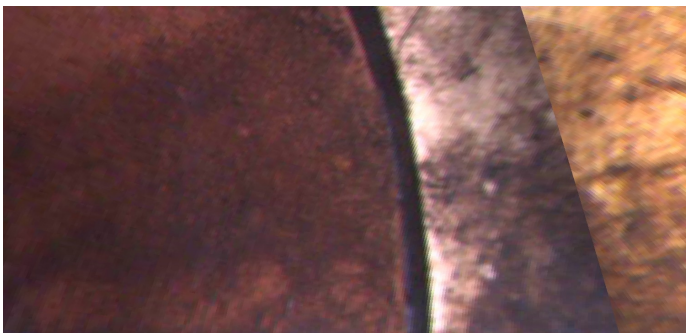
Code: **MMC**
Description: **Material Change**

Distance (ft): **165.8**
Structural Grade: **0**
O&M Grade: **0**
Clock Start/From:
Clock To:
1st Value:
2nd Value:
Value Percent:
Continuous Index:
Within 8" of Joint: **NO**
Remarks: **vcp**

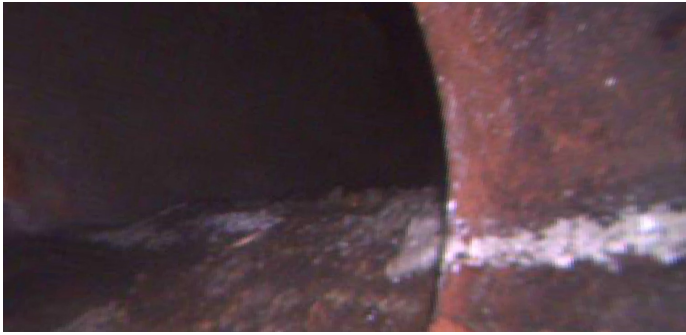
Code: **CM**
Description: **Crack Multiple**

Distance (ft): **192.4**
Structural Grade: **3**
O&M Grade: **0**
Clock Start/From: **9**
Clock To: **11**
1st Value:
2nd Value:
Value Percent:
Continuous Index: **F01**
Within 8" of Joint: **YES**
Remarks: **fine cracks/wandering**

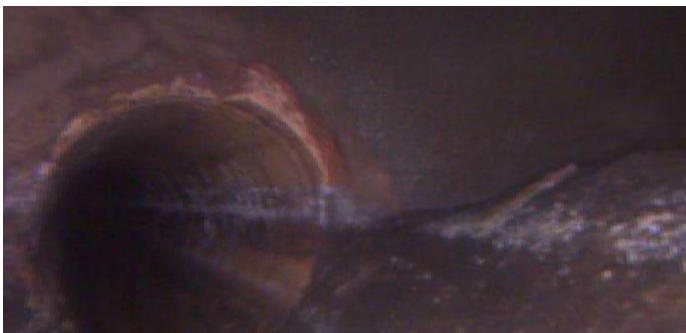
Code: **AMH**
Description: **Manhole**

Distance (ft): **193.5**
Structural Grade: **0**
O&M Grade: **0**
Clock Start/From:
Clock To:
1st Value:
2nd Value:
Value Percent:
Continuous Index:
Within 8" of Joint: **NO**
Remarks: **M-108-006**
