## Profile/Photo Observation Report

Date:	<b>03/24/2018</b>	Weather:		Coding:	<b>PACP 6.0</b>
Pipe Length (ft):	<b>281.8</b>	Owner:	<b>NA</b>	Pre Clean:	<b>No Pre-Cleaning</b>
P.O.#:		Surveyor:	<b>Byrd Fitzgerald</b>	PSR:	<b>P-108-006-007</b>
Customer:		Clean Date:	<b>01/01/1900</b>	Shape:	<b>C</b>

Street:	<b>14TH LN</b>	Flow Control:	<b>Not Controlled</b>
City:	<b>Hobart, IN</b>	Year Renewed:	
Location:	<b>Light Highway</b>	Tape/Media #:	
Purpose:	<b>Routine Assessment</b>	Dia/Height:	<b>12"</b>
Use:	<b>Sanitary</b>	Material:	<b>VCP</b>
Drain Area:	<b>NA</b>	Lining:	<b>Cured in Place</b>
Category:	<b>NA</b>		
Comment:	<b>Flow direction Wrong</b>		
Location Details:		Direction of Survey:	<b>Upstream</b>
US MH:	<b>M-108-007</b>	DS MH:	<b>M-108-006</b>
		Total Length Surveyed (ft):	<b>273.1</b>

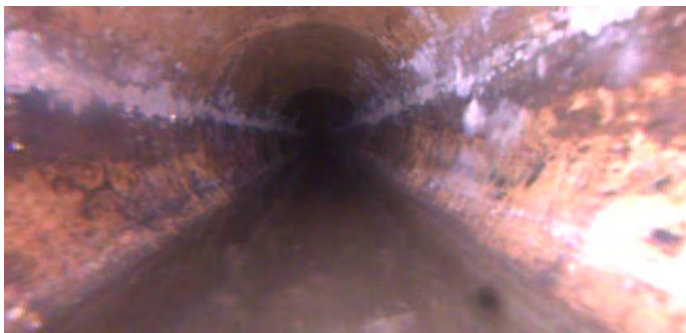
Code: **AMH**  
Description: **Manhole**

Distance (ft): **.0**  
Structural Grade: **0**  
O&M Grade: **0**  
Clock Start/From:  
Clock To:  
1st Value:  
2nd Value:  
Value Percent:  
Continuous Index:  
Within 8" of Joint: **NO**  
Remarks: **M-108-006**

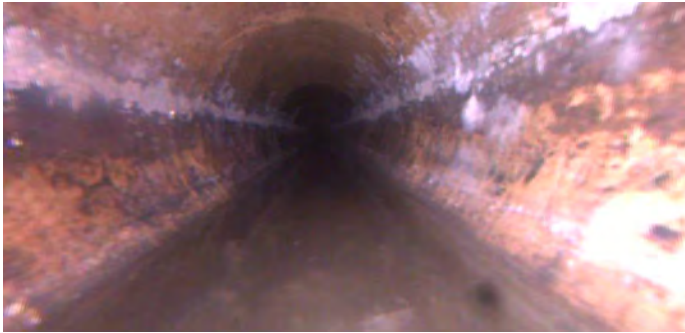
Code:	<b>MWL</b>
Description:	<b>Water Level</b>

Distance (ft):	<b>.0</b>
Structural Grade:	<b>0</b>
O&M Grade:	<b>0</b>
Clock Start/From:	
Clock To:	
1st Value:	
2nd Value:	
Value Percent:	<b>5.000</b>
Continuous Index:	
Within 8" of Joint:	<b>NO</b>
Remarks:

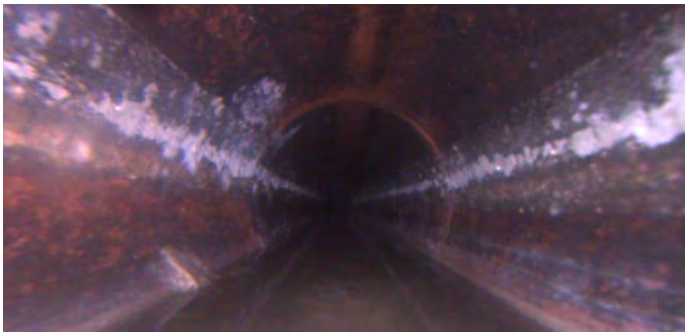
Code:	<b>MLC</b>
Description:	<b>Lining Change</b>

Distance (ft):	<b>4.5</b>
Structural Grade:	<b>0</b>
O&M Grade:	<b>0</b>
Clock Start/From:	
Clock To:	
1st Value:	
2nd Value:	
Value Percent:	
Continuous Index:	
Within 8" of Joint:	<b>NO</b>
Remarks:	<b>end cip</b>

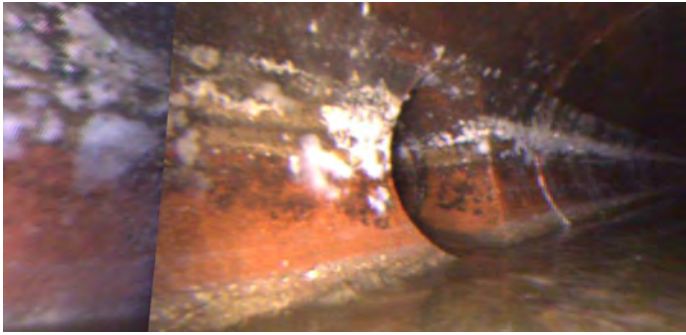
Code: **TF**  
Description: **Tap Factory**

Distance (ft): **13.3**  
Structural Grade: **0**  
O&M Grade: **0**  
Clock Start/From: **3**  
Clock To:  
1st Value: **4.000**  
2nd Value:  
Value Percent:  
Continuous Index:  
Within 8" of Joint: **YES**  
Remarks:

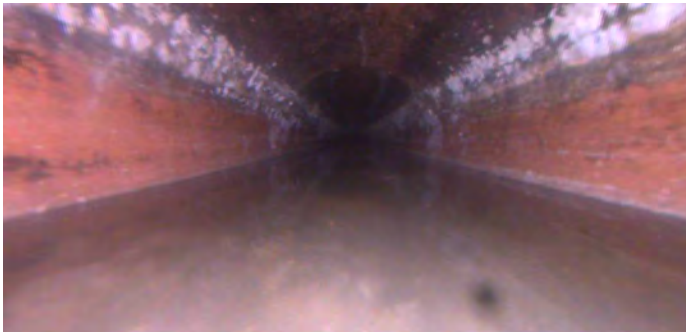
Code: **MWL**  
Description: **Water Level**

Distance (ft): **18.0**  
Structural Grade: **0**  
O&M Grade: **0**  
Clock Start/From:  
Clock To:  
1st Value:  
2nd Value:  
Value Percent: **25.000**  
Continuous Index:  
Within 8" of Joint: **NO**  
Remarks:

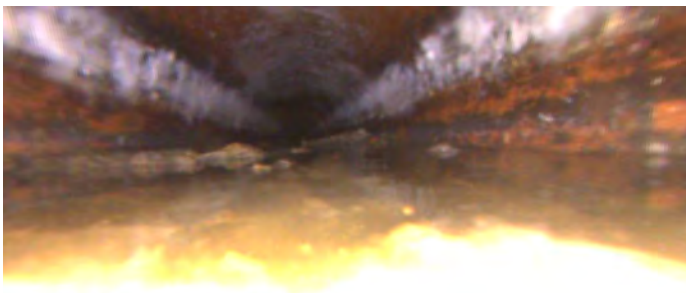
Code: **MCU**  
Description: **Camera Underwater**

Distance (ft): **121.8**  
Structural Grade: **0**  
O&M Grade: **4**  
Clock Start/From:  
Clock To:  
1st Value:  
2nd Value:  
Value Percent:  
Continuous Index: **F02**  
Within 8" of Joint: **NO**  
Remarks:

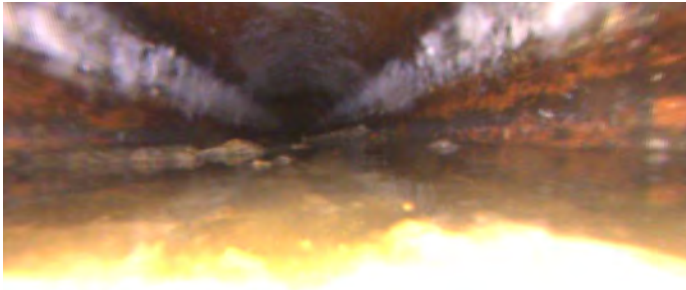
Code: **MGO**  
Description: **General Observation**

Distance (ft): **121.8**  
Structural Grade: **0**  
O&M Grade: **0**  
Clock Start/From:  
Clock To:  
1st Value:  
2nd Value:  
Value Percent:  
Continuous Index:  
Within 8" of Joint: **NO**  
Remarks: **rear camera/mcu**

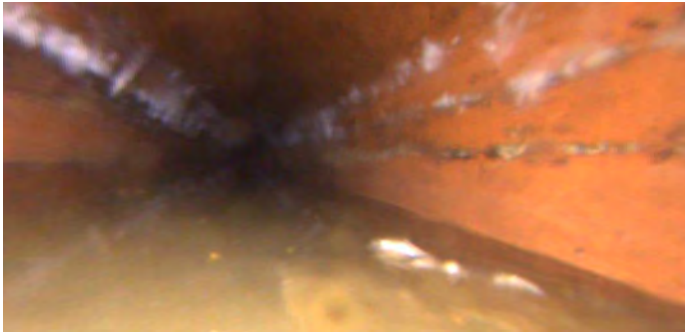
Code: **MCU**  
Description: **Camera Underwater**

Distance (ft): **157.4**  
Structural Grade: **0**  
O&M Grade: **4**  
Clock Start/From:  
Clock To:  
1st Value:  
2nd Value:  
Value Percent:  
Continuous Index: **F03**  
Within 8" of Joint: **NO**  
Remarks: **front and rear**

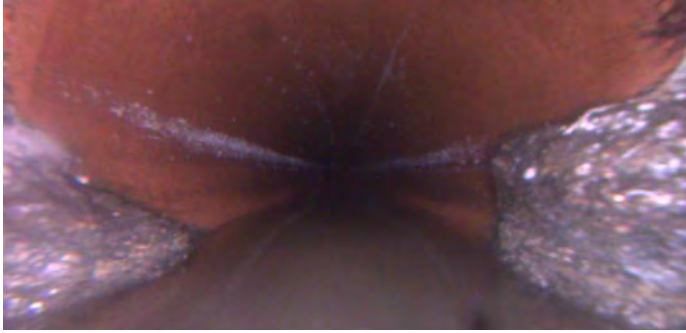
Code: **DAE**  
Description: **Deposits Attached Encrustation**

Distance (ft): **208.3**  
Structural Grade: **0**  
O&M Grade: **2**  
Clock Start/From: **8**  
Clock To: **4**  
1st Value:  
2nd Value:  
Value Percent: **10.000**  
Continuous Index:  
Within 8" of Joint: **YES**  
Remarks:

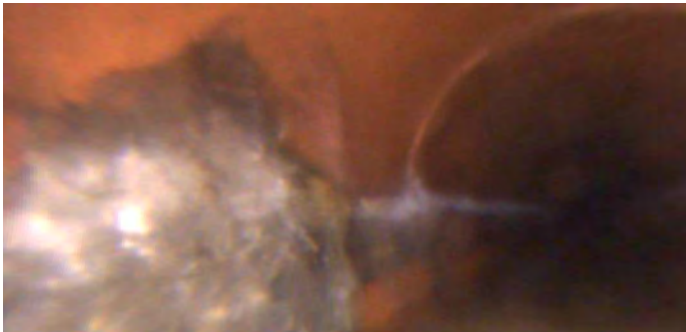
Code: **RML**  
Description: **Roots Medium Lateral**

Distance (ft): **221.8**  
Structural Grade: **0**  
O&M Grade: **3**  
Clock Start/From: **3**  
Clock To:  
1st Value:  
2nd Value:  
Value Percent: **10.000**  
Continuous Index:  
Within 8" of Joint: **NO**  
Remarks:

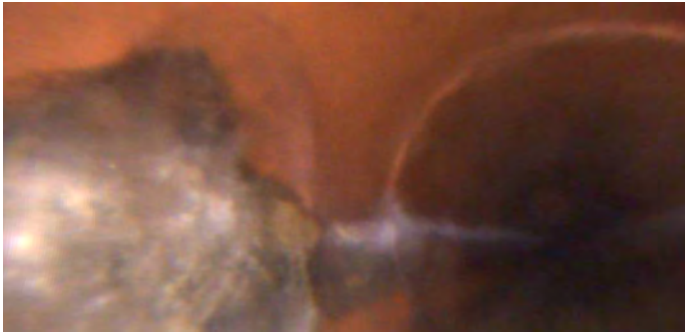
Code: **TFD**  
Description: **Tap Factory Defective**

Distance (ft): **221.8**  
Structural Grade: **0**  
O&M Grade: **2**  
Clock Start/From: **3**  
Clock To:  
1st Value: **4.000**  
2nd Value:  
Value Percent:  
Continuous Index:  
Within 8" of Joint: **YES**  
Remarks: **blocked**

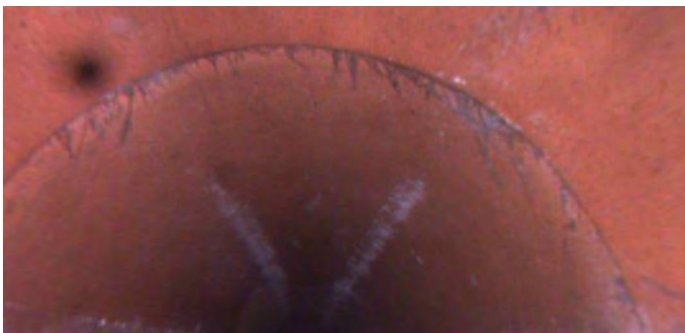
Code: **RFJ**  
Description: **Roots Fine Joint**

Distance (ft): **228.1**  
Structural Grade: **0**  
O&M Grade: **1**  
Clock Start/From: **8**  
Clock To: **4**  
1st Value:  
2nd Value:  
Value Percent:  
Continuous Index:  
Within 8" of Joint: **YES**  
Remarks:

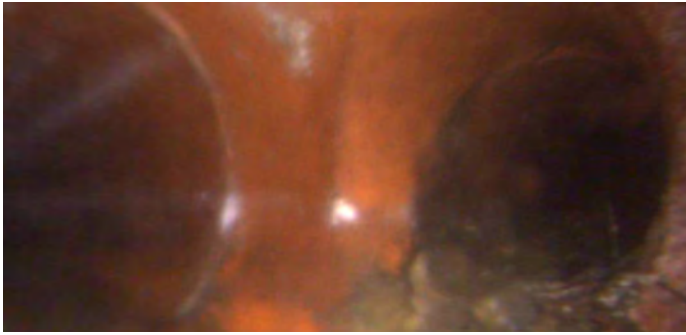
Code: **TF**  
Description: **Tap Factory**

Distance (ft): **247.6**  
Structural Grade: **0**  
O&M Grade: **0**  
Clock Start/From: **9**  
Clock To:  
1st Value: **4.000**  
2nd Value:  
Value Percent:  
Continuous Index:  
Within 8" of Joint:  
Remarks:

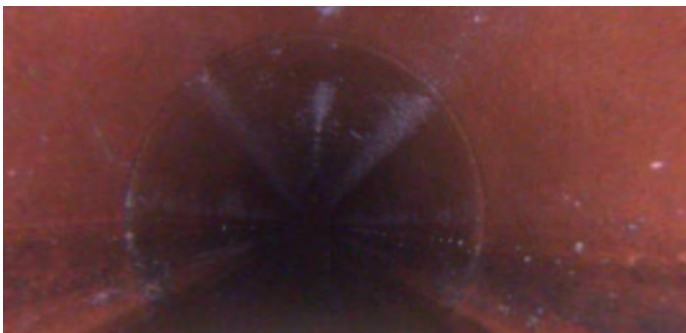
Code: **RFJ**  
Description: **Roots Fine Joint**

Distance (ft): **253.5**  
Structural Grade: **0**  
O&M Grade: **1**  
Clock Start/From: **8**  
Clock To: **9**  
1st Value:  
2nd Value:  
Value Percent:  
Continuous Index:  
Within 8" of Joint: **YES**  
Remarks:

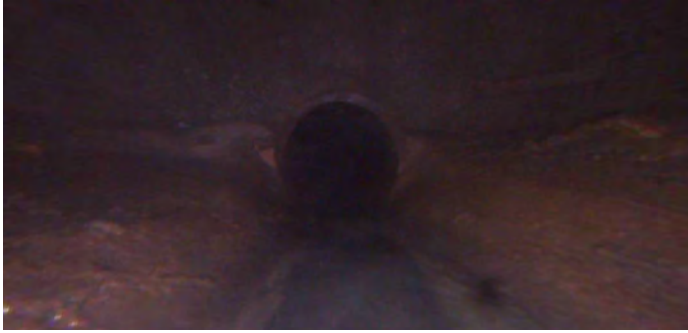
Code:	<b>AMH</b>
Description:	<b>Manhole</b>
Distance (ft):	<b>273.1</b>
Structural Grade:	<b>0</b>
O&M Grade:	<b>0</b>
Clock Start/From:	
Clock To:	
1st Value:	
2nd Value:	
Value Percent:	
Continuous Index:	
Within 8" of Joint:	<b>NO</b>
Remarks:	<b>M-108-007</b>
