Profile/Photo Observation Report

Street:	FOXCROFT STREET	Flow Control:	Not Controlled
City:	Hobart, IN	Year Renewed:	
Location:	Light Highway	Tape/Media #:	
Purpose:	Routine Assessment	Dia/Height:	12"
Use:	Sanitary	Material:	VCP
Drain Area:	NA	Lining:	Cured in Place
Category:	NA		
Comment:	Flow direction Wrong		
Location Details:		Direction of Survey:	Upstream
US MH:	M-108-007	DS MH:	M-108-006
		Total Length Surveyed (ft):	273.1

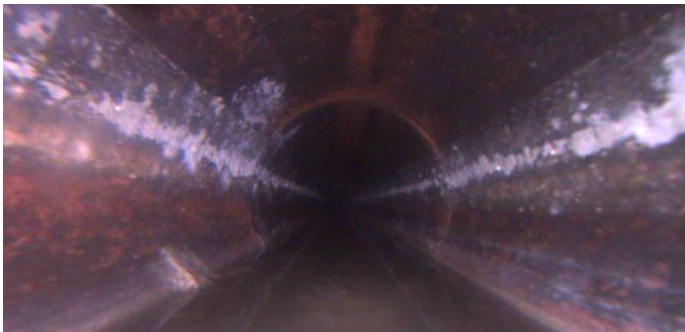
Code:	MLC
Description:	Lining Change

Distance (ft):	4.5
Structural Grade:	0
O&M Grade:	0
Clock Start/From:	
Clock To:	
1st Value:	
2nd Value:	
Value Percent:	
Continuous Index:	
Within 8" of Joint:	NO
Remarks:	end cip

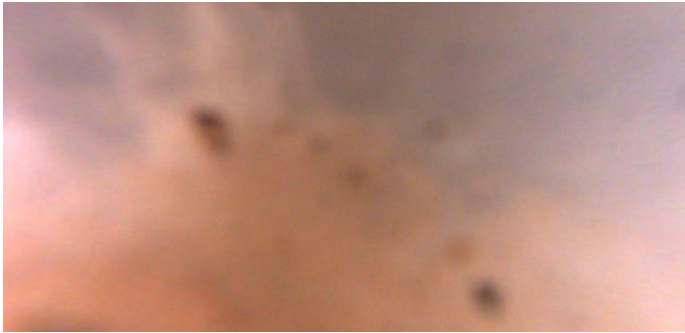
Code: **MCU**
Description: **Camera Underwater**

Distance (ft): **27.4**
Structural Grade: **0**
O&M Grade: **4**
Clock Start/From:
Clock To:
1st Value:
2nd Value:
Value Percent:
Continuous Index: **S02**
Within 8" of Joint: **NO**
Remarks: **front and rear**

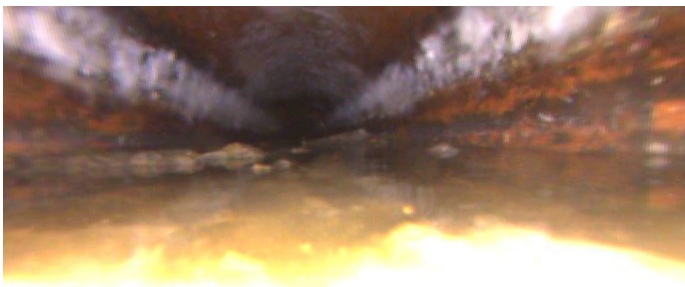
Code: **MCU**
Description: **Camera Underwater**

Distance (ft): **121.8**
Structural Grade: **0**
O&M Grade: **4**
Clock Start/From:
Clock To:
1st Value:
2nd Value:
Value Percent:
Continuous Index: **F02**
Within 8" of Joint: **NO**
Remarks:

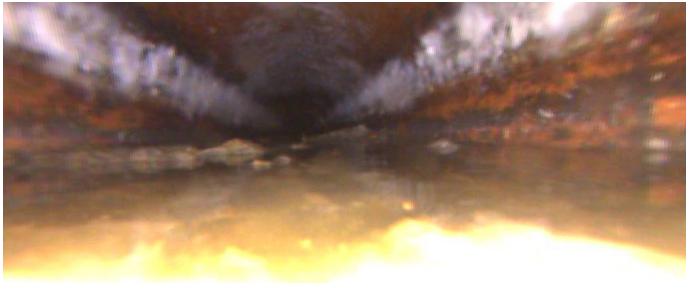
Code: **MGO**
Description: **General Observation**

Distance (ft): **121.8**
Structural Grade: **0**
O&M Grade: **0**
Clock Start/From:
Clock To:
1st Value:
2nd Value:
Value Percent:
Continuous Index:
Within 8" of Joint: **NO**
Remarks: **rear camera/mcu**

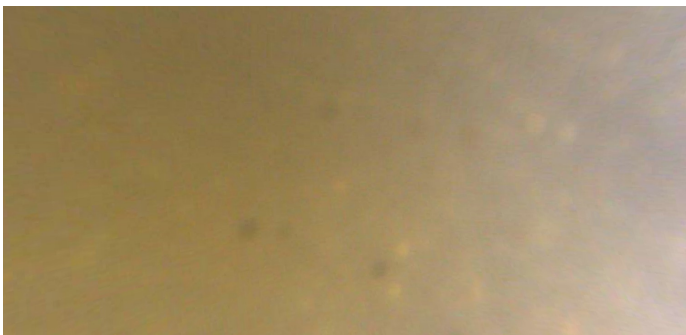
Code: **MCU**
Description: **Camera Underwater**

Distance (ft): **151.2**
Structural Grade: **0**
O&M Grade: **4**
Clock Start/From:
Clock To:
1st Value:
2nd Value:
Value Percent:
Continuous Index: **S03**
Within 8" of Joint: **NO**
Remarks: **front and rear**

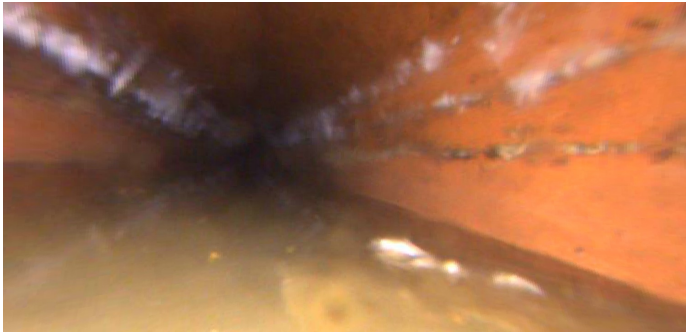
Code: **MCU**
Description: **Camera Underwater**

Distance (ft): **157.4**
Structural Grade: **0**
O&M Grade: **4**
Clock Start/From:
Clock To:
1st Value:
2nd Value:
Value Percent:
Continuous Index: **F03**
Within 8" of Joint: **NO**
Remarks: **front and rear**

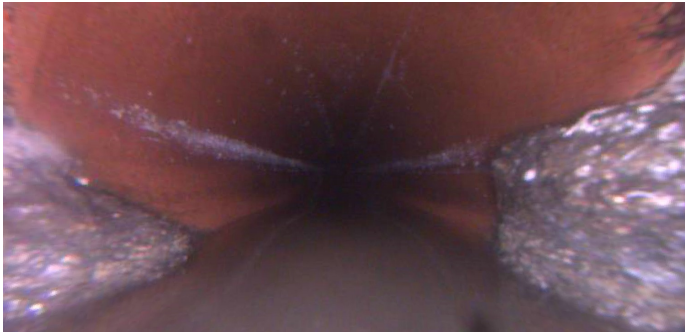
Code: **DAE**
Description: **Deposits Attached Encrustation**

Distance (ft): **208.3**
Structural Grade: **0**
O&M Grade: **2**
Clock Start/From: **8**
Clock To: **4**
1st Value:
2nd Value:
Value Percent: **10.000**
Continuous Index:
Within 8" of Joint: **YES**
Remarks:

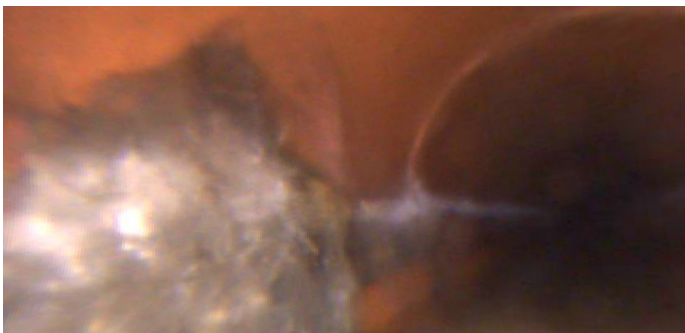
Code: **RML**
Description: **Roots Medium Lateral**

Distance (ft): **221.8**
Structural Grade: **0**
O&M Grade: **3**
Clock Start/From: **3**
Clock To:
1st Value:
2nd Value:
Value Percent: **10.000**
Continuous Index:
Within 8" of Joint: **NO**
Remarks:

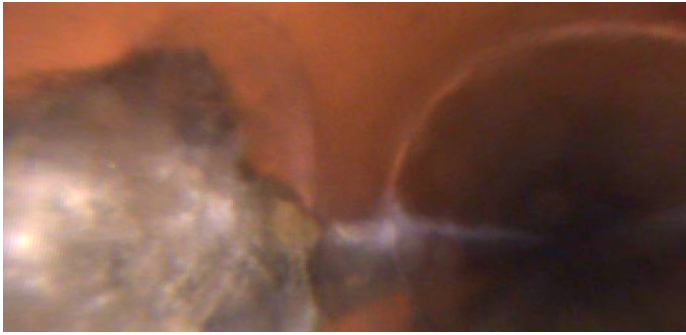
Code: **TFD**
Description: **Tap Factory Defective**

Distance (ft): **221.8**
Structural Grade: **0**
O&M Grade: **2**
Clock Start/From: **3**
Clock To:
1st Value: **4.000**
2nd Value:
Value Percent:
Continuous Index:
Within 8" of Joint: **YES**
Remarks: **blocked**

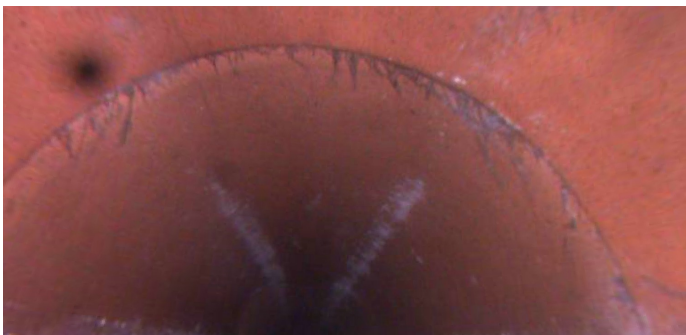
Code: **RFJ**
Description: **Roots Fine Joint**

Distance (ft): **228.1**
Structural Grade: **0**
O&M Grade: **1**
Clock Start/From: **8**
Clock To: **4**
1st Value:
2nd Value:
Value Percent:
Continuous Index:
Within 8" of Joint: **YES**
Remarks:

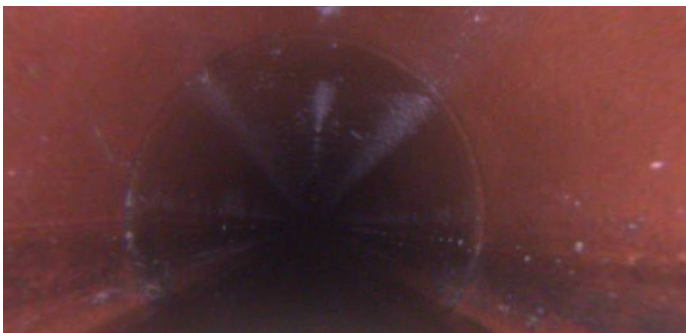
Code: **RFJ**
Description: **Roots Fine Joint**

Distance (ft): **253.5**
Structural Grade: **0**
O&M Grade: **1**
Clock Start/From: **8**
Clock To: **9**
1st Value:
2nd Value:
Value Percent:
Continuous Index:
Within 8" of Joint: **YES**
Remarks:
