## Profile/Photo Observation Report

Date:	<b>03/24/2018</b>	Weather:		Coding:	<b>PACP 6.0</b>
Pipe Length (ft):	<b>243.7</b>	Owner:	<b>NA</b>	Pre Clean:	<b>No Pre-Cleaning</b>
P.O.#:		Surveyor:	<b>Byrd Fitzgerald</b>	PSR:	<b>P-108-007-008</b>
Customer:		Clean Date:	<b>01/01/1900</b>	Shape:	<b>C</b>

Street:	<b>14TH LN</b>	Flow Control:	<b>Not Controlled</b>
City:	<b>Hobart, IN</b>	Year Renewed:	
Location:	<b>Light Highway</b>	Tape/Media #:	
Purpose:	<b>Routine Assessment</b>	Dia/Height:	<b>12"</b>
Use:	<b>Sanitary</b>	Material:	<b>VCP</b>
Drain Area:	<b>NA</b>	Lining:	
Category:	<b>NA</b>		
Comment:	<b>Flow direction wrong</b>

Location Details:		Direction of Survey:	<b>Downstream</b>
US MH:	<b>M-108-008</b>	DS MH:	<b>M-108-007</b>
		Total Length Surveyed (ft):	<b>245.7</b>

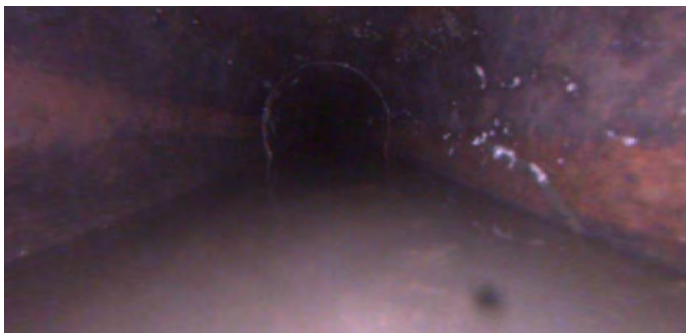
Code: **AMH**  
Description: **Manhole**

Distance (ft): **.0**  
Structural Grade: **0**  
O&M Grade: **0**  
Clock Start/From:  
Clock To:  
1st Value:  
2nd Value:  
Value Percent:  
Continuous Index:  
Within 8" of Joint: **NO**  
Remarks: **M-108-008**

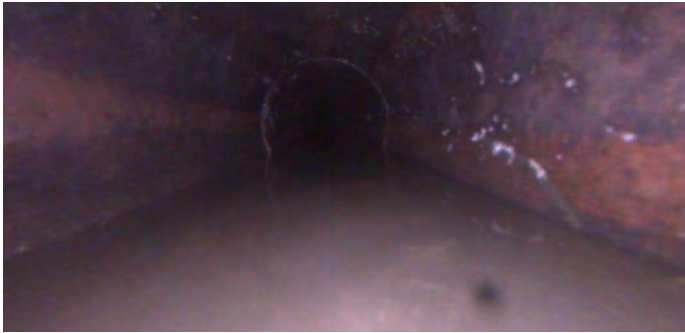
Code:	<b>MWL</b>
Description:	<b>Water Level</b>

Distance (ft):	<b>.0</b>
Structural Grade:	<b>0</b>
O&M Grade:	<b>0</b>
Clock Start/From:	
Clock To:	
1st Value:	
2nd Value:	
Value Percent:	<b>5.000</b>
Continuous Index:	
Within 8" of Joint:	<b>NO</b>
Remarks:

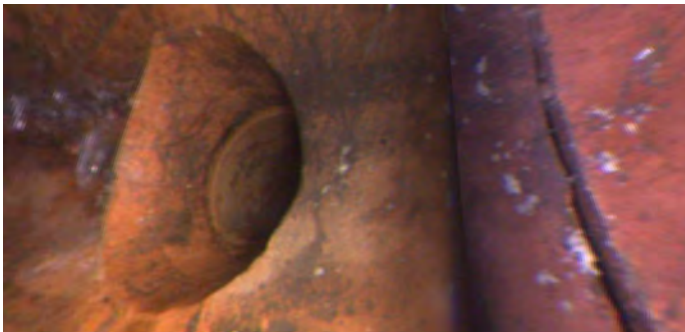
Code:	<b>TF</b>
Description:	<b>Tap Factory</b>

Distance (ft):	<b>11.1</b>
Structural Grade:	<b>0</b>
O&M Grade:	<b>0</b>
Clock Start/From:	<b>9</b>
Clock To:	
1st Value:	<b>4.000</b>
2nd Value:	
Value Percent:	
Continuous Index:	
Within 8" of Joint:	<b>YES</b>
Remarks:

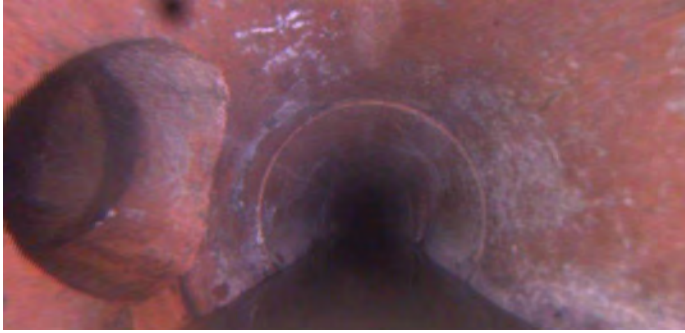
Code: **TF**  
Description: **Tap Factory**

Distance (ft): **48.1**  
Structural Grade: **0**  
O&M Grade: **0**  
Clock Start/From: **9**  
Clock To:  
1st Value: **4.000**  
2nd Value:  
Value Percent:  
Continuous Index:  
Within 8" of Joint: **YES**  
Remarks:

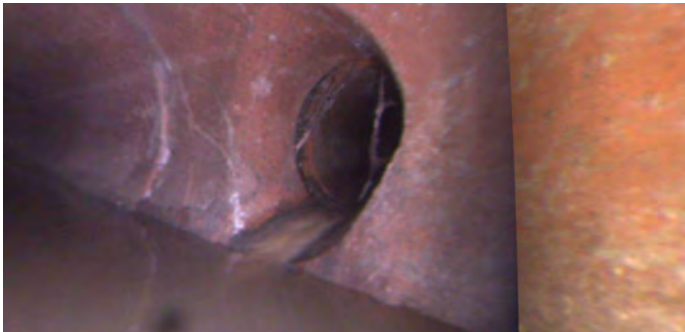
Code: **TF**  
Description: **Tap Factory**

Distance (ft): **50.2**  
Structural Grade: **0**  
O&M Grade: **0**  
Clock Start/From: **3**  
Clock To:  
1st Value: **4.000**  
2nd Value:  
Value Percent:  
Continuous Index:  
Within 8" of Joint:  
Remarks:

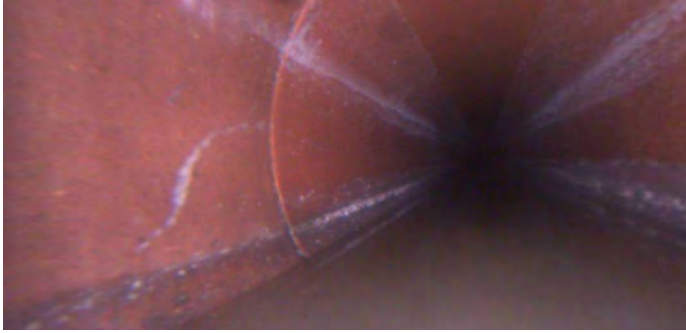
Code: **CS**  
Description: **Crack Spiral**

Distance (ft): **74.8**  
Structural Grade: **2**  
O&M Grade: **0**  
Clock Start/From: **8**  
Clock To: **9**  
1st Value:  
2nd Value:  
Value Percent:  
Continuous Index:  
Within 8" of Joint: **YES**  
Remarks:

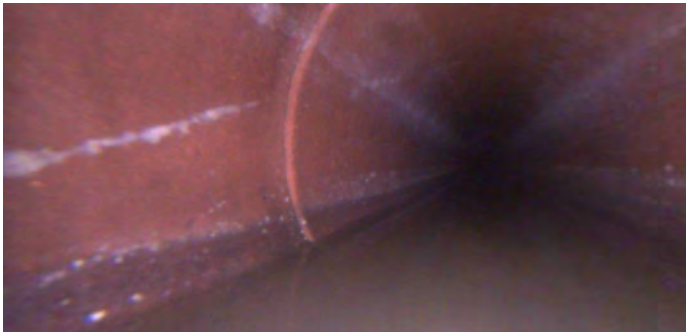
Code: **CS**  
Description: **Crack Spiral**

Distance (ft): **80.7**  
Structural Grade: **2**  
O&M Grade: **0**  
Clock Start/From: **8**  
Clock To: **9**  
1st Value:  
2nd Value:  
Value Percent:  
Continuous Index:  
Within 8" of Joint: **YES**  
Remarks:

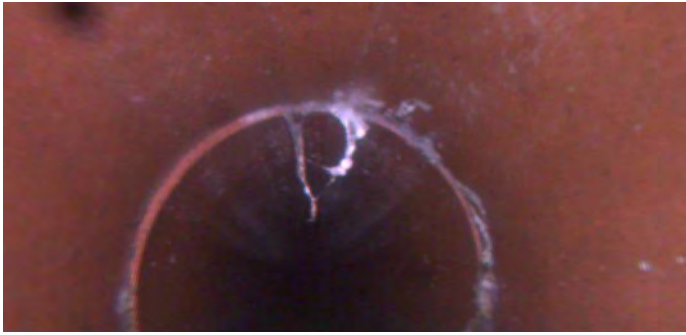
Code: **RFJ**  
Description: **Roots Fine Joint**

Distance (ft): **128.2**  
Structural Grade: **0**  
O&M Grade: **1**  
Clock Start/From: **12**  
Clock To:  
1st Value:  
2nd Value:  
Value Percent:  
Continuous Index:  
Within 8" of Joint: **YES**  
Remarks:

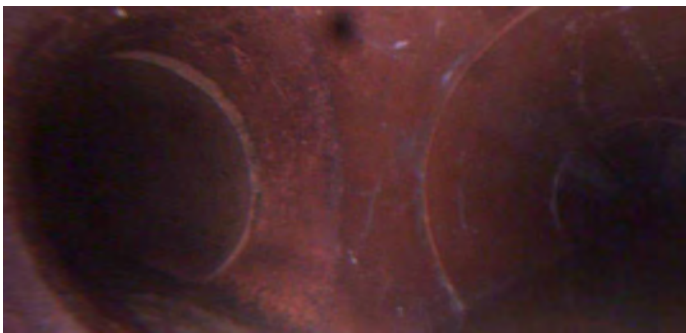
Code: **TF**  
Description: **Tap Factory**

Distance (ft): **136.3**  
Structural Grade: **0**  
O&M Grade: **0**  
Clock Start/From: **9**  
Clock To:  
1st Value: **4.000**  
2nd Value:  
Value Percent:  
Continuous Index:  
Within 8" of Joint: **YES**  
Remarks:

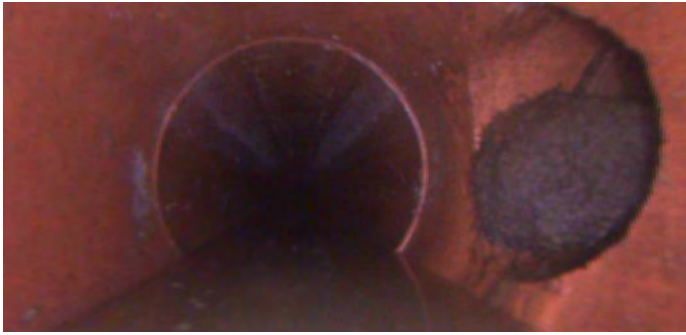
Code: **TFD**  
Description: **Tap Factory Defective**

Distance (ft): **137.9**  
Structural Grade: **0**  
O&M Grade: **2**  
Clock Start/From: **3**  
Clock To:  
1st Value: **4.000**  
2nd Value:  
Value Percent:  
Continuous Index:  
Within 8" of Joint: **YES**  
Remarks: **blocked by roots**

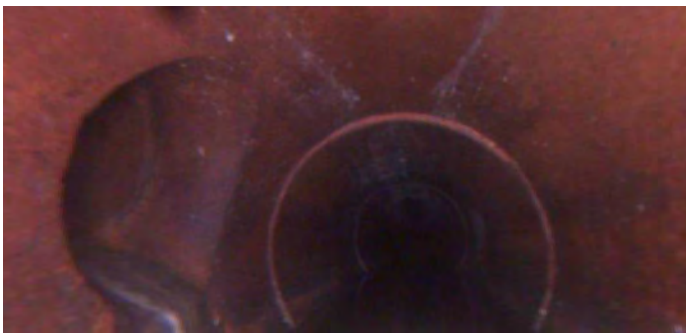
Code: **TF**  
Description: **Tap Factory**

Distance (ft): **193.9**  
Structural Grade: **0**  
O&M Grade: **0**  
Clock Start/From: **9**  
Clock To:  
1st Value: **4.000**  
2nd Value:  
Value Percent:  
Continuous Index:  
Within 8" of Joint: **YES**  
Remarks:

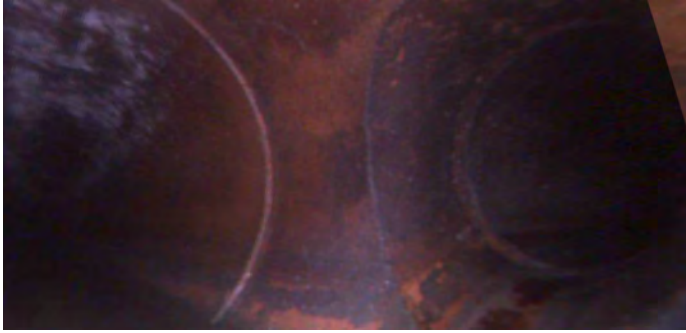
Code: **TF**  
Description: **Tap Factory**

Distance (ft): **196.4**  
Structural Grade: **0**  
O&M Grade: **0**  
Clock Start/From: **3**  
Clock To:  
1st Value: **4.000**  
2nd Value:  
Value Percent:  
Continuous Index:  
Within 8" of Joint: **YES**  
Remarks:

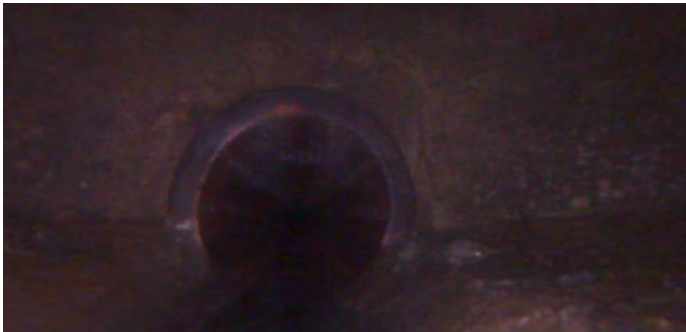
Code: **AMH**  
Description: **Manhole**

Distance (ft): **245.7**  
Structural Grade: **0**  
O&M Grade: **0**  
Clock Start/From:  
Clock To:  
1st Value:  
2nd Value:  
Value Percent:  
Continuous Index:  
Within 8" of Joint: **NO**  
Remarks: **M-108-007**
