Profile/Photo Observation Report

Date:	03/24/2018	Weather:		Coding:	PACP 6.0
Pipe Length (ft):	243.7	Owner:	NA	Pre Clean:	No Pre-Cleaning
P.O.#:		Surveyor:	Byrd Fitzgerald	PSR:	P-108-007-008
Customer:		Clean Date:	01/01/1900	Shape:	C

Street:	FOXCROFT STREET	Flow Control:	Not Controlled
City:	Hobart, IN	Year Renewed:	
Location:	Light Highway	Tape/Media #:	
Purpose:	Routine Assessment	Dia/Height:	12"
Use:	Sanitary	Material:	VCP
Drain Area:	NA	Lining:	
Category:	NA		
Comment:	Flow direction wrong		
Location Details:		Direction of Survey:	Downstream
US MH:	M-108-008	DS MH:	M-108-007
		Total Length Surveyed (ft):	245.7

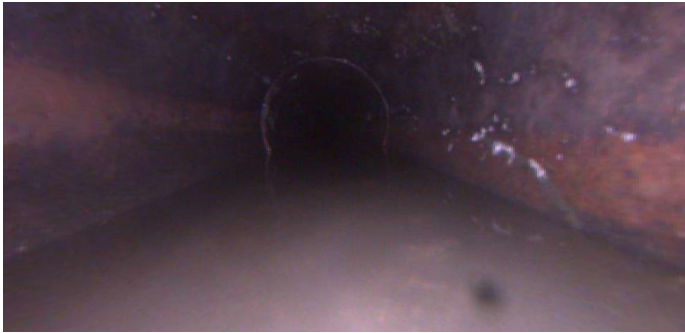
Code:	MWL
Description:	Water Level

Distance (ft):	.0
Structural Grade:	0
O&M Grade:	0
Clock Start/From:	
Clock To:	
1st Value:	
2nd Value:	
Value Percent:	5.000
Continuous Index:	
Within 8" of Joint:	NO
Remarks:

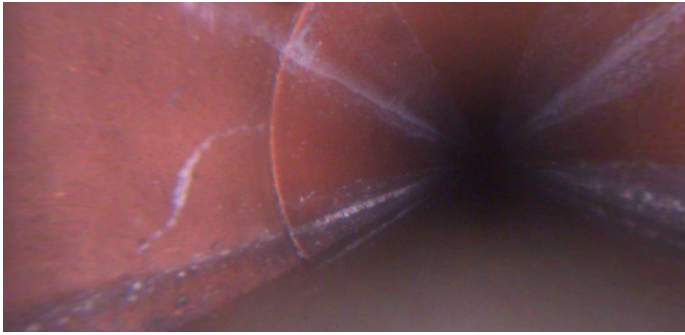
Code: **CS**
Description: **Crack Spiral**

Distance (ft): **74.8**
Structural Grade: **2**
O&M Grade: **0**
Clock Start/From: **8**
Clock To: **9**
1st Value:
2nd Value:
Value Percent:
Continuous Index:
Within 8" of Joint: **YES**
Remarks:

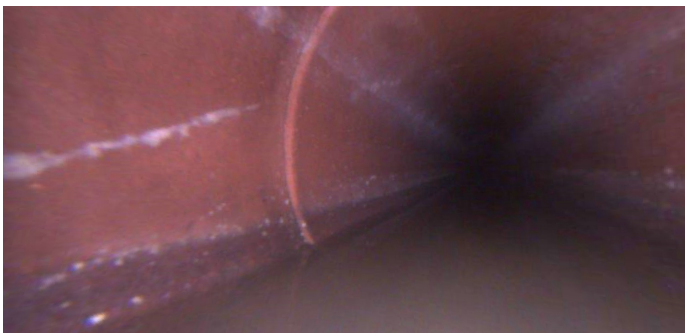
Code: **CS**
Description: **Crack Spiral**

Distance (ft): **80.7**
Structural Grade: **2**
O&M Grade: **0**
Clock Start/From: **8**
Clock To: **9**
1st Value:
2nd Value:
Value Percent:
Continuous Index:
Within 8" of Joint: **YES**
Remarks:

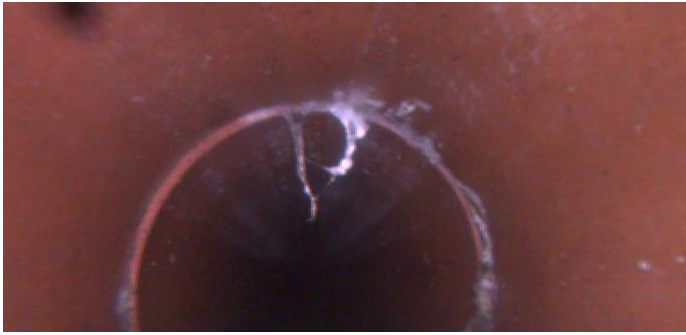
Code: **RFJ**
Description: **Roots Fine Joint**

Distance (ft): **128.2**
Structural Grade: **0**
O&M Grade: **1**
Clock Start/From: **12**
Clock To:
1st Value:
2nd Value:
Value Percent:
Continuous Index:
Within 8" of Joint: **YES**
Remarks:

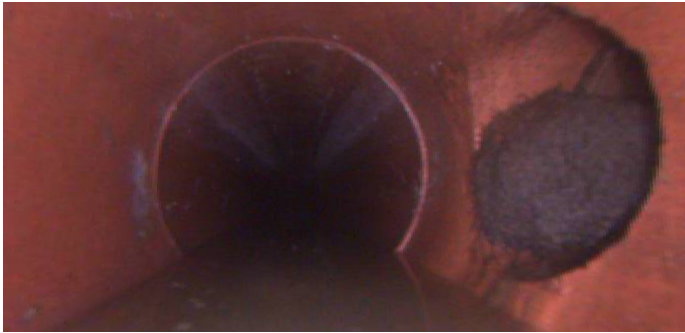
Code: **TFD**
Description: **Tap Factory Defective**

Distance (ft): **137.9**
Structural Grade: **0**
O&M Grade: **2**
Clock Start/From: **3**
Clock To:
1st Value: **4.000**
2nd Value:
Value Percent:
Continuous Index:
Within 8" of Joint: **YES**
Remarks: **blocked by roots**
