## Profile/Photo Observation Report

Street:	<b>14TH LN</b>	Flow Control:	<b>Not Controlled</b>
City:	<b>Hobart, IN</b>	Year Renewed:	
Location:	<b>Light Highway</b>	Tape/Media #:	
Purpose:	<b>Routine Assessment</b>	Dia/Height:	<b>8"</b>
Use:	<b>Sanitary</b>	Material:	<b>VCP</b>
Drain Area:	<b>NA</b>	Lining:	
Category:	<b>NA</b>		
Comment:	<b>Flow direction wrong</b>

Location Details:		Direction of Survey:	<b>Downstream</b>
US MH:	<b>M-108-008</b>	DS MH:	<b>M-108-009</b>
		Total Length Surveyed (ft):	<b>163.9</b>

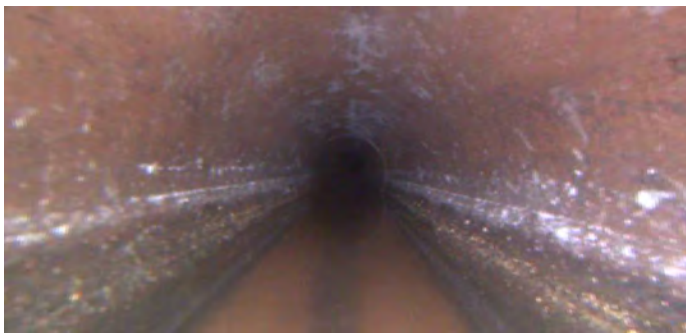
Code: **AMH**  
Description: **Manhole**

Distance (ft): **.0**  
Structural Grade: **0**  
O&M Grade: **0**  
Clock Start/From:  
Clock To:  
1st Value:  
2nd Value:  
Value Percent:  
Continuous Index:  
Within 8" of Joint: **NO**  
Remarks: **M-108-008**

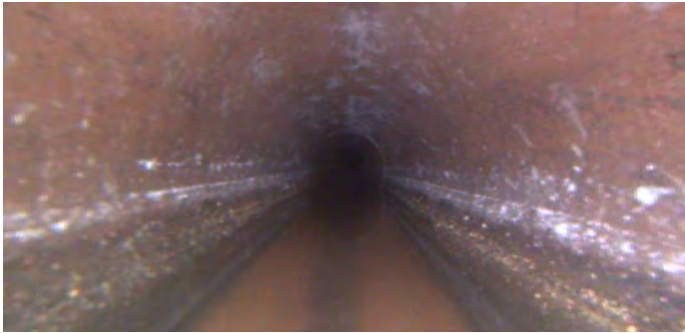
Code:	<b>MWL</b>
Description:	<b>Water Level</b>

Distance (ft):	<b>.0</b>
Structural Grade:	<b>0</b>
O&M Grade:	<b>0</b>
Clock Start/From:	
Clock To:	
1st Value:	
2nd Value:	
Value Percent:	<b>5.000</b>
Continuous Index:	
Within 8" of Joint:	<b>NO</b>
Remarks:

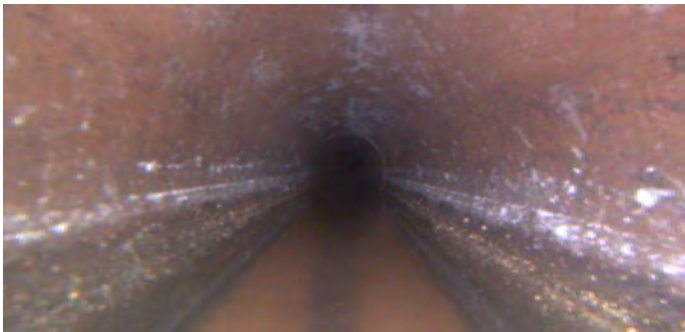
Code:	<b>DAZ</b>
Description:	<b>Deposits Attached Other</b>

Distance (ft):	<b>.0</b>
Structural Grade:	<b>0</b>
O&M Grade:	<b>2</b>
Clock Start/From:	<b>7</b>
Clock To:	<b>5</b>
1st Value:	
2nd Value:	
Value Percent:	<b>5.000</b>
Continuous Index:	<b>S01</b>
Within 8" of Joint:	<b>YES</b>
Remarks:	<b>WANDER</b>

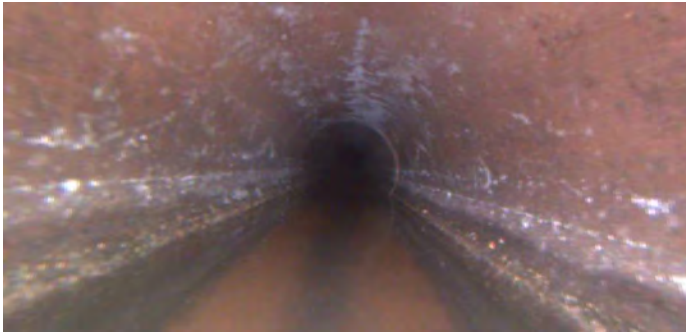
Code: **DAGS**  
Description: **Deposits Attached Grease**

Distance (ft): **1.4**  
Structural Grade: **0**  
O&M Grade: **2**  
Clock Start/From: **7**  
Clock To: **5**  
1st Value:  
2nd Value:  
Value Percent: **5.000**  
Continuous Index: **S02**  
Within 8" of Joint: **YES**  
Remarks: **WANDER**

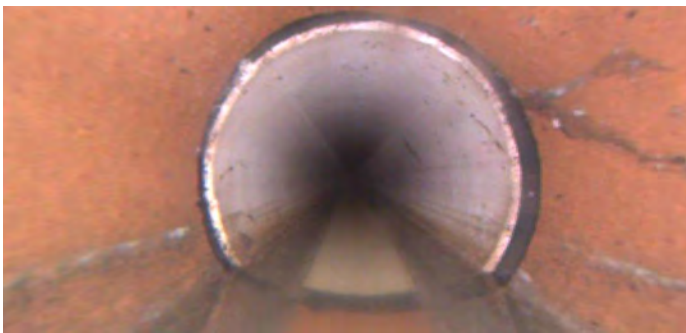
Code: **RPR**  
Description: **Repair Point Pipe Replaced**

Distance (ft): **23.4**  
Structural Grade: **0**  
O&M Grade: **0**  
Clock Start/From:  
Clock To:  
1st Value:  
2nd Value:  
Value Percent:  
Continuous Index:  
Within 8" of Joint: **NO**  
Remarks: **PVC**

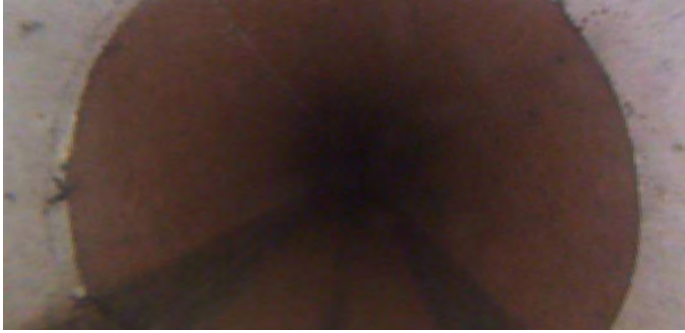
Code: **RPR**  
Description: **Repair Point Pipe Replaced**

Distance (ft): **35.4**  
Structural Grade: **0**  
O&M Grade: **0**  
Clock Start/From:  
Clock To:  
1st Value:  
2nd Value:  
Value Percent:  
Continuous Index:  
Within 8" of Joint: **NO**  
Remarks: **PVC END**

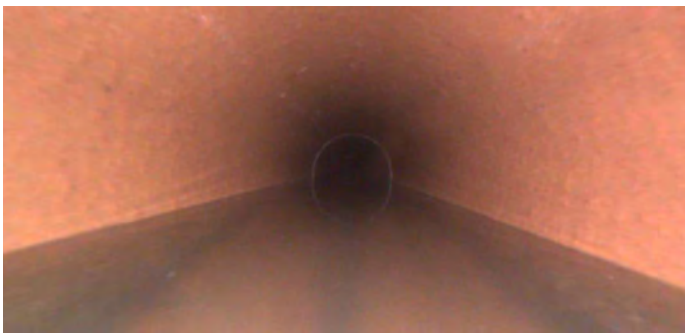
Code: **MWLS**  
Description: **Water Level Sag**

Distance (ft): **42.3**  
Structural Grade: **2**  
O&M Grade: **3**  
Clock Start/From:  
Clock To:  
1st Value:  
2nd Value:  
Value Percent: **15.000**  
Continuous Index:  
Within 8" of Joint: **NO**  
Remarks:

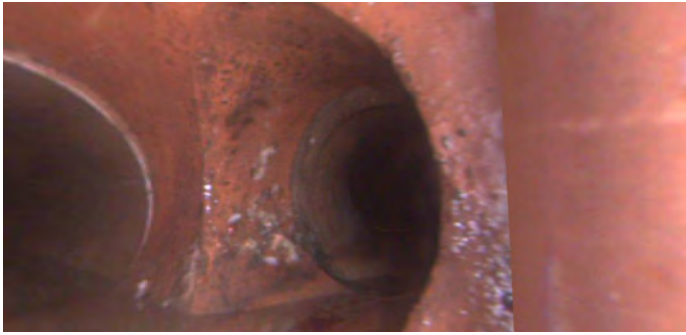
Code: **TF**  
Description: **Tap Factory**

Distance (ft): **56.7**  
Structural Grade: **0**  
O&M Grade: **0**  
Clock Start/From: **3**  
Clock To:  
1st Value: **4.000**  
2nd Value:  
Value Percent:  
Continuous Index:  
Within 8" of Joint:  
Remarks:

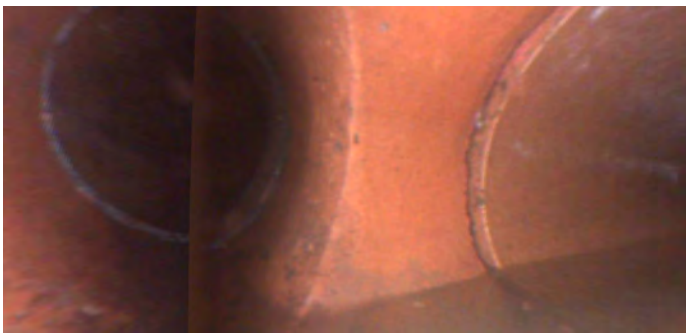
Code: **TF**  
Description: **Tap Factory**

Distance (ft): **75.2**  
Structural Grade: **0**  
O&M Grade: **0**  
Clock Start/From: **9**  
Clock To:  
1st Value: **4.000**  
2nd Value:  
Value Percent:  
Continuous Index:  
Within 8" of Joint:  
Remarks:

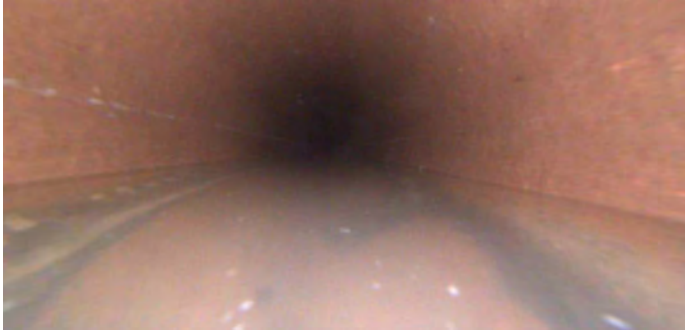
Code: **MWLS**  
Description: **Water Level Sag**

Distance (ft): **102.5**  
Structural Grade: **2**  
O&M Grade: **3**  
Clock Start/From:  
Clock To:  
1st Value:  
2nd Value:  
Value Percent: **15.000**  
Continuous Index:  
Within 8" of Joint: **NO**  
Remarks:

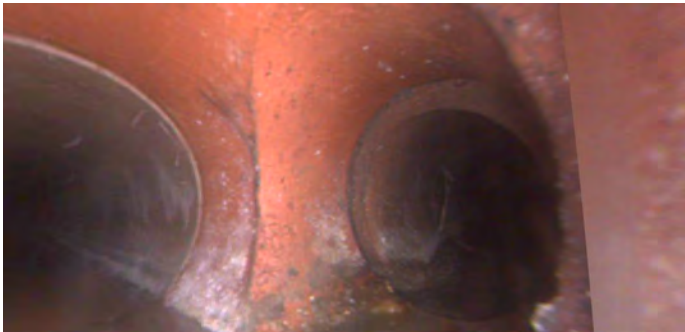
Code: **TF**  
Description: **Tap Factory**

Distance (ft): **135.4**  
Structural Grade: **0**  
O&M Grade: **0**  
Clock Start/From: **3**  
Clock To:  
1st Value: **4.000**  
2nd Value:  
Value Percent:  
Continuous Index:  
Within 8" of Joint:  
Remarks:

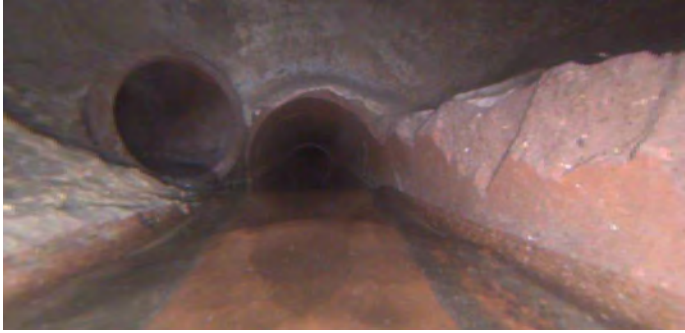
Code: **AMH**  
Description: **Manhole**

Distance (ft): **163.9**  
Structural Grade: **0**  
O&M Grade: **0**  
Clock Start/From:  
Clock To:  
1st Value:  
2nd Value:  
Value Percent:  
Continuous Index:  
Within 8" of Joint: **NO**  
Remarks: **M-108-009**

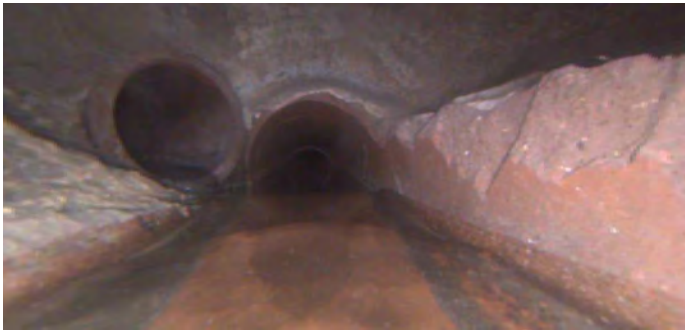
Code: **DAZ**  
Description: **Deposits Attached Other**

Distance (ft): **163.9**  
Structural Grade: **0**  
O&M Grade: **2**  
Clock Start/From: **7**  
Clock To: **5**  
1st Value:  
2nd Value:  
Value Percent: **5.000**  
Continuous Index: **F01**  
Within 8" of Joint: **YES**  
Remarks: **WANDER**

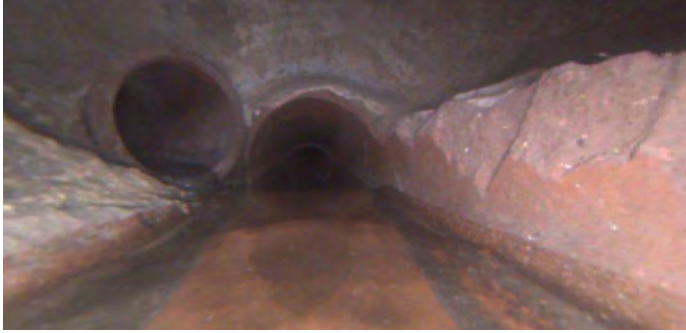
Code:	<b>DAGS</b>
Description:	<b>Deposits Attached Grease</b>
Distance (ft):	<b>163.9</b>
Structural Grade:	<b>0</b>
O&M Grade:	<b>2</b>
Clock Start/From:	<b>7</b>
Clock To:	<b>5</b>
1st Value:	
2nd Value:	
Value Percent:	<b>5.000</b>
Continuous Index:	<b>F02</b>
Within 8" of Joint:	<b>YES</b>
Remarks:	<b>WANDER</b>
