Profile/Photo Observation Report

Date:	03/24/2018	Weather:		Coding:	PACP 6.0
Pipe Length (ft):	161.2	Owner:	NA	Pre Clean:	No Pre-Cleaning
P.O.#:		Surveyor:	Justin Gonzales	PSR:	P-108-009-008
Customer:		Clean Date:	01/01/1900	Shape:	C

Street:	FOXCROFT STREET	Flow Control:	Not Controlled
City:	Hobart, IN	Year Renewed:	
Location:	Light Highway	Tape/Media #:	
Purpose:	Routine Assessment	Dia/Height:	8"
Use:	Sanitary	Material:	VCP
Drain Area:	NA	Lining:	
Category:	NA		
Comment:	Flow direction wrong

Location Details:		Direction of Survey:	Downstream
US MH:	M-108-008	DS MH:	M-108-009
		Total Length Surveyed (ft):	163.9

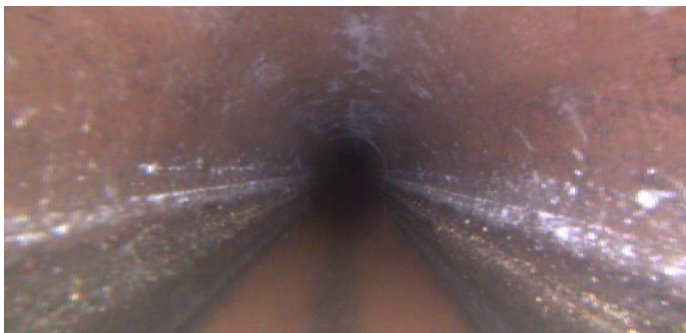
Code: **AMH**
Description: **Manhole**

Distance (ft): **.0**
Structural Grade: **0**
O&M Grade: **0**
Clock Start/From:
Clock To:
1st Value:
2nd Value:
Value Percent:
Continuous Index:
Within 8" of Joint: **NO**
Remarks: **M-108-008**

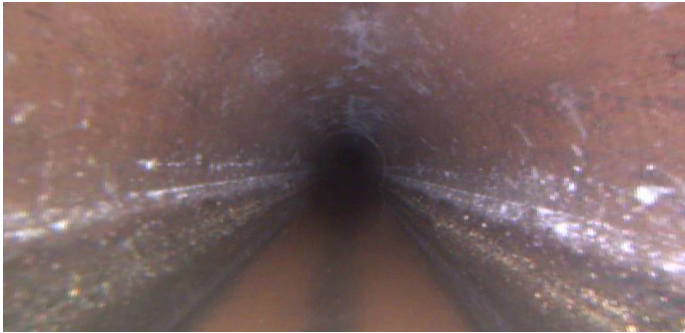
Code:	MWL
Description:	Water Level

Distance (ft):	.0
Structural Grade:	0
O&M Grade:	0
Clock Start/From:	
Clock To:	
1st Value:	
2nd Value:	
Value Percent:	5.000
Continuous Index:	
Within 8" of Joint:	NO
Remarks:

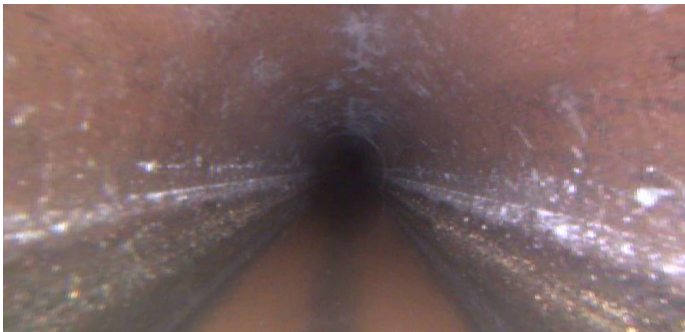
Code:	DAZ
Description:	Deposits Attached Other

Distance (ft):	.0
Structural Grade:	0
O&M Grade:	2
Clock Start/From:	7
Clock To:	5
1st Value:	
2nd Value:	
Value Percent:	5.000
Continuous Index:	S01
Within 8" of Joint:	YES
Remarks:	WANDER

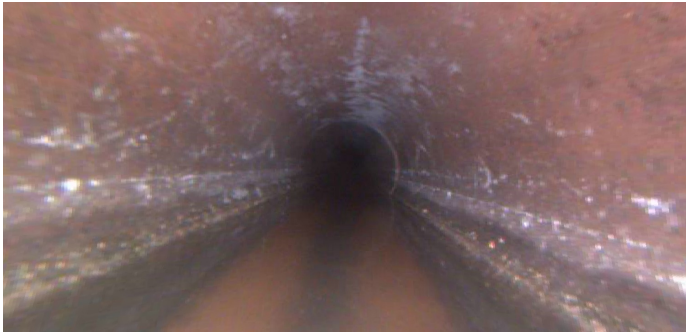
Code: **DAGS**
Description: **Deposits Attached Grease**

Distance (ft): **1.4**
Structural Grade: **0**
O&M Grade: **2**
Clock Start/From: **7**
Clock To: **5**
1st Value:
2nd Value:
Value Percent: **5.000**
Continuous Index: **S02**
Within 8" of Joint: **YES**
Remarks: **WANDER**

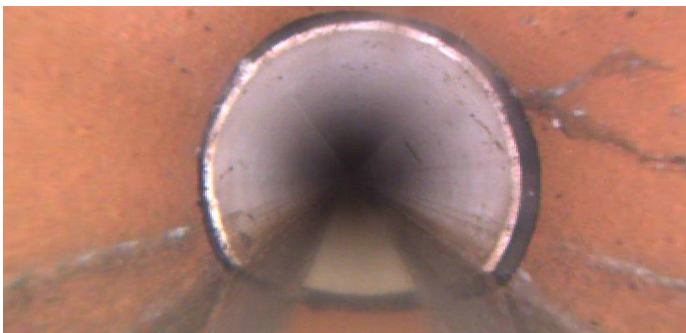
Code: **RPR**
Description: **Repair Point Pipe Replaced**

Distance (ft): **23.4**
Structural Grade: **0**
O&M Grade: **0**
Clock Start/From:
Clock To:
1st Value:
2nd Value:
Value Percent:
Continuous Index:
Within 8" of Joint: **NO**
Remarks: **PVC**

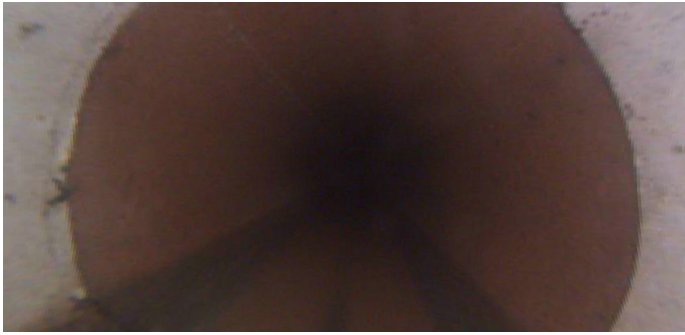
Code: **RPR**
Description: **Repair Point Pipe Replaced**

Distance (ft): **35.4**
Structural Grade: **0**
O&M Grade: **0**
Clock Start/From:
Clock To:
1st Value:
2nd Value:
Value Percent:
Continuous Index:
Within 8" of Joint: **NO**
Remarks: **PVC END**

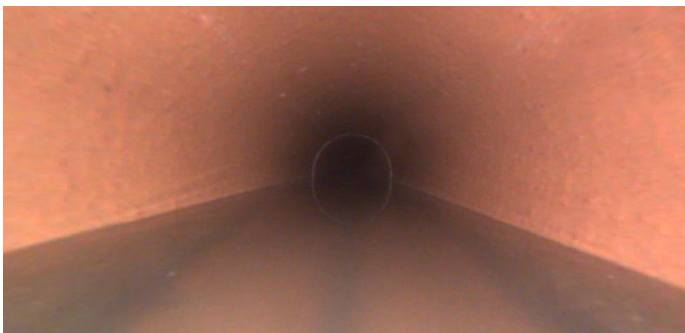
Code: **MWLS**
Description: **Water Level Sag**

Distance (ft): **42.3**
Structural Grade: **2**
O&M Grade: **3**
Clock Start/From:
Clock To:
1st Value:
2nd Value:
Value Percent: **15.000**
Continuous Index:
Within 8" of Joint: **NO**
Remarks:

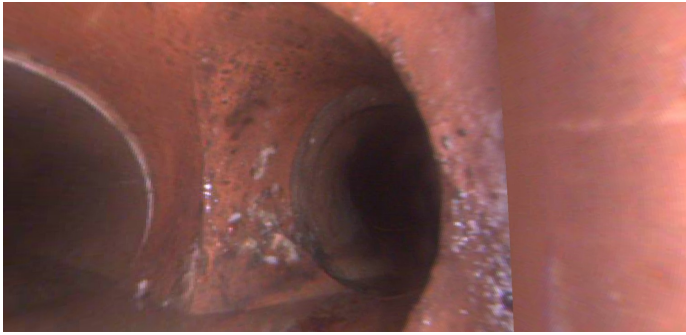
Code: **TF**
Description: **Tap Factory**

Distance (ft): **56.7**
Structural Grade: **0**
O&M Grade: **0**
Clock Start/From: **3**
Clock To:
1st Value: **4.000**
2nd Value:
Value Percent:
Continuous Index:
Within 8" of Joint:
Remarks:

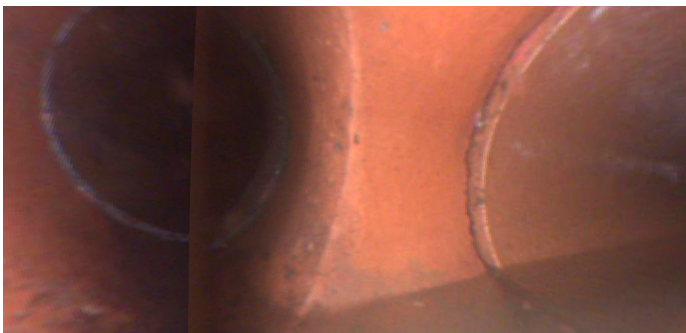
Code: **TF**
Description: **Tap Factory**

Distance (ft): **75.2**
Structural Grade: **0**
O&M Grade: **0**
Clock Start/From: **9**
Clock To:
1st Value: **4.000**
2nd Value:
Value Percent:
Continuous Index:
Within 8" of Joint:
Remarks:

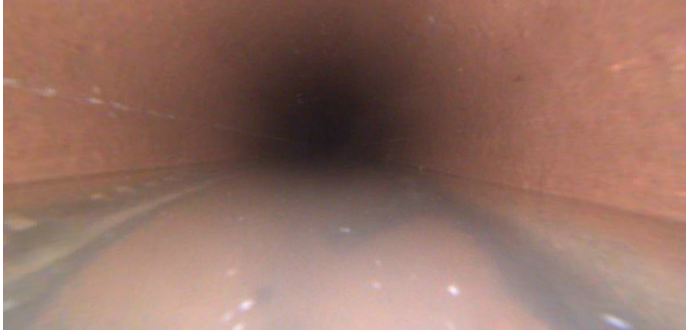
Code: **MWLS**
Description: **Water Level Sag**

Distance (ft): **102.5**
Structural Grade: **2**
O&M Grade: **3**
Clock Start/From:
Clock To:
1st Value:
2nd Value:
Value Percent: **15.000**
Continuous Index:
Within 8" of Joint: **NO**
Remarks:

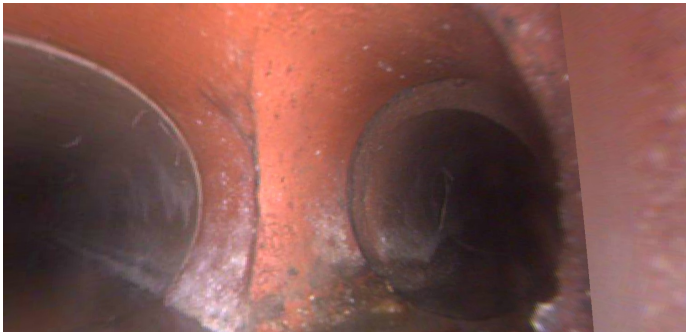
Code: **TF**
Description: **Tap Factory**

Distance (ft): **135.4**
Structural Grade: **0**
O&M Grade: **0**
Clock Start/From: **3**
Clock To:
1st Value: **4.000**
2nd Value:
Value Percent:
Continuous Index:
Within 8" of Joint:
Remarks:

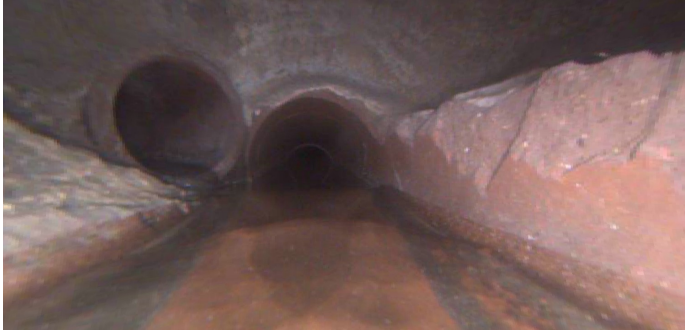
Code: **AMH**
Description: **Manhole**

Distance (ft): **163.9**
Structural Grade: **0**
O&M Grade: **0**
Clock Start/From:
Clock To:
1st Value:
2nd Value:
Value Percent:
Continuous Index:
Within 8" of Joint: **NO**
Remarks: **M-108-009**

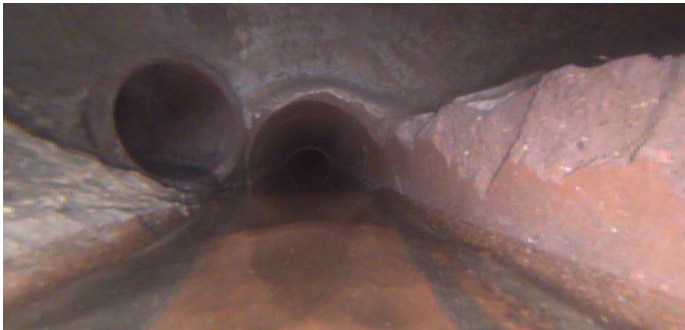
Code: **DAZ**
Description: **Deposits Attached Other**

Distance (ft): **163.9**
Structural Grade: **0**
O&M Grade: **2**
Clock Start/From: **7**
Clock To: **5**
1st Value:
2nd Value:
Value Percent: **5.000**
Continuous Index: **F01**
Within 8" of Joint: **YES**
Remarks: **WANDER**

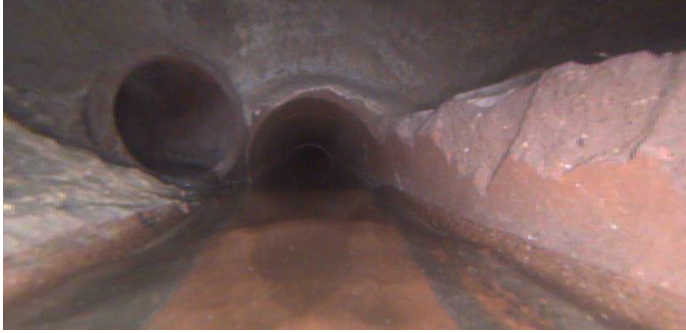
Code:	DAGS
Description:	Deposits Attached Grease
Distance (ft):	163.9
Structural Grade:	0
O&M Grade:	2
Clock Start/From:	7
Clock To:	5
1st Value:	
2nd Value:	
Value Percent:	5.000
Continuous Index:	F02
Within 8" of Joint:	YES
Remarks:	WANDER
