Profile/Photo Observation Report

Date:	03/25/2018	Weather:		Coding:	PACP 6.0
Pipe Length (ft):	181.7	Owner:	NA	Pre Clean:	No Pre-Cleaning
P.O.#:		Surveyor:	Byrd Fitzgerald	PSR:	P-108-010-009
Customer:		Clean Date:	01/01/1900	Shape:	C

Street:	15TH ST	Flow Control:	Not Controlled
City:	Hobart, IN	Year Renewed:	
Location:	Light Highway	Tape/Media #:	
Purpose:	Routine Assessment	Dia/Height:	8"
Use:	Sanitary	Material:	VCP
Drain Area:	NA	Lining:	
Category:	NA		
Comment:	Flow direction wrong

Location Details:		Direction of Survey:	Upstream
US MH:	M-108-009	DS MH:	M-108-010
		Total Length Surveyed (ft):	189.9

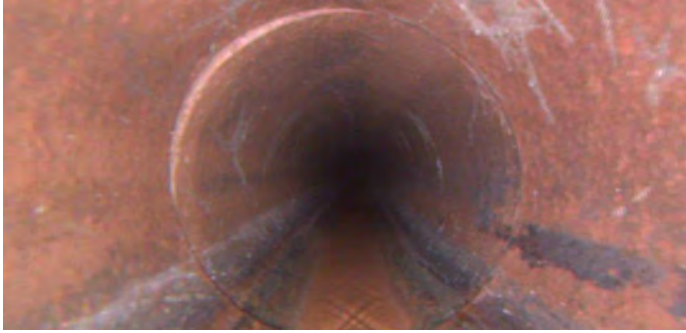
Code: **AMH**
Description: **Manhole**

Distance (ft): **.0**
Structural Grade: **0**
O&M Grade: **0**
Clock Start/From:
Clock To:
1st Value:
2nd Value:
Value Percent:
Continuous Index:
Within 8" of Joint: **NO**
Remarks: **M-108-010**

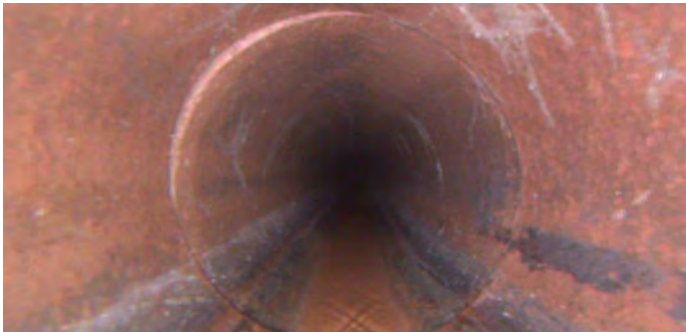
Code: **MWL**
Description: **Water Level**

Distance (ft): **.0**
Structural Grade: **0**
O&M Grade: **0**
Clock Start/From:
Clock To:
1st Value:
2nd Value:
Value Percent: **5.000**
Continuous Index:
Within 8" of Joint: **NO**
Remarks:

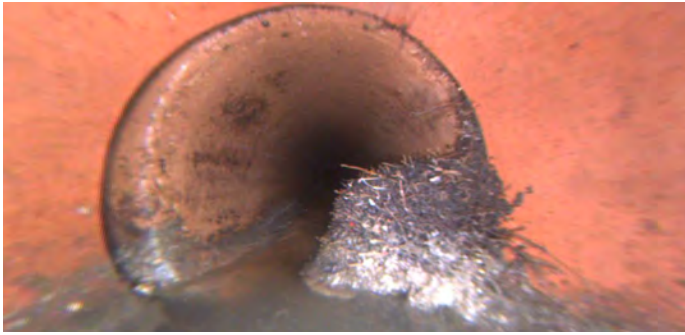
Code: **RMJ**
Description: **Roots Medium Joint**

Distance (ft): **31.7**
Structural Grade: **0**
O&M Grade: **3**
Clock Start/From: **3**
Clock To: **5**
1st Value:
2nd Value:
Value Percent: **15.000**
Continuous Index:
Within 8" of Joint: **YES**
Remarks:

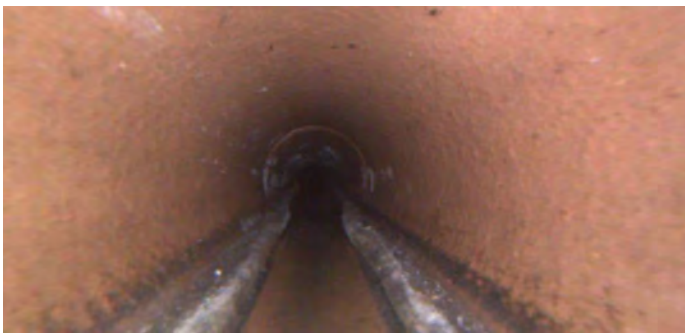
Code: **DAGS**
Description: **Deposits Attached Grease**

Distance (ft): **35.2**
Structural Grade: **0**
O&M Grade: **2**
Clock Start/From: **4**
Clock To: **8**
1st Value:
2nd Value:
Value Percent: **10.000**
Continuous Index: **S03**
Within 8" of Joint: **NO**
Remarks:

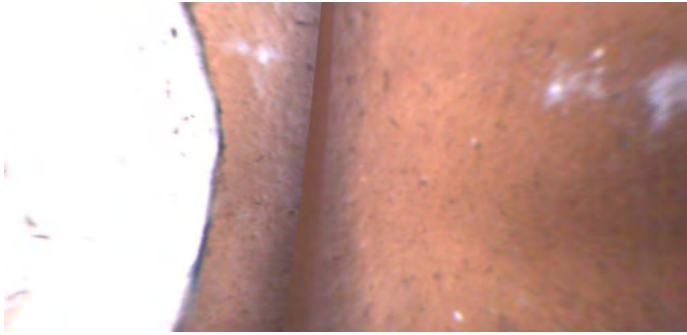
Code: **MMC**
Description: **Material Change**

Distance (ft): **40.1**
Structural Grade: **0**
O&M Grade: **0**
Clock Start/From:
Clock To:
1st Value:
2nd Value:
Value Percent:
Continuous Index:
Within 8" of Joint: **NO**
Remarks: **pvc**

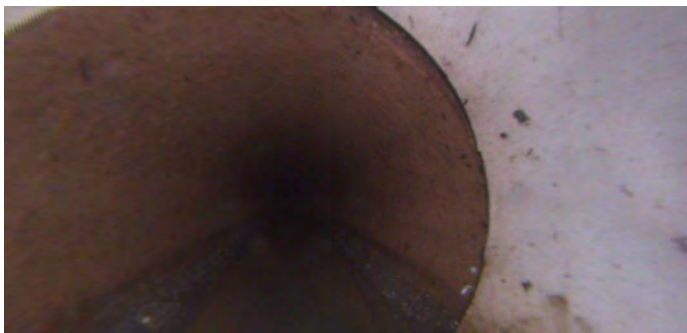
Code: **MMC**
Description: **Material Change**

Distance (ft): **44.2**
Structural Grade: **0**
O&M Grade: **0**
Clock Start/From:
Clock To:
1st Value:
2nd Value:
Value Percent:
Continuous Index:
Within 8" of Joint: **NO**
Remarks: **vcp**

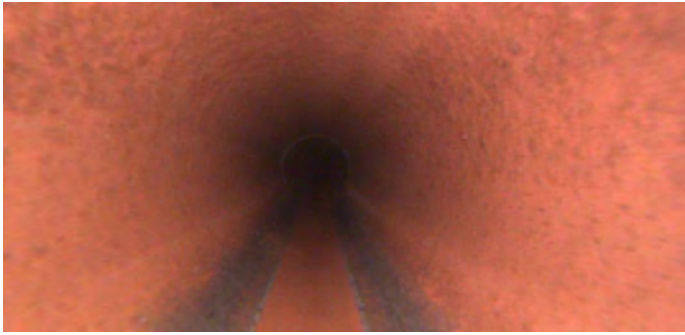
Code: **DAGS**
Description: **Deposits Attached Grease**

Distance (ft): **49.8**
Structural Grade: **0**
O&M Grade: **2**
Clock Start/From: **4**
Clock To: **8**
1st Value:
2nd Value:
Value Percent: **10.000**
Continuous Index: **F03**
Within 8" of Joint: **NO**
Remarks:

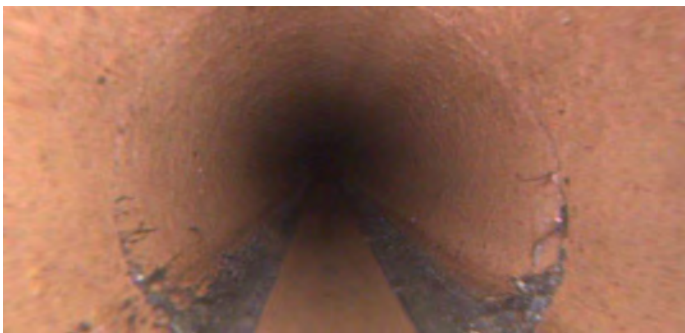
Code: **FC**
Description: **Fracture Circumferential**

Distance (ft): **53.8**
Structural Grade: **2**
O&M Grade: **0**
Clock Start/From: **12**
Clock To: **12**
1st Value:
2nd Value:
Value Percent:
Continuous Index:
Within 8" of Joint:
Remarks:

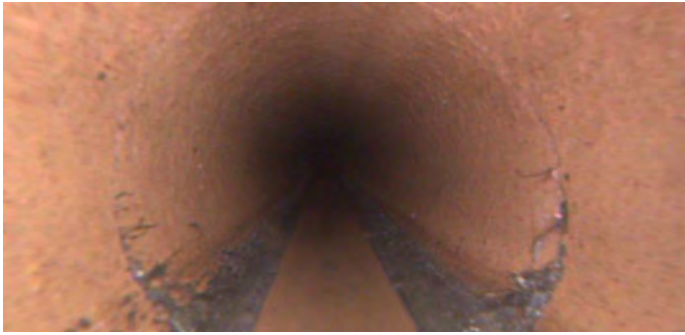
Code: **RFB**
Description: **Roots Fine Barrel**

Distance (ft): **53.8**
Structural Grade: **0**
O&M Grade: **2**
Clock Start/From: **3**
Clock To: **9**
1st Value:
2nd Value:
Value Percent:
Continuous Index:
Within 8" of Joint: **NO**
Remarks:

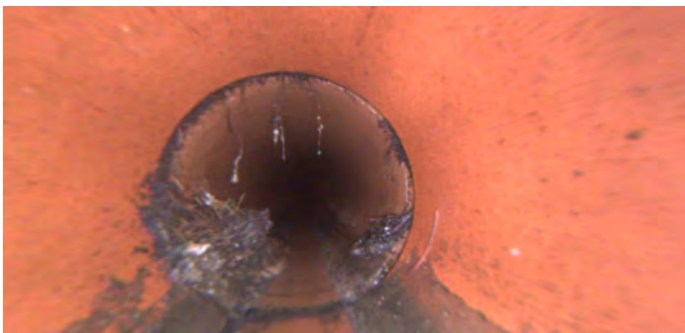
Code: **RMJ**
Description: **Roots Medium Joint**

Distance (ft): **63.0**
Structural Grade: **0**
O&M Grade: **3**
Clock Start/From: **7**
Clock To: **5**
1st Value:
2nd Value:
Value Percent: **10.000**
Continuous Index:
Within 8" of Joint: **YES**
Remarks:

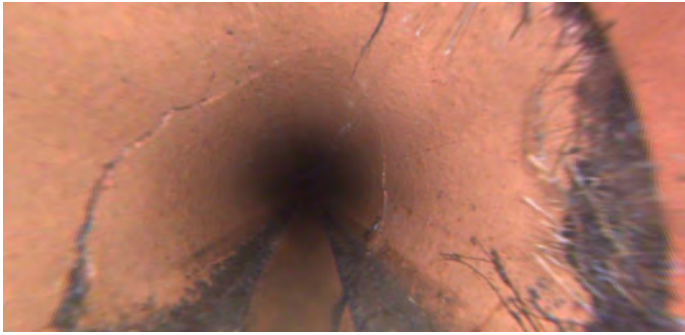
Code: **FM**
Description: **Fracture Multiple**

Distance (ft): **68.7**
Structural Grade: **4**
O&M Grade: **0**
Clock Start/From: **7**
Clock To: **5**
1st Value:
2nd Value:
Value Percent:
Continuous Index:
Within 8" of Joint: **YES**
Remarks:

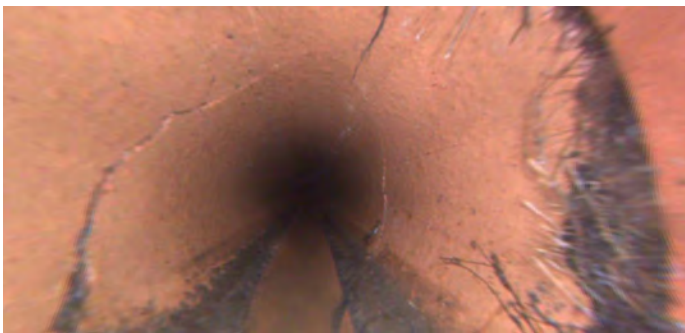
Code: **RFJ**
Description: **Roots Fine Joint**

Distance (ft): **68.7**
Structural Grade: **0**
O&M Grade: **1**
Clock Start/From: **7**
Clock To: **5**
1st Value:
2nd Value:
Value Percent:
Continuous Index: **S01**
Within 8" of Joint: **YES**
Remarks: **wandering**

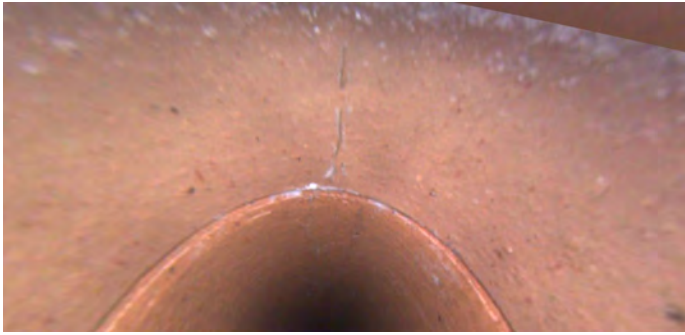
Code: **FL**
Description: **Fracture Longitudinal**

Distance (ft): **84.1**
Structural Grade: **3**
O&M Grade: **0**
Clock Start/From: **12**
Clock To:
1st Value:
2nd Value:
Value Percent:
Continuous Index:
Within 8" of Joint: **YES**
Remarks:

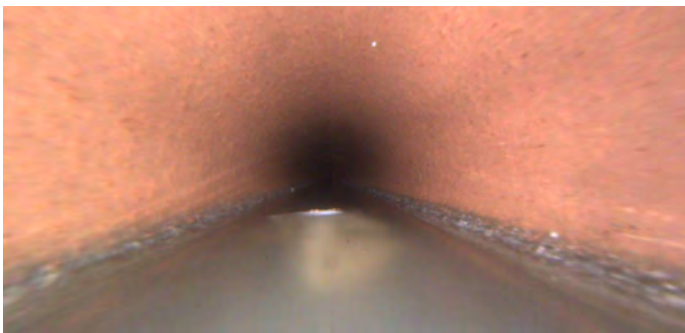
Code: **MWL**
Description: **Water Level**

Distance (ft): **101.9**
Structural Grade: **0**
O&M Grade: **0**
Clock Start/From:
Clock To:
1st Value:
2nd Value:
Value Percent: **30.000**
Continuous Index:
Within 8" of Joint: **NO**
Remarks:

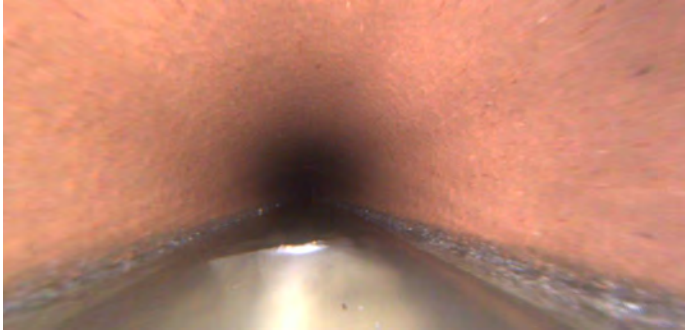
Code: **DSZ**
Description: **Deposits Settled Other**

Distance (ft): **102.3**
Structural Grade: **0**
O&M Grade: **2**
Clock Start/From: **6**
Clock To:
1st Value:
2nd Value:
Value Percent: **5.000**
Continuous Index:
Within 8" of Joint: **NO**
Remarks: **tissue**

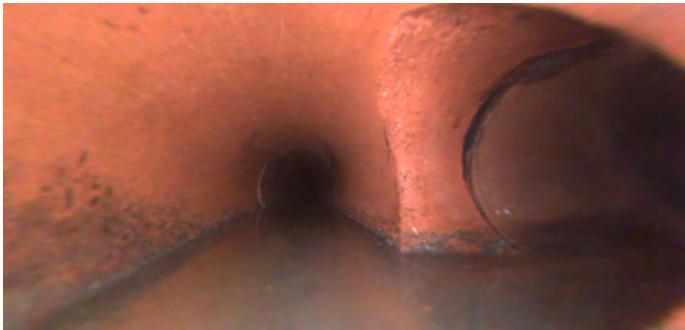
Code: **TF**
Description: **Tap Factory**

Distance (ft): **111.2**
Structural Grade: **0**
O&M Grade: **0**
Clock Start/From: **3**
Clock To:
1st Value: **4.000**
2nd Value:
Value Percent:
Continuous Index:
Within 8" of Joint:
Remarks:

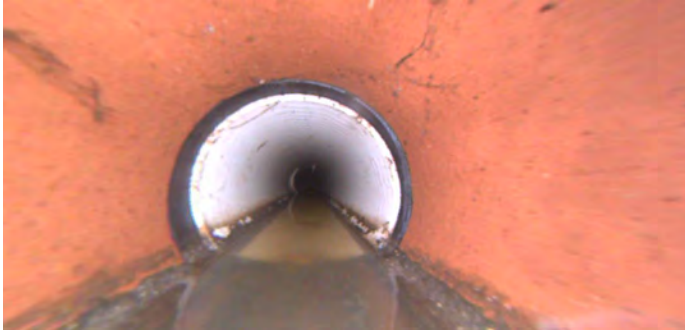
Code: **MMC**
Description: **Material Change**

Distance (ft): **131.9**
Structural Grade: **0**
O&M Grade: **0**
Clock Start/From:
Clock To:
1st Value:
2nd Value:
Value Percent:
Continuous Index:
Within 8" of Joint: **NO**
Remarks: **pvc**

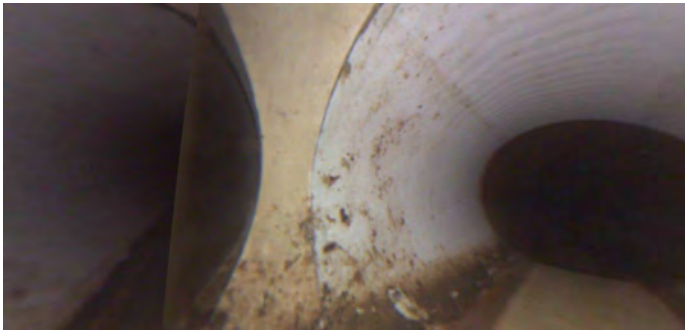
Code: **TF**
Description: **Tap Factory**

Distance (ft): **135.9**
Structural Grade: **0**
O&M Grade: **0**
Clock Start/From: **9**
Clock To:
1st Value: **4.000**
2nd Value:
Value Percent:
Continuous Index:
Within 8" of Joint: **YES**
Remarks:

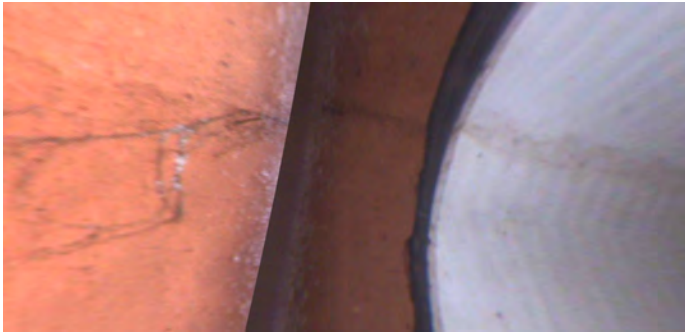
Code: **MMC**
Description: **Material Change**

Distance (ft): **137.6**
Structural Grade: **0**
O&M Grade: **0**
Clock Start/From:
Clock To:
1st Value:
2nd Value:
Value Percent:
Continuous Index:
Within 8" of Joint: **NO**
Remarks: **vcp**

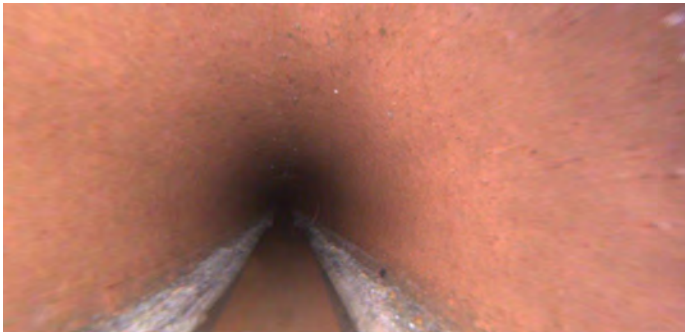
Code: **DAGS**
Description: **Deposits Attached Grease**

Distance (ft): **155.2**
Structural Grade: **0**
O&M Grade: **2**
Clock Start/From: **7**
Clock To: **5**
1st Value:
2nd Value:
Value Percent: **5.000**
Continuous Index: **S02**
Within 8" of Joint: **NO**
Remarks: **7 and 5 oclock**

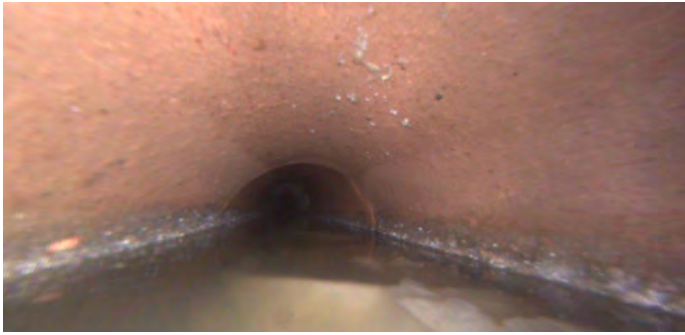
Code: **MWL**
Description: **Water Level**

Distance (ft): **183.1**
Structural Grade: **0**
O&M Grade: **0**
Clock Start/From:
Clock To:
1st Value:
2nd Value:
Value Percent: **40.000**
Continuous Index:
Within 8" of Joint: **NO**
Remarks:

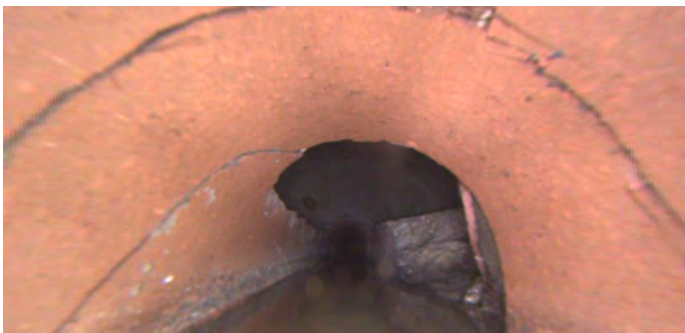
Code: **FM**
Description: **Fracture Multiple**

Distance (ft): **186.2**
Structural Grade: **4**
O&M Grade: **0**
Clock Start/From: **8**
Clock To: **4**
1st Value:
2nd Value:
Value Percent:
Continuous Index:
Within 8" of Joint:
Remarks:

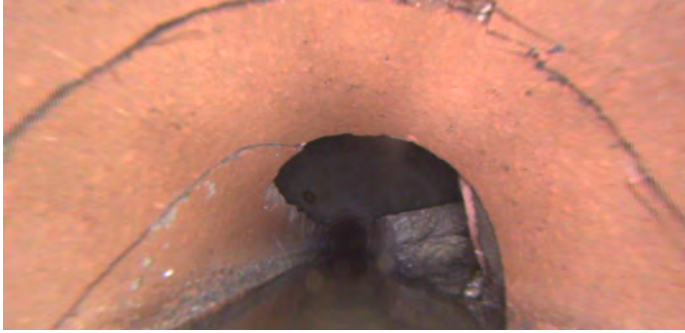
Code: **RFJ**
Description: **Roots Fine Joint**

Distance (ft): **186.2**
Structural Grade: **0**
O&M Grade: **1**
Clock Start/From: **7**
Clock To: **5**
1st Value:
2nd Value:
Value Percent:
Continuous Index: **F01**
Within 8" of Joint: **YES**
Remarks: **wandering**

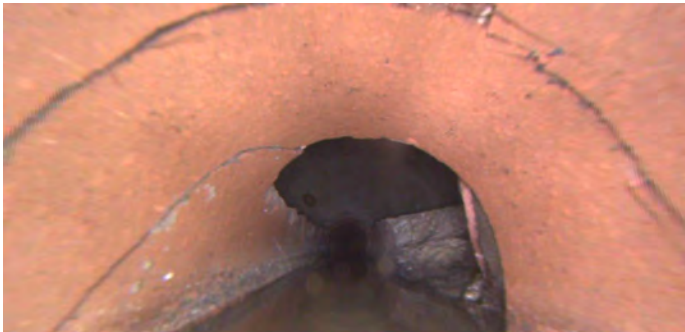
Code: **DAGS**
Description: **Deposits Attached Grease**

Distance (ft): **186.2**
Structural Grade: **0**
O&M Grade: **2**
Clock Start/From: **7**
Clock To: **5**
1st Value:
2nd Value:
Value Percent: **5.000**
Continuous Index: **F02**
Within 8" of Joint: **NO**
Remarks: **7 and 5 oclock**

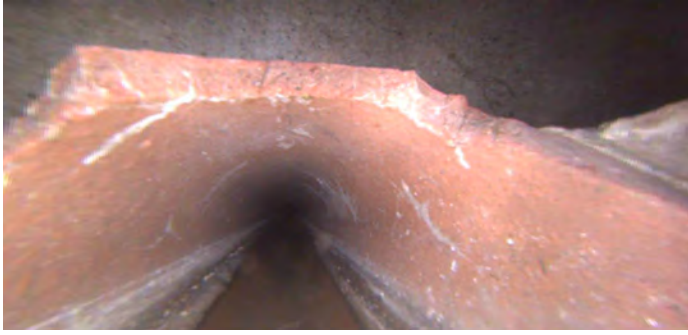
Code:	AMH
Description:	Manhole
Distance (ft):	189.9
Structural Grade:	0
O&M Grade:	0
Clock Start/From:	
Clock To:	
1st Value:	
2nd Value:	
Value Percent:	
Continuous Index:	
Within 8" of Joint:	NO
Remarks:	M-108-009
