## Profile/Photo Observation Report

Street:	<b>FOXCROFT STREET</b>	Flow Control:	<b>Not Controlled</b>
City:	<b>Hobart, IN</b>	Year Renewed:	
Location:	<b>Light Highway</b>	Tape/Media #:	
Purpose:	<b>Routine Assessment</b>	Dia/Height:	<b>8"</b>
Use:	<b>Sanitary</b>	Material:	<b>VCP</b>
Drain Area:	<b>NA</b>	Lining:	
Category:	<b>NA</b>		
Comment:	<b>Flow direction wrong</b>

Location Details:		Direction of Survey:	<b>Upstream</b>
US MH:	<b>M-108-009</b>	DS MH:	<b>M-108-010</b>
		Total Length Surveyed (ft):	<b>189.9</b>

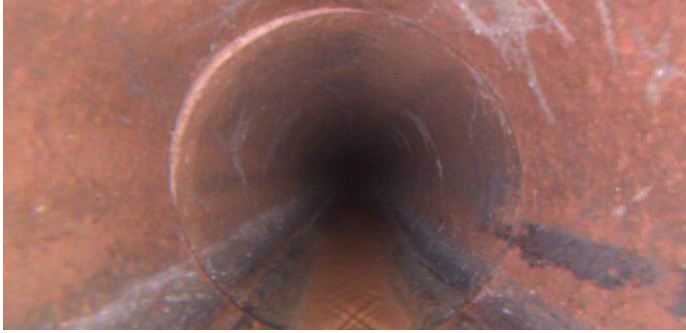
Code: **AMH**  
Description: **Manhole**

Distance (ft): **.0**  
Structural Grade: **0**  
O&M Grade: **0**  
Clock Start/From:  
Clock To:  
1st Value:  
2nd Value:  
Value Percent:  
Continuous Index:  
Within 8" of Joint: **NO**  
Remarks: **M-108-010**

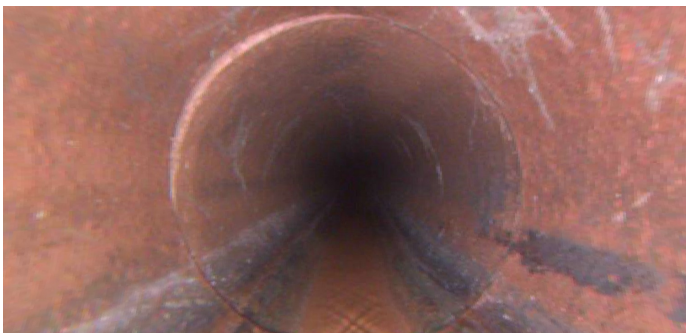
Code: **MWL**  
Description: **Water Level**

Distance (ft): **.0**  
Structural Grade: **0**  
O&M Grade: **0**  
Clock Start/From:  
Clock To:  
1st Value:  
2nd Value:  
Value Percent: **5.000**  
Continuous Index:  
Within 8" of Joint: **NO**  
Remarks:

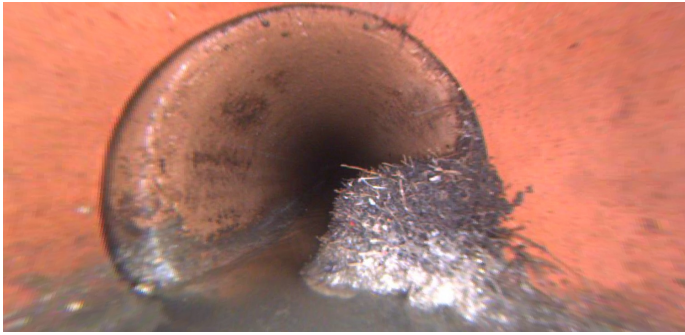
Code: **RMJ**  
Description: **Roots Medium Joint**

Distance (ft): **31.7**  
Structural Grade: **0**  
O&M Grade: **3**  
Clock Start/From: **3**  
Clock To: **5**  
1st Value:  
2nd Value:  
Value Percent: **15.000**  
Continuous Index:  
Within 8" of Joint: **YES**  
Remarks:

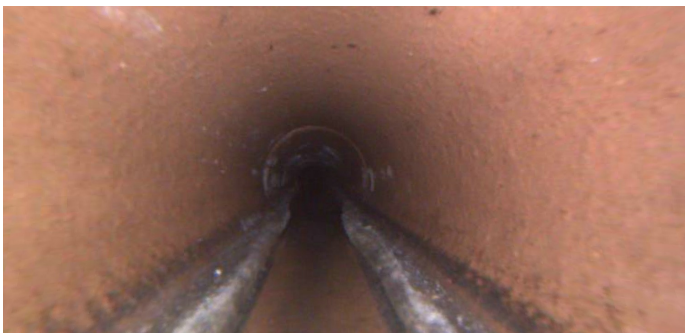
Code: **DAGS**  
Description: **Deposits Attached Grease**

Distance (ft): **35.2**  
Structural Grade: **0**  
O&M Grade: **2**  
Clock Start/From: **4**  
Clock To: **8**  
1st Value:  
2nd Value:  
Value Percent: **10.000**  
Continuous Index: **S03**  
Within 8" of Joint: **NO**  
Remarks:

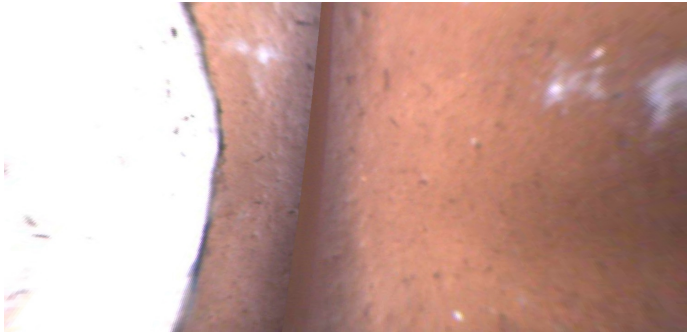
Code: **MMC**  
Description: **Material Change**

Distance (ft): **40.1**  
Structural Grade: **0**  
O&M Grade: **0**  
Clock Start/From:  
Clock To:  
1st Value:  
2nd Value:  
Value Percent:  
Continuous Index:  
Within 8" of Joint: **NO**  
Remarks: **pvc**

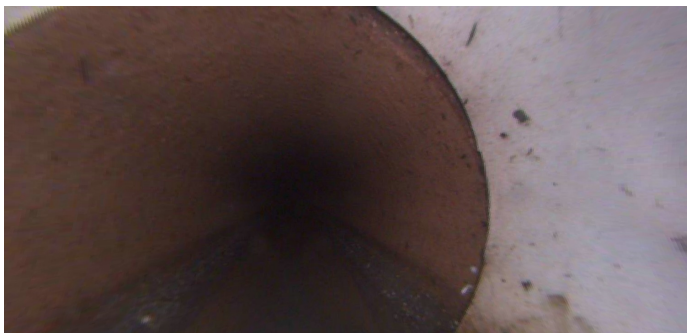
Code: **MMC**  
Description: **Material Change**

Distance (ft): **44.2**  
Structural Grade: **0**  
O&M Grade: **0**  
Clock Start/From:  
Clock To:  
1st Value:  
2nd Value:  
Value Percent:  
Continuous Index:  
Within 8" of Joint: **NO**  
Remarks: **vcp**

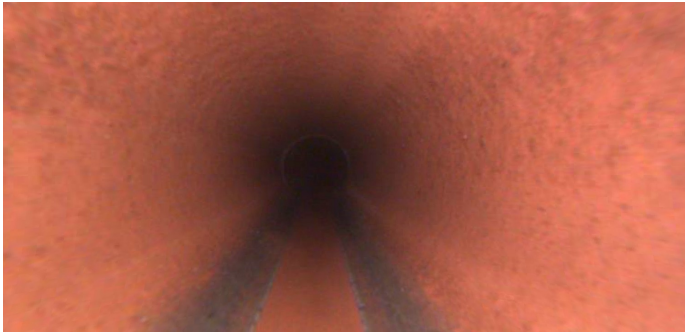
Code: **DAGS**  
Description: **Deposits Attached Grease**

Distance (ft): **49.8**  
Structural Grade: **0**  
O&M Grade: **2**  
Clock Start/From: **4**  
Clock To: **8**  
1st Value:  
2nd Value:  
Value Percent: **10.000**  
Continuous Index: **F03**  
Within 8" of Joint: **NO**  
Remarks:

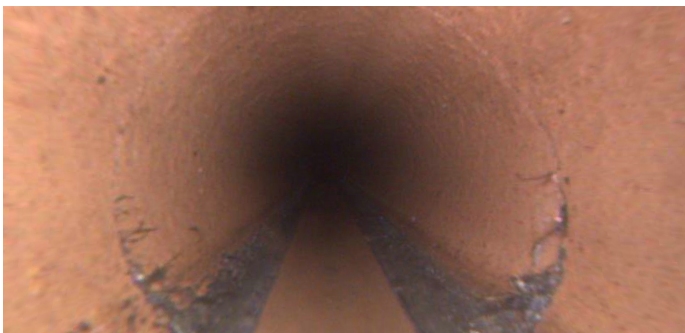
Code: **FC**  
Description: **Fracture Circumferential**

Distance (ft): **53.8**  
Structural Grade: **2**  
O&M Grade: **0**  
Clock Start/From: **12**  
Clock To: **12**  
1st Value:  
2nd Value:  
Value Percent:  
Continuous Index:  
Within 8" of Joint:  
Remarks:

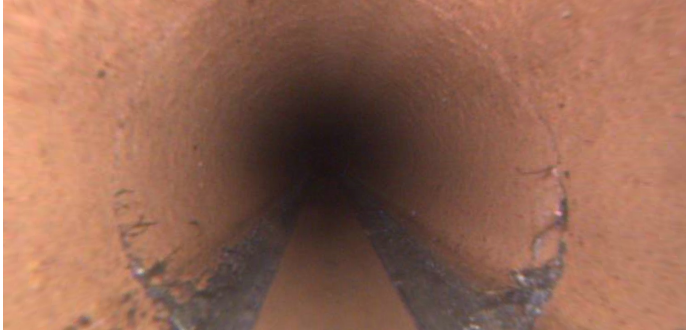
Code: **RFB**  
Description: **Roots Fine Barrel**

Distance (ft): **53.8**  
Structural Grade: **0**  
O&M Grade: **2**  
Clock Start/From: **3**  
Clock To: **9**  
1st Value:  
2nd Value:  
Value Percent:  
Continuous Index:  
Within 8" of Joint: **NO**  
Remarks:

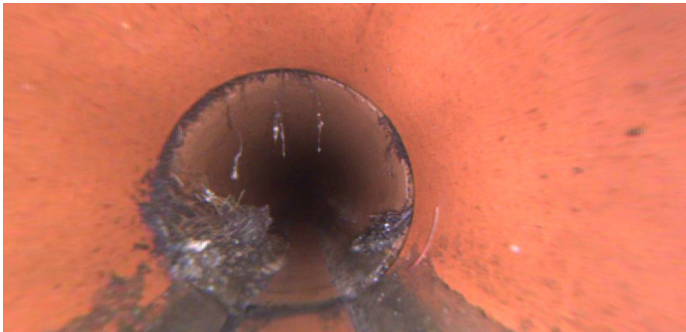
Code: **RMJ**  
Description: **Roots Medium Joint**

Distance (ft): **63.0**  
Structural Grade: **0**  
O&M Grade: **3**  
Clock Start/From: **7**  
Clock To: **5**  
1st Value:  
2nd Value:  
Value Percent: **10.000**  
Continuous Index:  
Within 8" of Joint: **YES**  
Remarks:

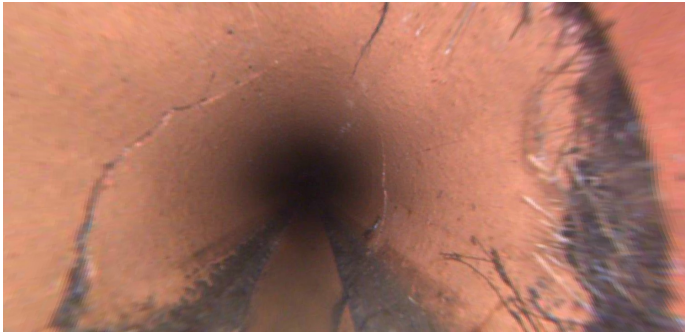
Code: **FM**  
Description: **Fracture Multiple**

Distance (ft): **68.7**  
Structural Grade: **4**  
O&M Grade: **0**  
Clock Start/From: **7**  
Clock To: **5**  
1st Value:  
2nd Value:  
Value Percent:  
Continuous Index:  
Within 8" of Joint: **YES**  
Remarks:

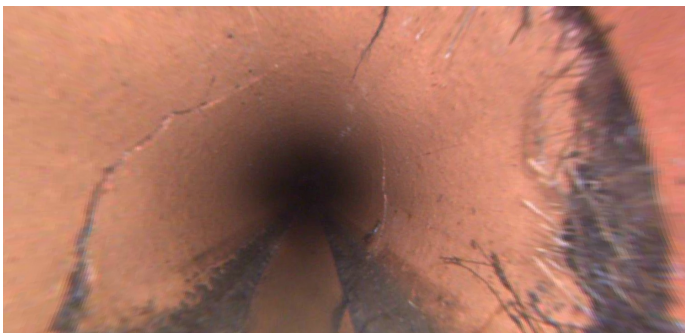
Code: **RFJ**  
Description: **Roots Fine Joint**

Distance (ft): **68.7**  
Structural Grade: **0**  
O&M Grade: **1**  
Clock Start/From: **7**  
Clock To: **5**  
1st Value:  
2nd Value:  
Value Percent:  
Continuous Index: **S01**  
Within 8" of Joint: **YES**  
Remarks: **wandering**

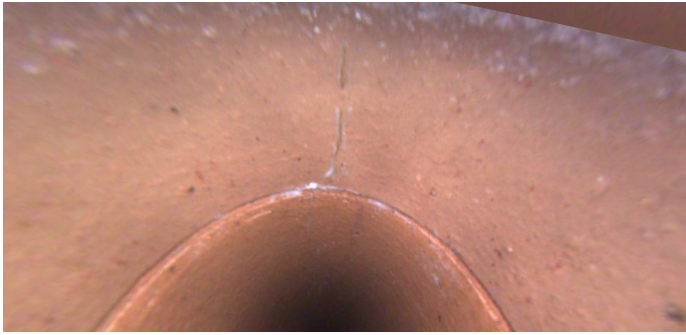
Code: **FL**  
Description: **Fracture Longitudinal**

Distance (ft): **84.1**  
Structural Grade: **3**  
O&M Grade: **0**  
Clock Start/From: **12**  
Clock To:  
1st Value:  
2nd Value:  
Value Percent:  
Continuous Index:  
Within 8" of Joint: **YES**  
Remarks:

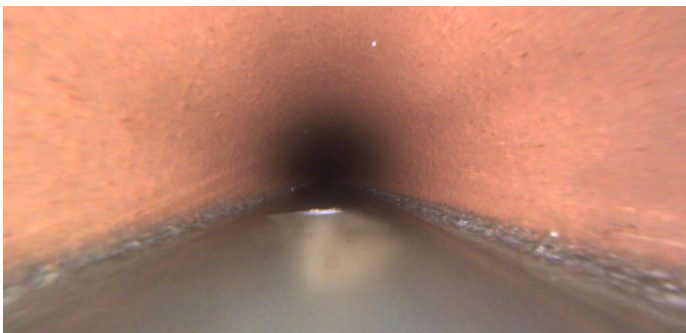
Code: **MWL**  
Description: **Water Level**

Distance (ft): **101.9**  
Structural Grade: **0**  
O&M Grade: **0**  
Clock Start/From:  
Clock To:  
1st Value:  
2nd Value:  
Value Percent: **30.000**  
Continuous Index:  
Within 8" of Joint: **NO**  
Remarks:

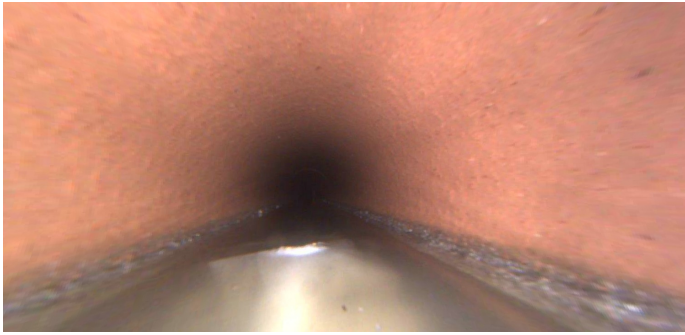
Code: **DSZ**  
Description: **Deposits Settled Other**

Distance (ft): **102.3**  
Structural Grade: **0**  
O&M Grade: **2**  
Clock Start/From: **6**  
Clock To:  
1st Value:  
2nd Value:  
Value Percent: **5.000**  
Continuous Index:  
Within 8" of Joint: **NO**  
Remarks: **tissue**

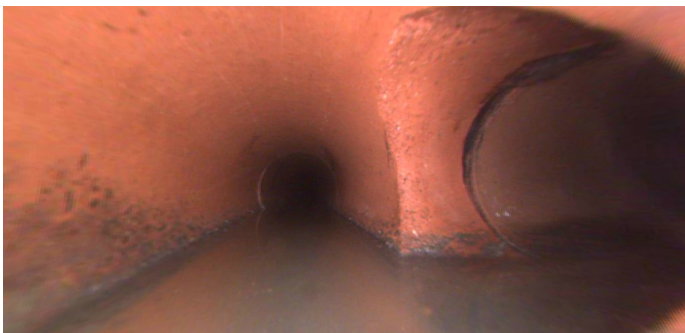
Code: **TF**  
Description: **Tap Factory**

Distance (ft): **111.2**  
Structural Grade: **0**  
O&M Grade: **0**  
Clock Start/From: **3**  
Clock To:  
1st Value: **4.000**  
2nd Value:  
Value Percent:  
Continuous Index:  
Within 8" of Joint:  
Remarks:

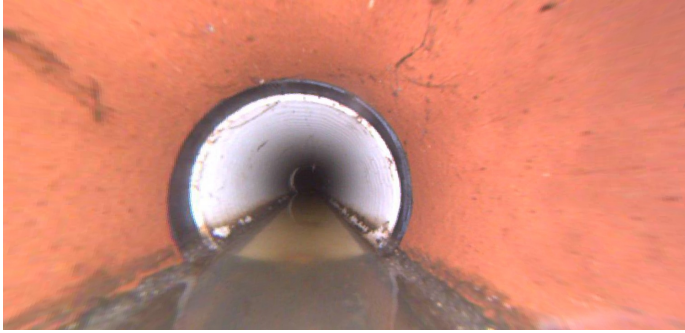
Code: **MMC**  
Description: **Material Change**

Distance (ft): **131.9**  
Structural Grade: **0**  
O&M Grade: **0**  
Clock Start/From:  
Clock To:  
1st Value:  
2nd Value:  
Value Percent:  
Continuous Index:  
Within 8" of Joint: **NO**  
Remarks: **pvc**

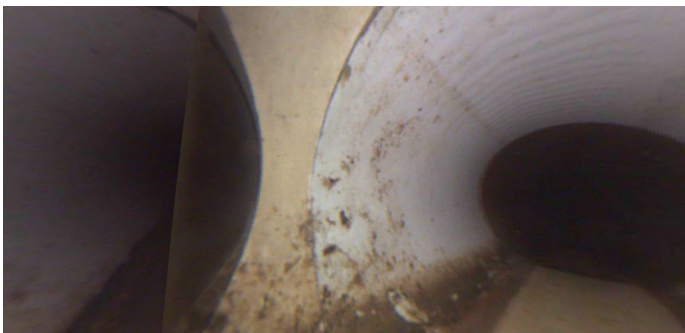
Code: **TF**  
Description: **Tap Factory**

Distance (ft): **135.9**  
Structural Grade: **0**  
O&M Grade: **0**  
Clock Start/From: **9**  
Clock To:  
1st Value: **4.000**  
2nd Value:  
Value Percent:  
Continuous Index:  
Within 8" of Joint: **YES**  
Remarks:

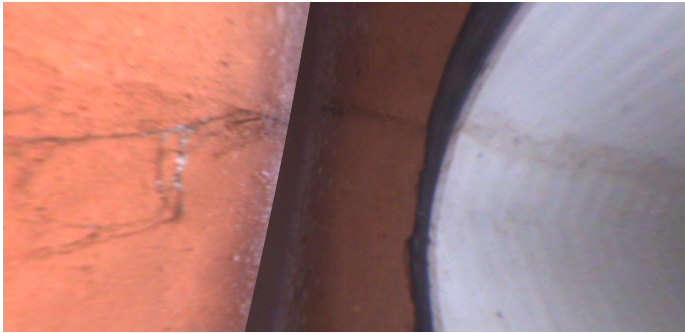
Code: **MMC**  
Description: **Material Change**

Distance (ft): **137.6**  
Structural Grade: **0**  
O&M Grade: **0**  
Clock Start/From:  
Clock To:  
1st Value:  
2nd Value:  
Value Percent:  
Continuous Index:  
Within 8" of Joint: **NO**  
Remarks: **vcp**

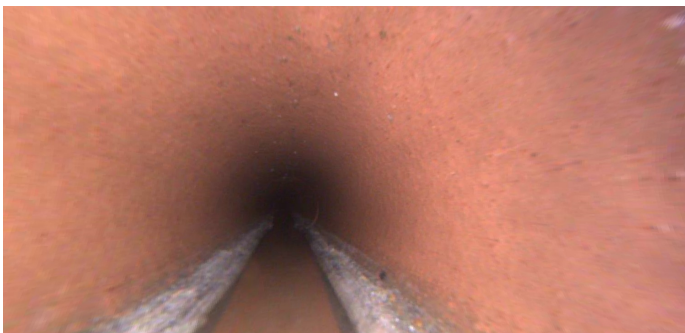
Code: **DAGS**  
Description: **Deposits Attached Grease**

Distance (ft): **155.2**  
Structural Grade: **0**  
O&M Grade: **2**  
Clock Start/From: **7**  
Clock To: **5**  
1st Value:  
2nd Value:  
Value Percent: **5.000**  
Continuous Index: **S02**  
Within 8" of Joint: **NO**  
Remarks: **7 and 5 oclock**

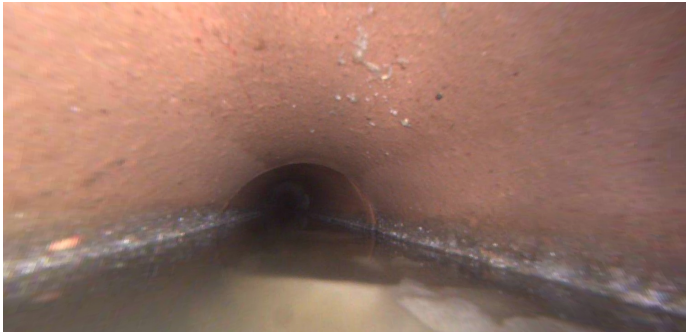
Code: **MWL**  
Description: **Water Level**

Distance (ft): **183.1**  
Structural Grade: **0**  
O&M Grade: **0**  
Clock Start/From:  
Clock To:  
1st Value:  
2nd Value:  
Value Percent: **40.000**  
Continuous Index:  
Within 8" of Joint: **NO**  
Remarks:

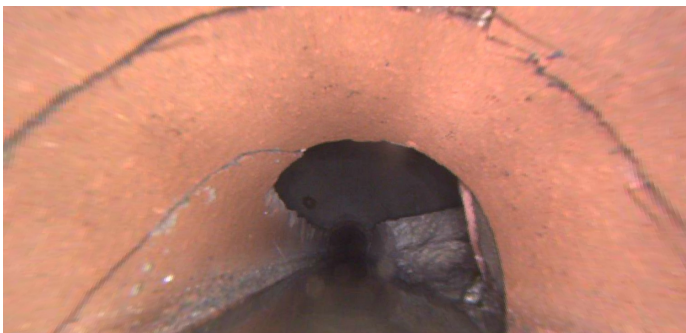
Code: **FM**  
Description: **Fracture Multiple**

Distance (ft): **186.2**  
Structural Grade: **4**  
O&M Grade: **0**  
Clock Start/From: **8**  
Clock To: **4**  
1st Value:  
2nd Value:  
Value Percent:  
Continuous Index:  
Within 8" of Joint:  
Remarks:

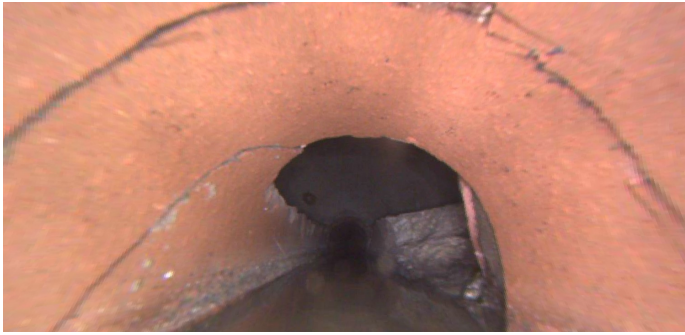
Code: **RFJ**  
Description: **Roots Fine Joint**

Distance (ft): **186.2**  
Structural Grade: **0**  
O&M Grade: **1**  
Clock Start/From: **7**  
Clock To: **5**  
1st Value:  
2nd Value:  
Value Percent:  
Continuous Index: **F01**  
Within 8" of Joint: **YES**  
Remarks: **wandering**

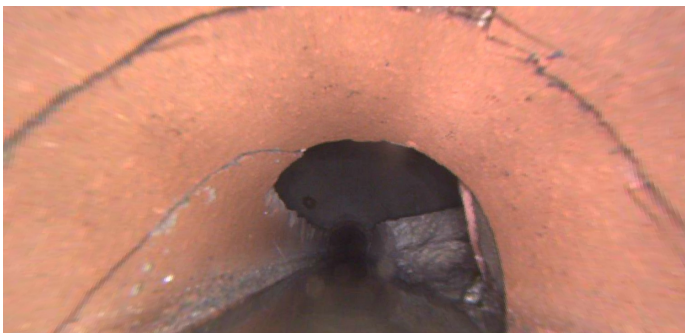
Code: **DAGS**  
Description: **Deposits Attached Grease**

Distance (ft): **186.2**  
Structural Grade: **0**  
O&M Grade: **2**  
Clock Start/From: **7**  
Clock To: **5**  
1st Value:  
2nd Value:  
Value Percent: **5.000**  
Continuous Index: **F02**  
Within 8" of Joint: **NO**  
Remarks: **7 and 5 oclock**

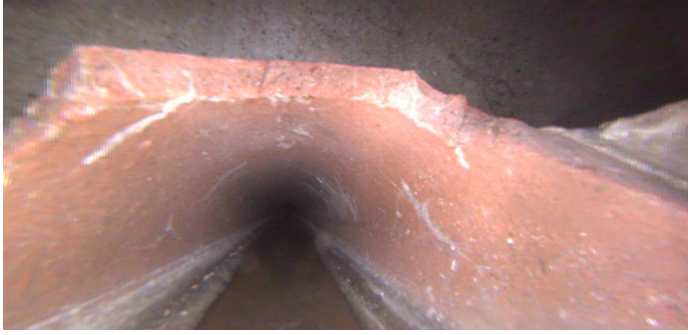
Code:	<b>AMH</b>
Description:	<b>Manhole</b>
Distance (ft):	<b>189.9</b>
Structural Grade:	<b>0</b>
O&M Grade:	<b>0</b>
Clock Start/From:	
Clock To:	
1st Value:	
2nd Value:	
Value Percent:	
Continuous Index:	
Within 8" of Joint:	<b>NO</b>
Remarks:	<b>M-108-009</b>
