Profile/Photo Observation Report

Date:	03/25/2018	Weather:		Coding:	PACP 6.0
Pipe Length (ft):	166.8	Owner:	NA	Pre Clean:	No Pre-Cleaning
P.O.#:		Surveyor:	Byrd Fitzgerald	PSR:	P-108-011-010
Customer:		Clean Date:	01/01/1900	Shape:	C

Street:	15TH ST	Flow Control:	Not Controlled
City:	Hobart, IN	Year Renewed:	
Location:	Light Highway	Tape/Media #:	
Purpose:	Routine Assessment	Dia/Height:	8"
Use:	Sanitary	Material:	VCP
Drain Area:	NA	Lining:	
Category:	NA		
Comment:	P_C at 158 ft roots/ debris . Flow direction wrong		
Location Details:		Direction of Survey:	Downstream
US MH:	M-108-010	DS MH:	M-108-011
		Total Length Surveyed (ft):	160.0

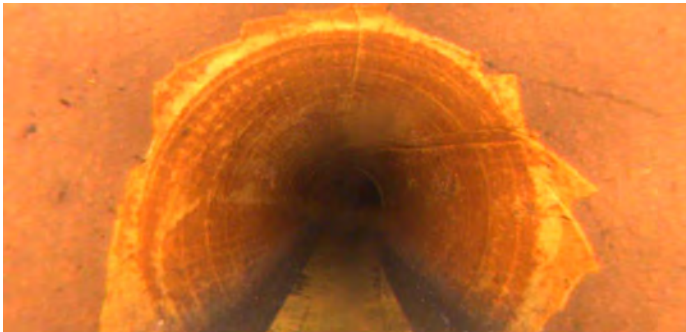
Code: **FS**
Description: **Fracture Spiral**

Distance (ft): **.8**
Structural Grade: **3**
O&M Grade: **0**
Clock Start/From: **1**
Clock To: **2**
1st Value:
2nd Value:
Value Percent:
Continuous Index:
Within 8" of Joint:
Remarks:

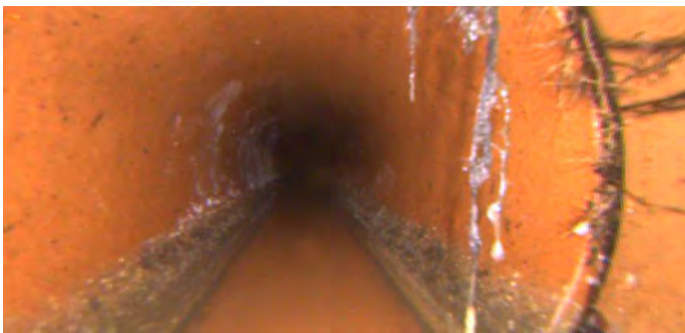
Code: **RFJ**
Description: **Roots Fine Joint**

Distance (ft): **13.5**
Structural Grade: **0**
O&M Grade: **1**
Clock Start/From: **7**
Clock To: **5**
1st Value:
2nd Value:
Value Percent:
Continuous Index:
Within 8" of Joint: **YES**
Remarks:

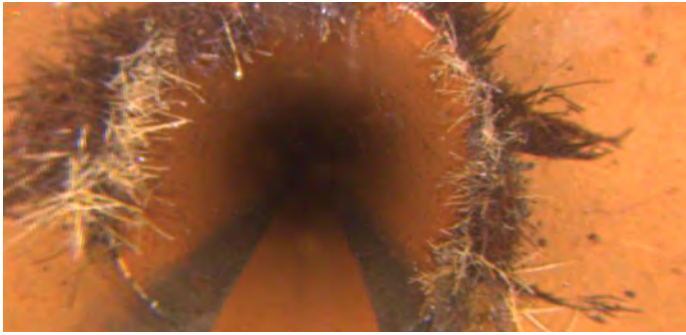
Code: **RMJ**
Description: **Roots Medium Joint**

Distance (ft): **23.3**
Structural Grade: **0**
O&M Grade: **3**
Clock Start/From: **7**
Clock To: **5**
1st Value:
2nd Value:
Value Percent: **5.000**
Continuous Index:
Within 8" of Joint: **YES**
Remarks:

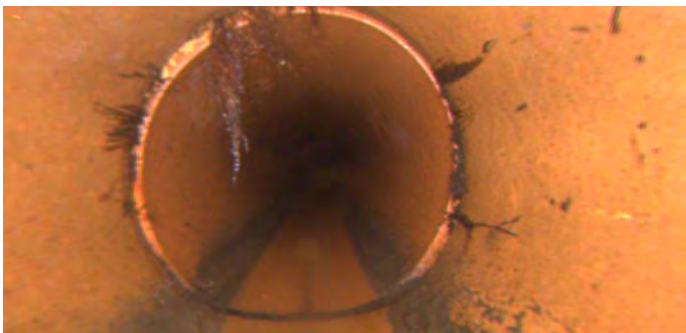
Code: **RFJ**
Description: **Roots Fine Joint**

Distance (ft): **28.3**
Structural Grade: **0**
O&M Grade: **1**
Clock Start/From: **7**
Clock To: **5**
1st Value:
2nd Value:
Value Percent:
Continuous Index:
Within 8" of Joint: **YES**
Remarks:

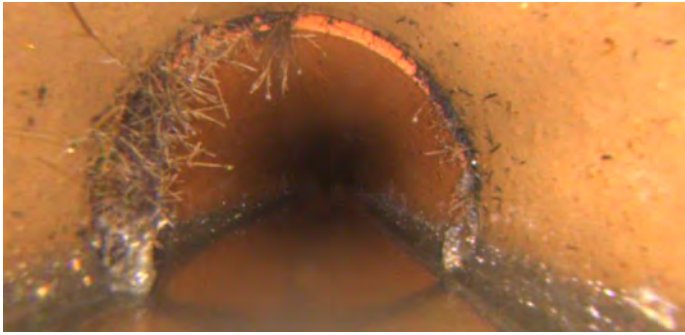
Code: **RMJ**
Description: **Roots Medium Joint**

Distance (ft): **48.7**
Structural Grade: **0**
O&M Grade: **3**
Clock Start/From: **8**
Clock To: **4**
1st Value:
2nd Value:
Value Percent: **10.000**
Continuous Index: **S03**
Within 8" of Joint: **YES**
Remarks:

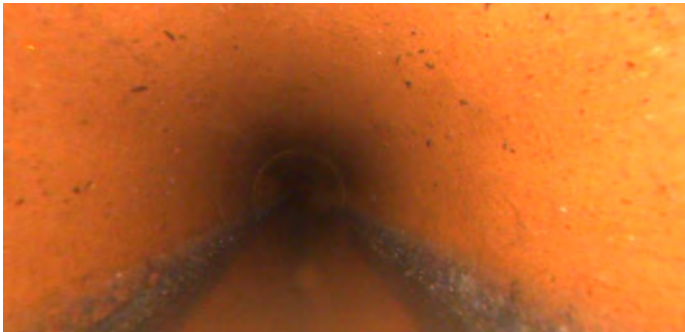
Code: **RMJ**
Description: **Roots Medium Joint**

Distance (ft): **65.6**
Structural Grade: **0**
O&M Grade: **3**
Clock Start/From: **8**
Clock To: **4**
1st Value:
2nd Value:
Value Percent: **10.000**
Continuous Index: **F03**
Within 8" of Joint: **YES**
Remarks:

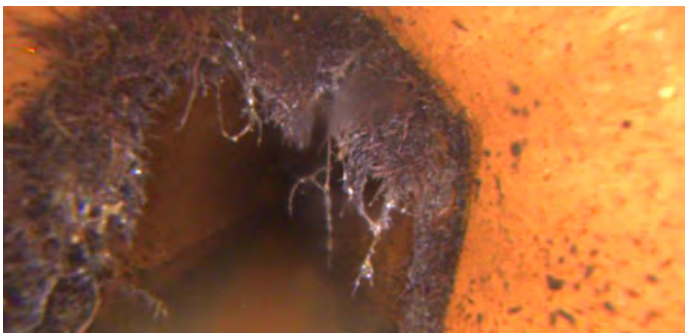
Code: **RMJ**
Description: **Roots Medium Joint**

Distance (ft): **83.4**
Structural Grade: **0**
O&M Grade: **3**
Clock Start/From: **8**
Clock To: **4**
1st Value:
2nd Value:
Value Percent: **20.000**
Continuous Index:
Within 8" of Joint: **YES**
Remarks:

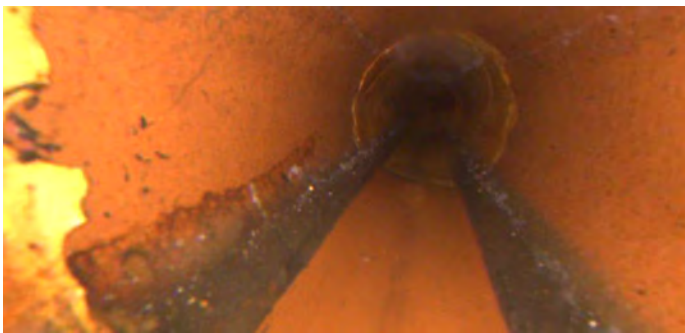
Code: **FL**
Description: **Fracture Longitudinal**

Distance (ft): **100.9**
Structural Grade: **3**
O&M Grade: **0**
Clock Start/From: **9**
Clock To:
1st Value:
2nd Value:
Value Percent:
Continuous Index:
Within 8" of Joint:
Remarks:

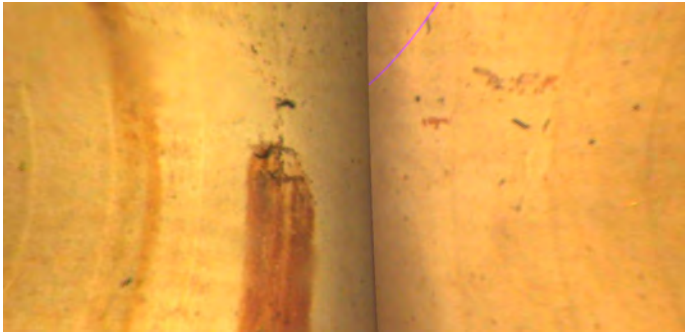
Code: **H**
Description: **Hole**

Distance (ft): **113.1**
Structural Grade: **3**
O&M Grade: **0**
Clock Start/From: **10**
Clock To:
1st Value:
2nd Value:
Value Percent:
Continuous Index:
Within 8" of Joint:
Remarks: **pin hole**

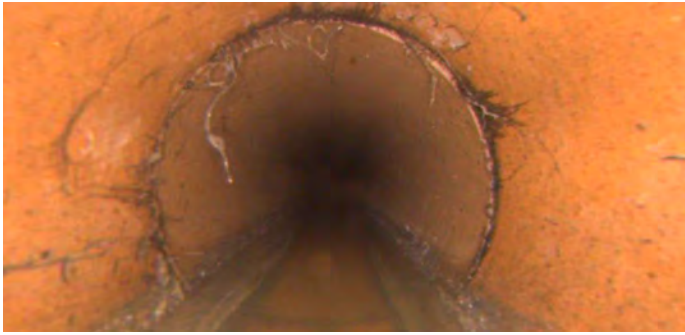
Code: **RFJ**
Description: **Roots Fine Joint**

Distance (ft): **124.2**
Structural Grade: **0**
O&M Grade: **1**
Clock Start/From: **8**
Clock To: **4**
1st Value:
2nd Value:
Value Percent:
Continuous Index:
Within 8" of Joint: **YES**
Remarks:

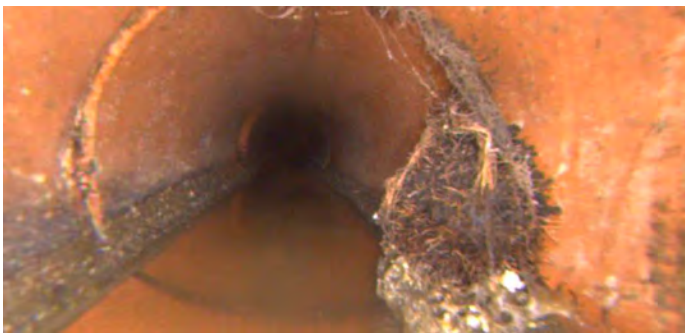
Code: **RMJ**
Description: **Roots Medium Joint**

Distance (ft): **136.5**
Structural Grade: **0**
O&M Grade: **3**
Clock Start/From: **8**
Clock To: **4**
1st Value:
2nd Value:
Value Percent: **10.000**
Continuous Index:
Within 8" of Joint: **YES**
Remarks:

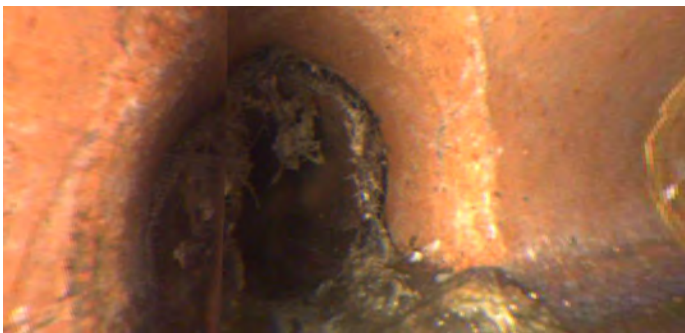
Code: **RML**
Description: **Roots Medium Lateral**

Distance (ft): **136.6**
Structural Grade: **0**
O&M Grade: **3**
Clock Start/From: **7**
Clock To: **5**
1st Value:
2nd Value:
Value Percent: **5.000**
Continuous Index:
Within 8" of Joint: **NO**
Remarks:

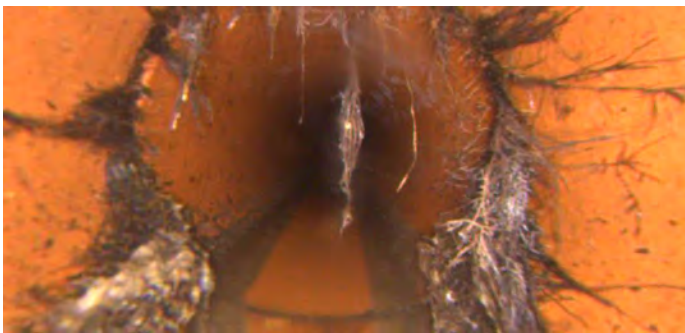
Code: **RMJ**
Description: **Roots Medium Joint**

Distance (ft): **148.9**
Structural Grade: **0**
O&M Grade: **3**
Clock Start/From: **8**
Clock To: **4**
1st Value:
2nd Value:
Value Percent: **10.000**
Continuous Index: **S04**
Within 8" of Joint: **YES**
Remarks:

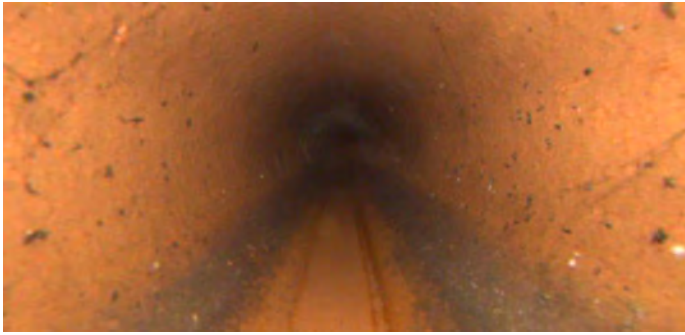
Code: **RMJ**
Description: **Roots Medium Joint**

Distance (ft): **160.0**
Structural Grade: **0**
O&M Grade: **3**
Clock Start/From: **8**
Clock To: **4**
1st Value:
2nd Value:
Value Percent: **10.000**
Continuous Index: **F04**
Within 8" of Joint: **YES**
Remarks:

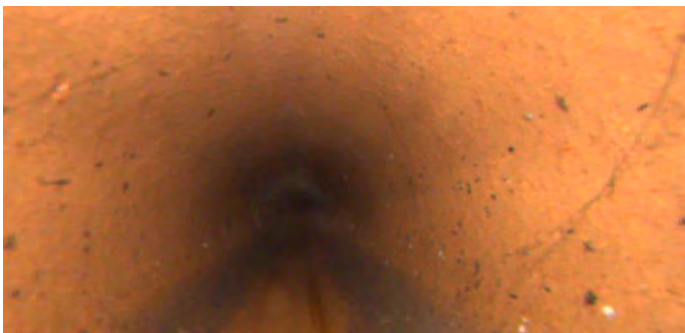
Code: **MSA**
Description: **Abandoned Survey**

Distance (ft): **160.0**
Structural Grade: **0**
O&M Grade: **0**
Clock Start/From:
Clock To:
1st Value:
2nd Value:
Value Percent:
Continuous Index:
Within 8" of Joint: **NO**
Remarks: **rmj**
