Profile/Photo Observation Report

Date:	03/25/2018	Weather:		Coding:	PACP 6.0
Pipe Length (ft):	166.8	Owner:	NA	Pre Clean:	No Pre-Cleaning
P.O.#:		Surveyor:	Byrd Fitzgerald	PSR:	P-108-011-010
Customer:		Clean Date:	01/01/1900	Shape:	C

Street:	FOXCROFT STREET	Flow Control:	Not Controlled
City:	Hobart, IN	Year Renewed:	
Location:	Light Highway	Tape/Media #:	
Purpose:	Routine Assessment	Dia/Height:	8"
Use:	Sanitary	Material:	VCP
Drain Area:	NA	Lining:	
Category:	NA		
Comment:	P_C at 158 ft roots/ debris . Flow direction wrong		
Location Details:		Direction of Survey:	Downstream
US MH:	M-108-010	DS MH:	M-108-011
		Total Length Surveyed (ft):	160.0

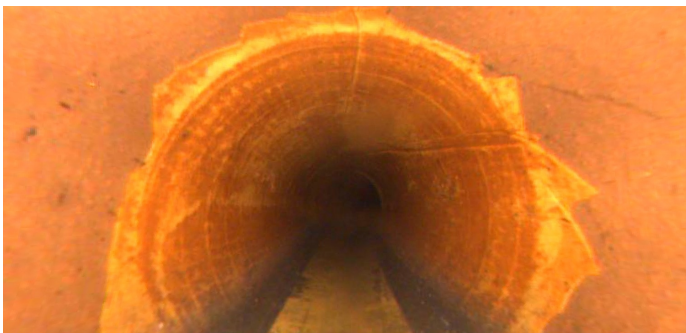
Code: **FS**
Description: **Fracture Spiral**

Distance (ft): **.8**
Structural Grade: **3**
O&M Grade: **0**
Clock Start/From: **1**
Clock To: **2**
1st Value:
2nd Value:
Value Percent:
Continuous Index:
Within 8" of Joint:
Remarks:

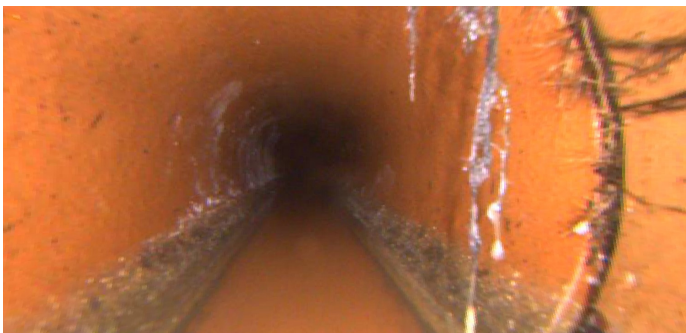
Code: **RFJ**
Description: **Roots Fine Joint**

Distance (ft): **13.5**
Structural Grade: **0**
O&M Grade: **1**
Clock Start/From: **7**
Clock To: **5**
1st Value:
2nd Value:
Value Percent:
Continuous Index:
Within 8" of Joint: **YES**
Remarks:

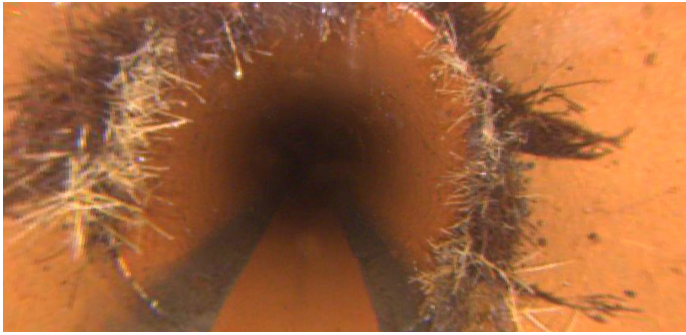
Code: **RMJ**
Description: **Roots Medium Joint**

Distance (ft): **23.3**
Structural Grade: **0**
O&M Grade: **3**
Clock Start/From: **7**
Clock To: **5**
1st Value:
2nd Value:
Value Percent: **5.000**
Continuous Index:
Within 8" of Joint: **YES**
Remarks:

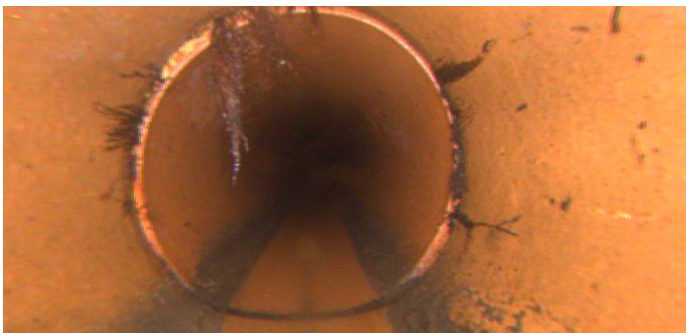
Code: **RFJ**
Description: **Roots Fine Joint**

Distance (ft): **28.3**
Structural Grade: **0**
O&M Grade: **1**
Clock Start/From: **7**
Clock To: **5**
1st Value:
2nd Value:
Value Percent:
Continuous Index:
Within 8" of Joint: **YES**
Remarks:

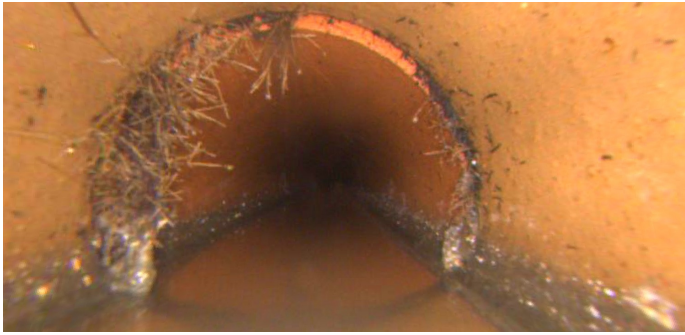
Code: **RMJ**
Description: **Roots Medium Joint**

Distance (ft): **48.7**
Structural Grade: **0**
O&M Grade: **3**
Clock Start/From: **8**
Clock To: **4**
1st Value:
2nd Value:
Value Percent: **10.000**
Continuous Index: **S03**
Within 8" of Joint: **YES**
Remarks:

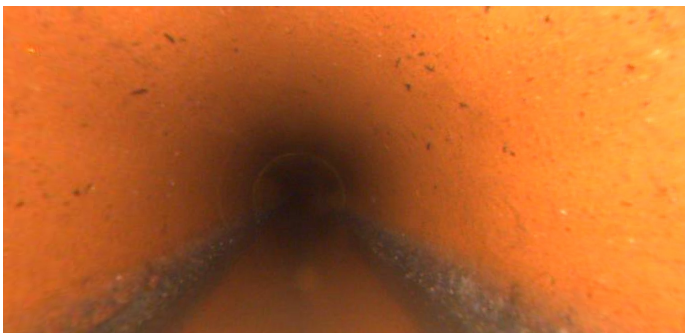
Code: **RMJ**
Description: **Roots Medium Joint**

Distance (ft): **65.6**
Structural Grade: **0**
O&M Grade: **3**
Clock Start/From: **8**
Clock To: **4**
1st Value:
2nd Value:
Value Percent: **10.000**
Continuous Index: **F03**
Within 8" of Joint: **YES**
Remarks:

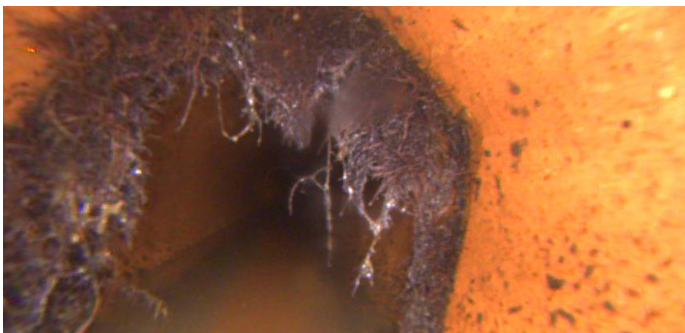
Code: **RMJ**
Description: **Roots Medium Joint**

Distance (ft): **83.4**
Structural Grade: **0**
O&M Grade: **3**
Clock Start/From: **8**
Clock To: **4**
1st Value:
2nd Value:
Value Percent: **20.000**
Continuous Index:
Within 8" of Joint: **YES**
Remarks:

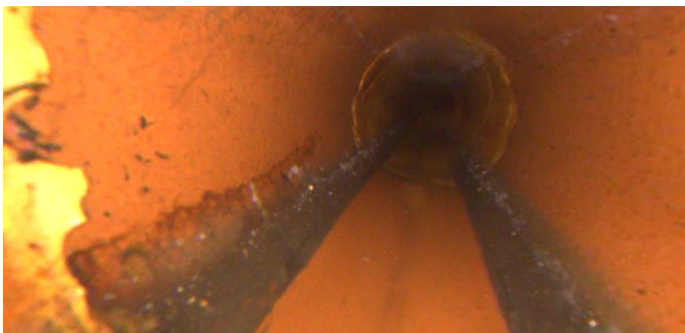
Code: **FL**
Description: **Fracture Longitudinal**

Distance (ft): **100.9**
Structural Grade: **3**
O&M Grade: **0**
Clock Start/From: **9**
Clock To:
1st Value:
2nd Value:
Value Percent:
Continuous Index:
Within 8" of Joint:
Remarks:

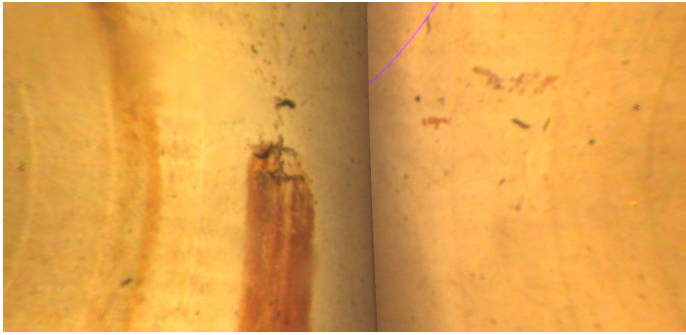
Code: **H**
Description: **Hole**

Distance (ft): **113.1**
Structural Grade: **3**
O&M Grade: **0**
Clock Start/From: **10**
Clock To:
1st Value:
2nd Value:
Value Percent:
Continuous Index:
Within 8" of Joint:
Remarks: **pin hole**

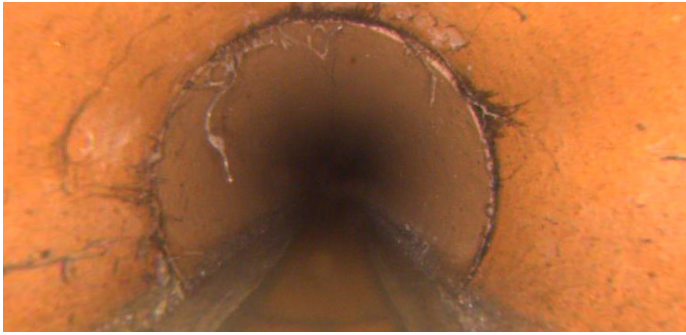
Code: **RFJ**
Description: **Roots Fine Joint**

Distance (ft): **124.2**
Structural Grade: **0**
O&M Grade: **1**
Clock Start/From: **8**
Clock To: **4**
1st Value:
2nd Value:
Value Percent:
Continuous Index:
Within 8" of Joint: **YES**
Remarks:

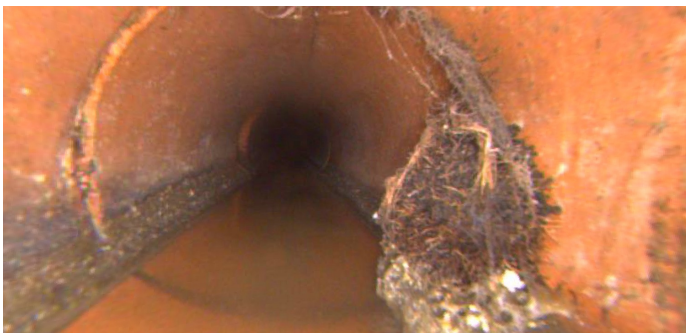
Code: **RMJ**
Description: **Roots Medium Joint**

Distance (ft): **136.5**
Structural Grade: **0**
O&M Grade: **3**
Clock Start/From: **8**
Clock To: **4**
1st Value:
2nd Value:
Value Percent: **10.000**
Continuous Index:
Within 8" of Joint: **YES**
Remarks:

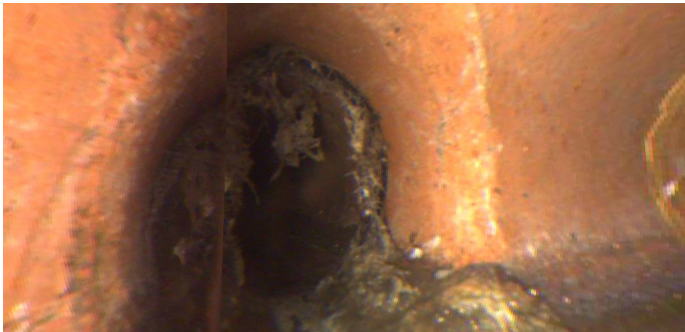
Code: **RML**
Description: **Roots Medium Lateral**

Distance (ft): **136.6**
Structural Grade: **0**
O&M Grade: **3**
Clock Start/From: **7**
Clock To: **5**
1st Value:
2nd Value:
Value Percent: **5.000**
Continuous Index:
Within 8" of Joint: **NO**
Remarks:

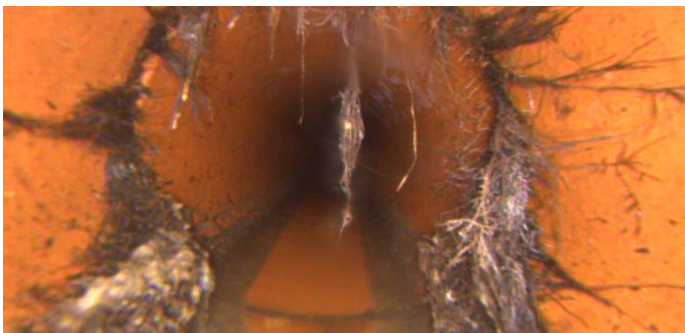
Code: **RMJ**
Description: **Roots Medium Joint**

Distance (ft): **148.9**
Structural Grade: **0**
O&M Grade: **3**
Clock Start/From: **8**
Clock To: **4**
1st Value:
2nd Value:
Value Percent: **10.000**
Continuous Index: **S04**
Within 8" of Joint: **YES**
Remarks:

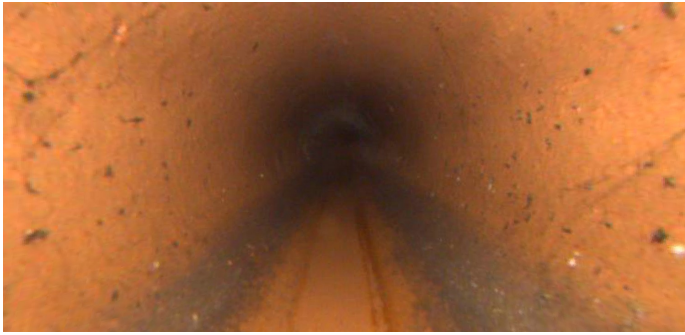
Code: **RMJ**
Description: **Roots Medium Joint**

Distance (ft): **160.0**
Structural Grade: **0**
O&M Grade: **3**
Clock Start/From: **8**
Clock To: **4**
1st Value:
2nd Value:
Value Percent: **10.000**
Continuous Index: **F04**
Within 8" of Joint: **YES**
Remarks:

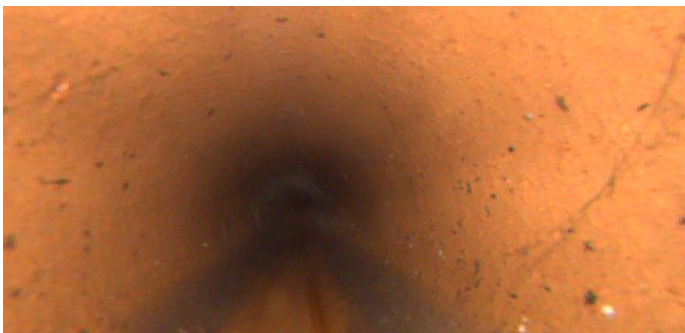
Code: **MSA**
Description: **Abandoned Survey**

Distance (ft): **160.0**
Structural Grade: **0**
O&M Grade: **0**
Clock Start/From:
Clock To:
1st Value:
2nd Value:
Value Percent:
Continuous Index:
Within 8" of Joint: **NO**
Remarks: **rmj**
