## Profile/Photo Observation Report

Date:	<b>03/25/2018</b>	Weather:		Coding:	<b>PACP 6.0</b>
Pipe Length (ft):	<b>186.5</b>	Owner:	<b>NA</b>	Pre Clean:	<b>No Pre-Cleaning</b>
P.O.#:		Surveyor:	<b>Byrd Fitzgerald</b>	PSR:	<b>P-108-013-010</b>
Customer:		Clean Date:	<b>01/01/1900</b>	Shape:	<b>C</b>

Street:	<b>15TH ST</b>	Flow Control:	<b>Not Controlled</b>
City:	<b>Hobart, IN</b>	Year Renewed:	
Location:	<b>Light Highway</b>	Tape/Media #:	
Purpose:	<b>Routine Assessment</b>	Dia/Height:	<b>8"</b>
Use:	<b>Sanitary</b>	Material:	<b>VCP</b>
Drain Area:	<b>NA</b>	Lining:	
Category:	<b>NA</b>		
Comment:	<b>Flow direction wrong</b>

Location Details:		Direction of Survey:	<b>Downstream</b>
US MH:	<b>M-108-010</b>	DS MH:	<b>M-108-013</b>
		Total Length Surveyed (ft):	<b>184.1</b>

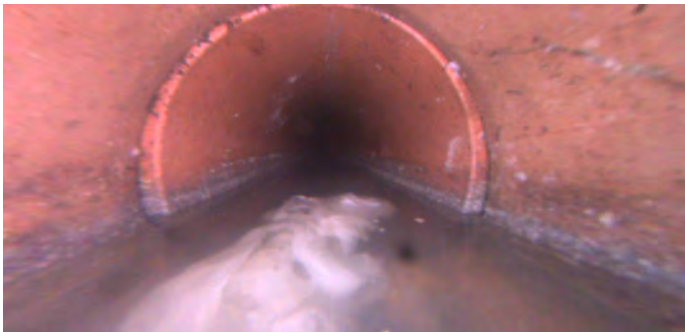
Code:	<b>DSZ</b>
Description:	<b>Deposits Settled Other</b>

Distance (ft):	<b>4.7</b>
Structural Grade:	<b>0</b>
O&M Grade:	<b>2</b>
Clock Start/From:	<b>6</b>
Clock To:	
1st Value:	
2nd Value:	
Value Percent:	<b>5.000</b>
Continuous Index:	
Within 8" of Joint:	<b>NO</b>
Remarks:	<b>tissue</b>

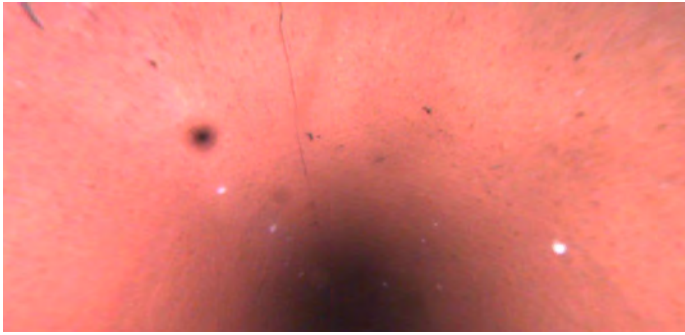
Code: **FL**  
Description: **Fracture Longitudinal**

Distance (ft): **15.4**  
Structural Grade: **3**  
O&M Grade: **0**  
Clock Start/From: **12**  
Clock To:  
1st Value:  
2nd Value:  
Value Percent:  
Continuous Index:  
Within 8" of Joint:  
Remarks:

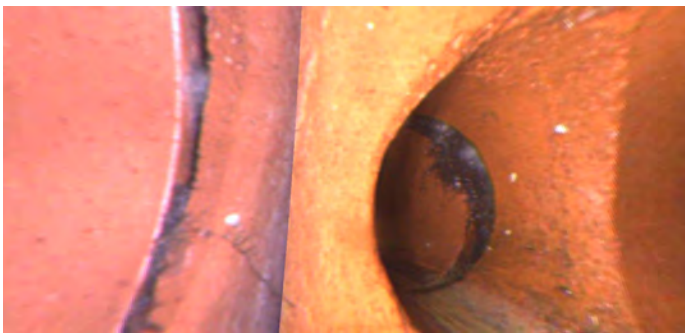
Code: **TFD**  
Description: **Tap Factory Defective**

Distance (ft): **36.8**  
Structural Grade: **0**  
O&M Grade: **2**  
Clock Start/From: **2**  
Clock To:  
1st Value: **4.000**  
2nd Value:  
Value Percent:  
Continuous Index:  
Within 8" of Joint: **YES**  
Remarks: **ROOTS**

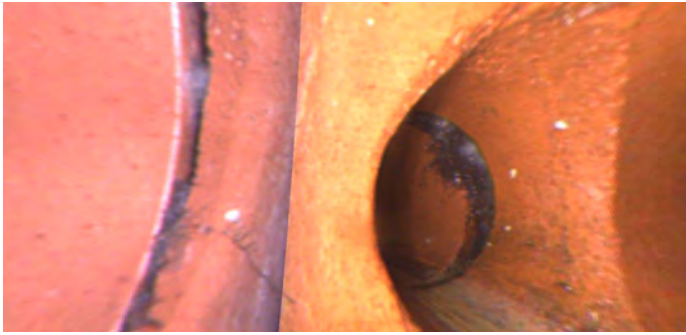
Code: **RFL**  
Description: **Roots Fine Lateral**

Distance (ft): **36.8**  
Structural Grade: **0**  
O&M Grade: **1**  
Clock Start/From: **1**  
Clock To: **5**  
1st Value:  
2nd Value:  
Value Percent:  
Continuous Index:  
Within 8" of Joint: **NO**  
Remarks:

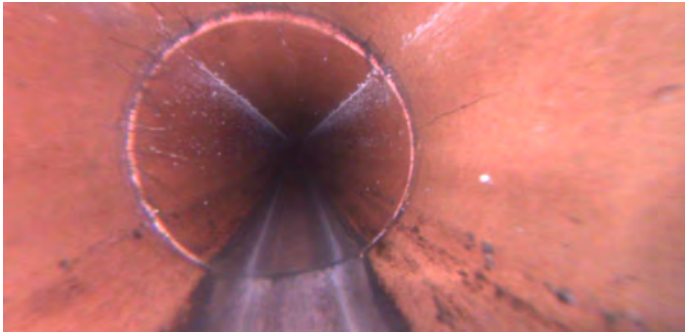
Code: **RFJ**  
Description: **Roots Fine Joint**

Distance (ft): **58.6**  
Structural Grade: **0**  
O&M Grade: **1**  
Clock Start/From: **8**  
Clock To: **4**  
1st Value:  
2nd Value:  
Value Percent:  
Continuous Index:  
Within 8" of Joint: **YES**  
Remarks:

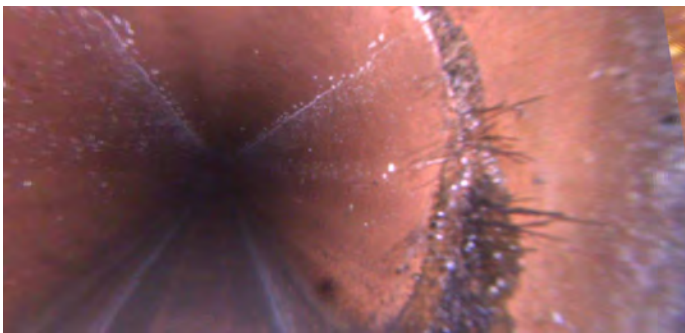
Code: **RFJ**  
Description: **Roots Fine Joint**

Distance (ft): **63.9**  
Structural Grade: **0**  
O&M Grade: **1**  
Clock Start/From: **7**  
Clock To: **5**  
1st Value:  
2nd Value:  
Value Percent:  
Continuous Index: **S01**  
Within 8" of Joint: **YES**  
Remarks: **wandering**

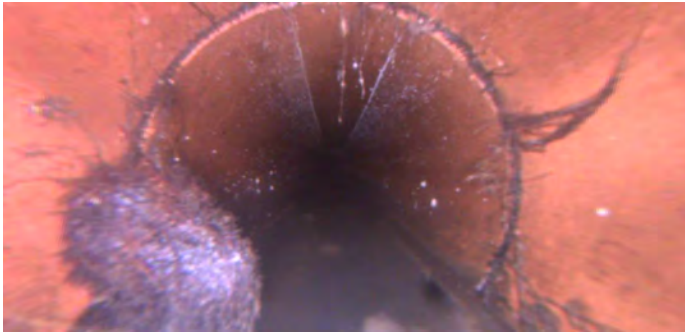
Code: **RMJ**  
Description: **Roots Medium Joint**

Distance (ft): **68.8**  
Structural Grade: **0**  
O&M Grade: **3**  
Clock Start/From: **8**  
Clock To:  
1st Value:  
2nd Value:  
Value Percent: **5.000**  
Continuous Index:  
Within 8" of Joint: **YES**  
Remarks:

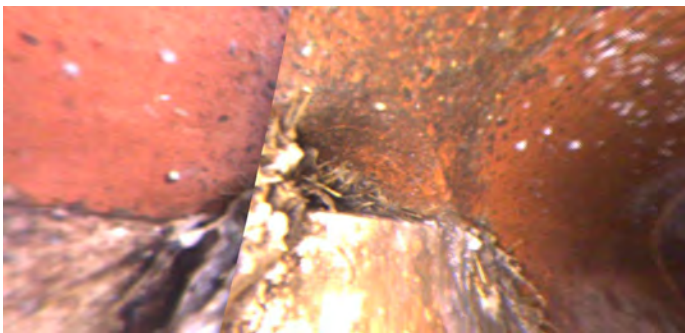
Code: **TFD**  
Description: **Tap Factory Defective**

Distance (ft): **101.0**  
Structural Grade: **0**  
O&M Grade: **2**  
Clock Start/From: **2**  
Clock To:  
1st Value: **4.000**  
2nd Value:  
Value Percent:  
Continuous Index:  
Within 8" of Joint:  
Remarks: **closed up 50%**

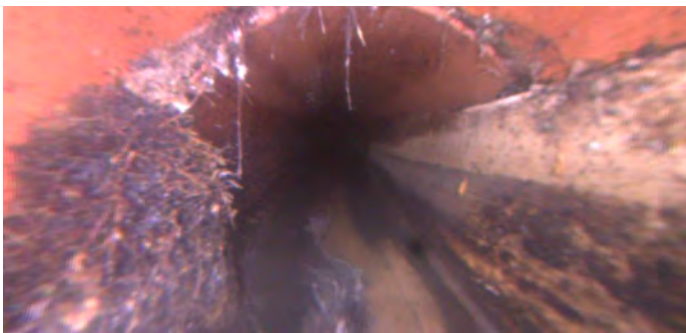
Code: **RMJ**  
Description: **Roots Medium Joint**

Distance (ft): **101.0**  
Structural Grade: **0**  
O&M Grade: **3**  
Clock Start/From: **7**  
Clock To: **10**  
1st Value:  
2nd Value:  
Value Percent: **10.000**  
Continuous Index:  
Within 8" of Joint: **YES**  
Remarks:

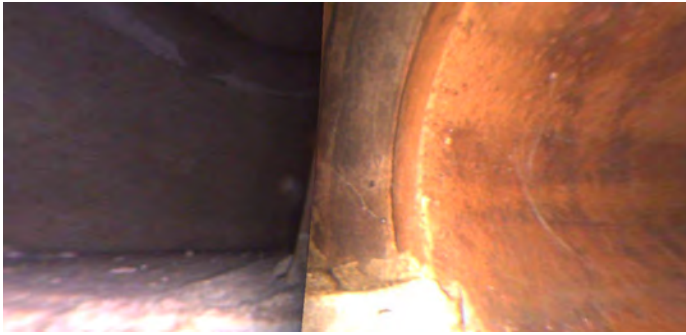
Code: **RFJ**  
Description: **Roots Fine Joint**

Distance (ft): **182.2**  
Structural Grade: **0**  
O&M Grade: **1**  
Clock Start/From: **7**  
Clock To: **5**  
1st Value:  
2nd Value:  
Value Percent:  
Continuous Index: **F01**  
Within 8" of Joint: **YES**  
Remarks: **wandering**
