Profile/Photo Observation Report

Date:	03/25/2018	Weather:		Coding:	PACP 6.0
Pipe Length (ft):	186.5	Owner:	NA	Pre Clean:	No Pre-Cleaning
P.O.#:		Surveyor:	Byrd Fitzgerald	PSR:	P-108-013-010
Customer:		Clean Date:	01/01/1900	Shape:	C

Street:	FOXCROFT STREET	Flow Control:	Not Controlled
City:	Hobart, IN	Year Renewed:	
Location:	Light Highway	Tape/Media #:	
Purpose:	Routine Assessment	Dia/Height:	8"
Use:	Sanitary	Material:	VCP
Drain Area:	NA	Lining:	
Category:	NA		
Comment:	Flow direction wrong

Location Details:		Direction of Survey:	Downstream
US MH:	M-108-010	DS MH:	M-108-013
		Total Length Surveyed (ft):	184.1

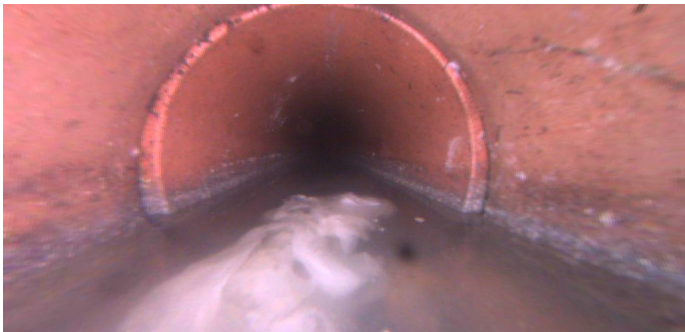
Code:	DSZ
Description:	Deposits Settled Other

Distance (ft):	4.7
Structural Grade:	0
O&M Grade:	2
Clock Start/From:	6
Clock To:	
1st Value:	
2nd Value:	
Value Percent:	5.000
Continuous Index:	
Within 8" of Joint:	NO
Remarks:	tissue

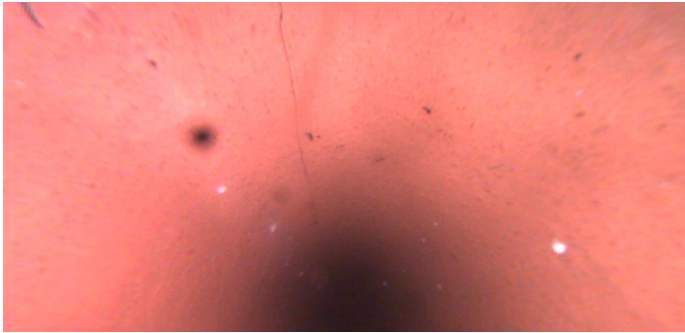
Code: **FL**
Description: **Fracture Longitudinal**

Distance (ft): **15.4**
Structural Grade: **3**
O&M Grade: **0**
Clock Start/From: **12**
Clock To:
1st Value:
2nd Value:
Value Percent:
Continuous Index:
Within 8" of Joint:
Remarks:

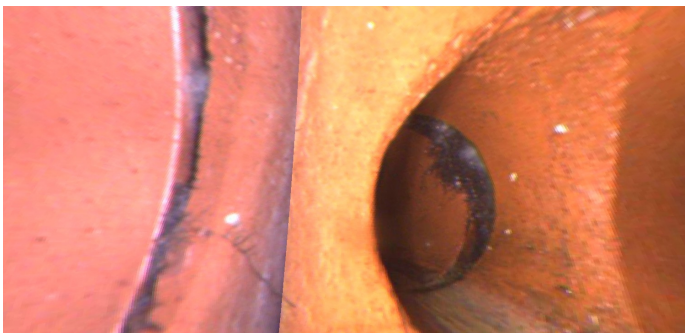
Code: **TFD**
Description: **Tap Factory Defective**

Distance (ft): **36.8**
Structural Grade: **0**
O&M Grade: **2**
Clock Start/From: **2**
Clock To:
1st Value: **4.000**
2nd Value:
Value Percent:
Continuous Index:
Within 8" of Joint: **YES**
Remarks: **ROOTS**

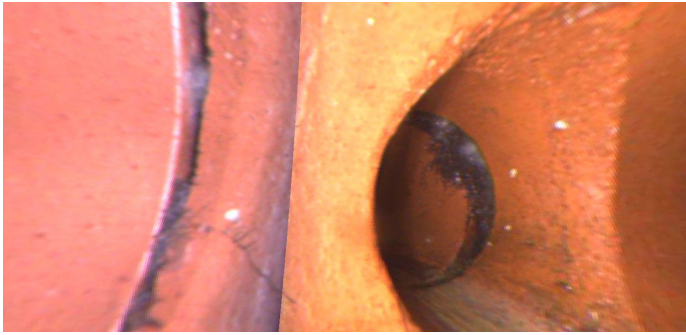
Code: **RFL**
Description: **Roots Fine Lateral**

Distance (ft): **36.8**
Structural Grade: **0**
O&M Grade: **1**
Clock Start/From: **1**
Clock To: **5**
1st Value:
2nd Value:
Value Percent:
Continuous Index:
Within 8" of Joint: **NO**
Remarks:

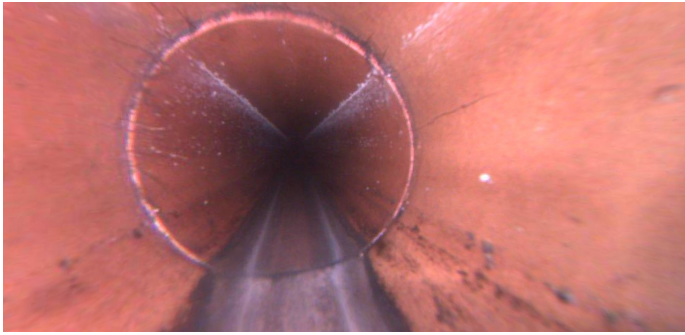
Code: **RFJ**
Description: **Roots Fine Joint**

Distance (ft): **58.6**
Structural Grade: **0**
O&M Grade: **1**
Clock Start/From: **8**
Clock To: **4**
1st Value:
2nd Value:
Value Percent:
Continuous Index:
Within 8" of Joint: **YES**
Remarks:

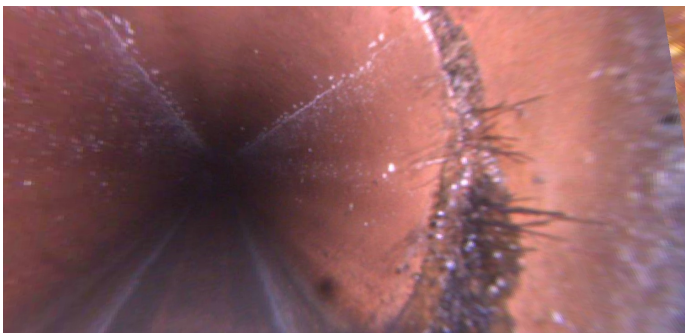
Code: **RFJ**
Description: **Roots Fine Joint**

Distance (ft): **63.9**
Structural Grade: **0**
O&M Grade: **1**
Clock Start/From: **7**
Clock To: **5**
1st Value:
2nd Value:
Value Percent:
Continuous Index: **S01**
Within 8" of Joint: **YES**
Remarks: **wandering**

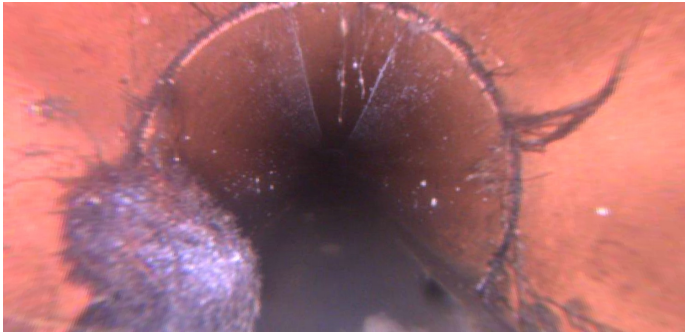
Code: **RMJ**
Description: **Roots Medium Joint**

Distance (ft): **68.8**
Structural Grade: **0**
O&M Grade: **3**
Clock Start/From: **8**
Clock To:
1st Value:
2nd Value:
Value Percent: **5.000**
Continuous Index:
Within 8" of Joint: **YES**
Remarks:

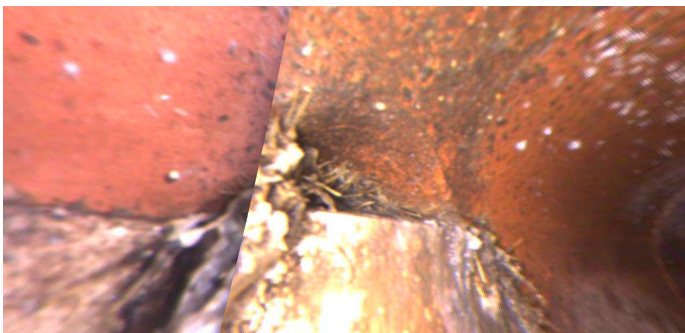
Code: **TFD**
Description: **Tap Factory Defective**

Distance (ft): **101.0**
Structural Grade: **0**
O&M Grade: **2**
Clock Start/From: **2**
Clock To:
1st Value: **4.000**
2nd Value:
Value Percent:
Continuous Index:
Within 8" of Joint:
Remarks: **closed up 50%**

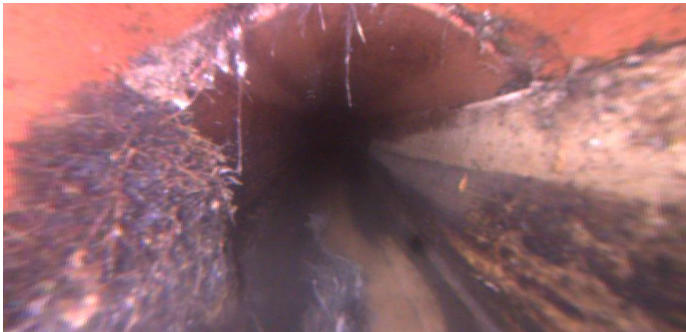
Code: **RMJ**
Description: **Roots Medium Joint**

Distance (ft): **101.0**
Structural Grade: **0**
O&M Grade: **3**
Clock Start/From: **7**
Clock To: **10**
1st Value:
2nd Value:
Value Percent: **10.000**
Continuous Index:
Within 8" of Joint: **YES**
Remarks:

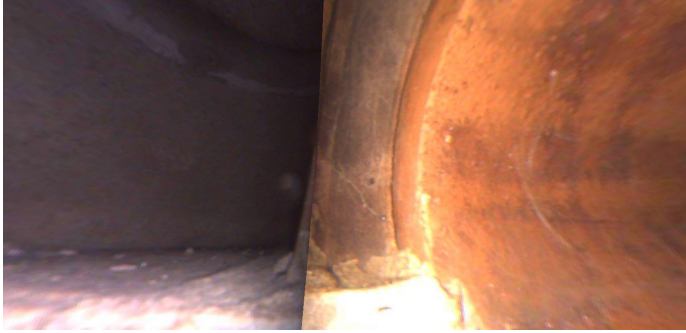
Code: **RFJ**
Description: **Roots Fine Joint**

Distance (ft): **182.2**
Structural Grade: **0**
O&M Grade: **1**
Clock Start/From: **7**
Clock To: **5**
1st Value:
2nd Value:
Value Percent:
Continuous Index: **F01**
Within 8" of Joint: **YES**
Remarks: **wandering**
