Profile/Photo Observation Report

Date:	03/25/2018	Weather:		Coding:	PACP 6.0
Pipe Length (ft):	165.3	Owner:	NA	Pre Clean:	No Pre-Cleaning
P.O.#:		Surveyor:	Byrd Fitzgerald	PSR:	P-108-012-011
Customer:		Clean Date:	01/01/1900	Shape:	C

Street:	15TH ST	Flow Control:	Not Controlled
City:	Hobart, IN	Year Renewed:	
Location:	Light Highway	Tape/Media #:	
Purpose:	Routine Assessment	Dia/Height:	8"
Use:	Sanitary	Material:	VCP
Drain Area:	NA	Lining:	
Category:	NA		
Comment:	Flow direction wrong

Location Details:		Direction of Survey:	Downstream
US MH:	M-108-011	DS MH:	M-108-012
		Total Length Surveyed (ft):	163.2

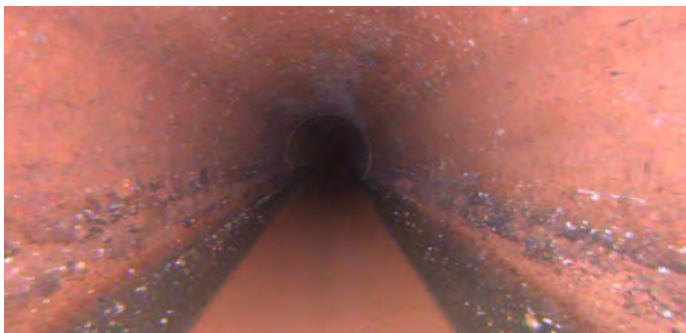
Code: **AMH**
Description: **Manhole**

Distance (ft): **.0**
Structural Grade: **0**
O&M Grade: **0**
Clock Start/From:
Clock To:
1st Value:
2nd Value:
Value Percent:
Continuous Index:
Within 8" of Joint: **NO**
Remarks: **M-108-011**

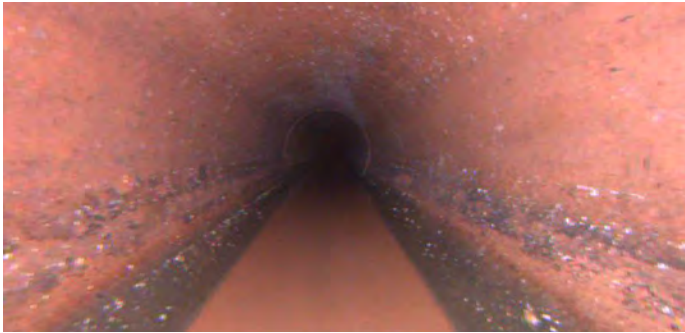
Code:	MWL
Description:	Water Level

Distance (ft):	.0
Structural Grade:	0
O&M Grade:	0
Clock Start/From:	
Clock To:	
1st Value:	
2nd Value:	
Value Percent:	5.000
Continuous Index:	
Within 8" of Joint:	NO
Remarks:

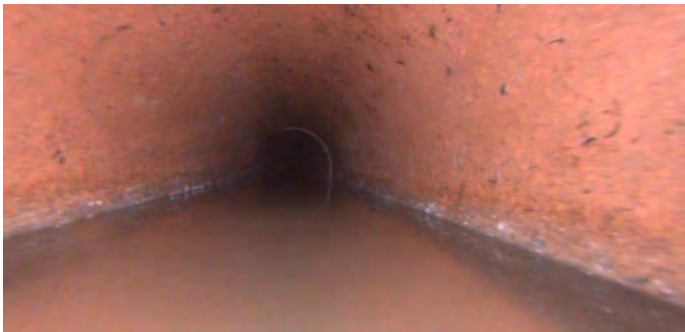
Code:	MWL
Description:	Water Level

Distance (ft):	16.0
Structural Grade:	0
O&M Grade:	0
Clock Start/From:	
Clock To:	
1st Value:	
2nd Value:	
Value Percent:	15.000
Continuous Index:	
Within 8" of Joint:	NO
Remarks:

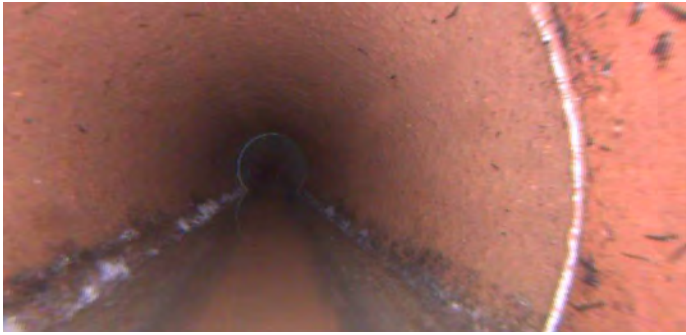
Code: **MWL**
Description: **Water Level**

Distance (ft): **23.4**
Structural Grade: **0**
O&M Grade: **0**
Clock Start/From:
Clock To:
1st Value:
2nd Value:
Value Percent: **5.000**
Continuous Index:
Within 8" of Joint: **NO**
Remarks:

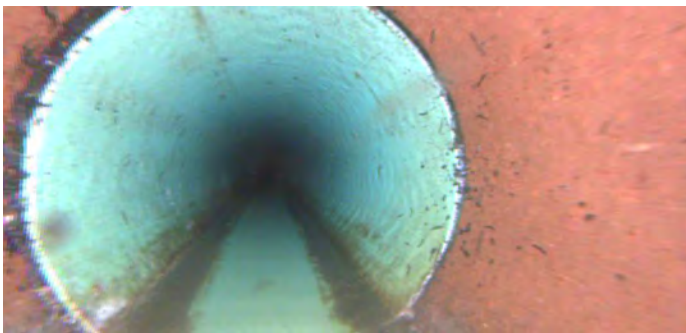
Code: **MMC**
Description: **Material Change**

Distance (ft): **25.8**
Structural Grade: **0**
O&M Grade: **0**
Clock Start/From:
Clock To:
1st Value:
2nd Value:
Value Percent:
Continuous Index:
Within 8" of Joint: **NO**
Remarks: **pvc**

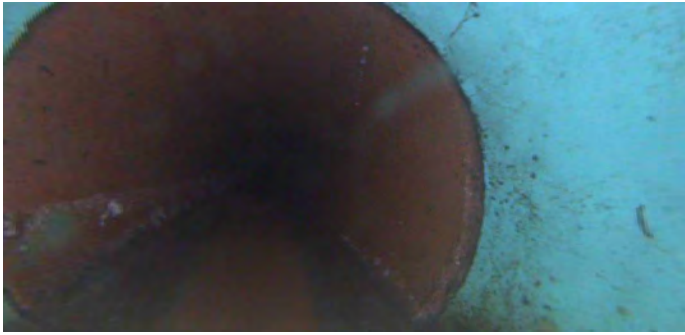
Code: **MMC**
Description: **Material Change**

Distance (ft): **33.5**
Structural Grade: **0**
O&M Grade: **0**
Clock Start/From:
Clock To:
1st Value:
2nd Value:
Value Percent:
Continuous Index:
Within 8" of Joint: **NO**
Remarks: **vcp**

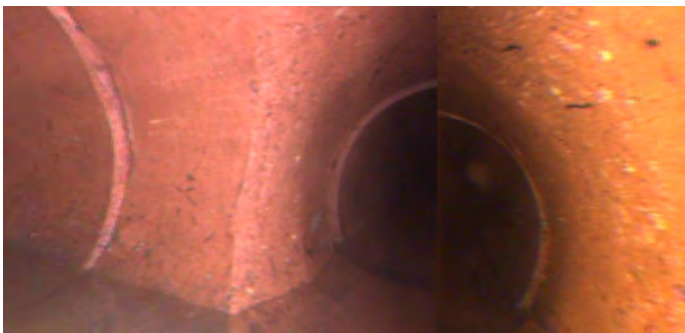
Code: **TF**
Description: **Tap Factory**

Distance (ft): **40.1**
Structural Grade: **0**
O&M Grade: **0**
Clock Start/From: **3**
Clock To:
1st Value: **4.000**
2nd Value:
Value Percent:
Continuous Index:
Within 8" of Joint: **YES**
Remarks:

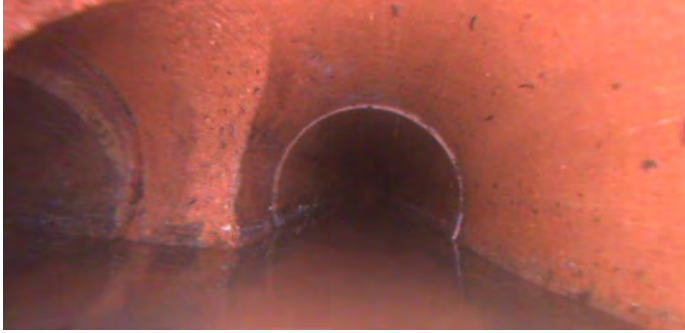
Code: **TF**
Description: **Tap Factory**

Distance (ft): **41.7**
Structural Grade: **0**
O&M Grade: **0**
Clock Start/From: **9**
Clock To:
1st Value: **4.000**
2nd Value:
Value Percent:
Continuous Index:
Within 8" of Joint: **YES**
Remarks:

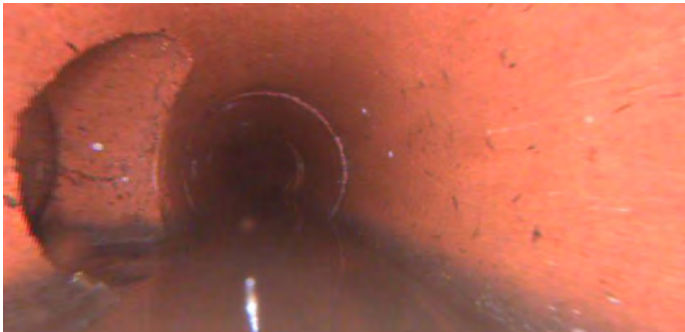
Code: **TF**
Description: **Tap Factory**

Distance (ft): **98.7**
Structural Grade: **0**
O&M Grade: **0**
Clock Start/From: **9**
Clock To:
1st Value: **4.000**
2nd Value:
Value Percent:
Continuous Index:
Within 8" of Joint: **YES**
Remarks:

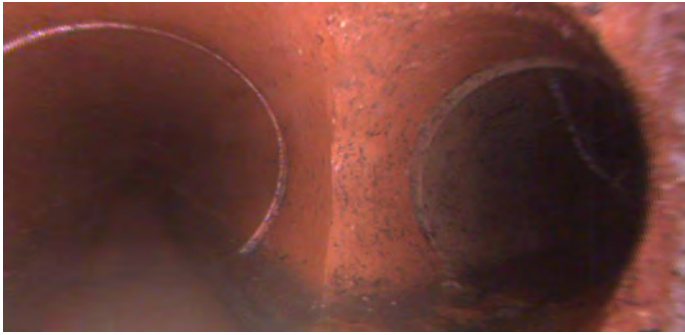
Code: **TF**
Description: **Tap Factory**

Distance (ft): **101.2**
Structural Grade: **0**
O&M Grade: **0**
Clock Start/From: **3**
Clock To:
1st Value: **4.000**
2nd Value:
Value Percent:
Continuous Index:
Within 8" of Joint: **YES**
Remarks:

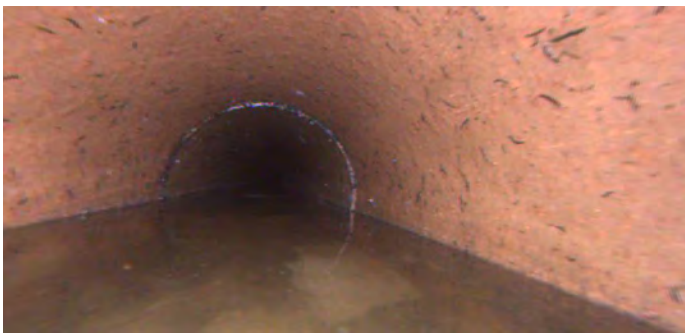
Code: **MWL**
Description: **Water Level**

Distance (ft): **130.9**
Structural Grade: **0**
O&M Grade: **0**
Clock Start/From:
Clock To:
1st Value:
2nd Value:
Value Percent: **25.000**
Continuous Index:
Within 8" of Joint: **NO**
Remarks:

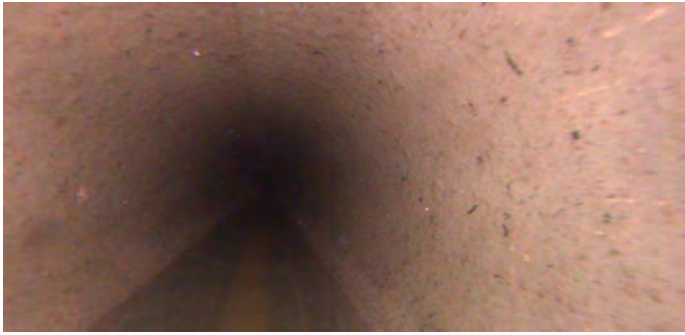
Code: **MWL**
Description: **Water Level**

Distance (ft): **137.9**
Structural Grade: **0**
O&M Grade: **0**
Clock Start/From:
Clock To:
1st Value:
2nd Value:
Value Percent: **5.000**
Continuous Index:
Within 8" of Joint: **NO**
Remarks:

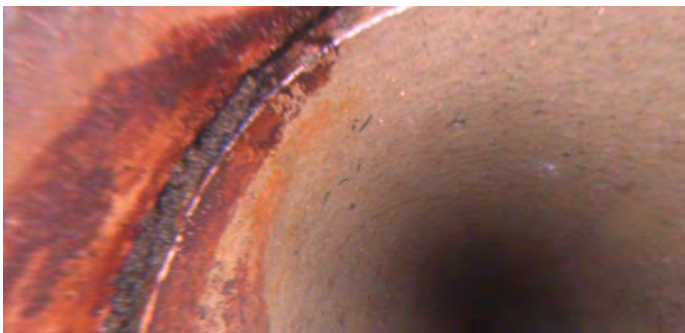
Code: **IS**
Description: **Infil Stain**

Distance (ft): **146.9**
Structural Grade: **0**
O&M Grade: **0**
Clock Start/From: **11**
Clock To:
1st Value:
2nd Value:
Value Percent:
Continuous Index:
Within 8" of Joint: **YES**
Remarks:

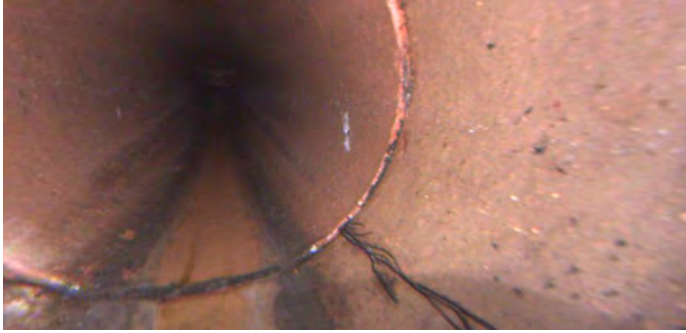
Code: **RFJ**
Description: **Roots Fine Joint**

Distance (ft): **156.7**
Structural Grade: **0**
O&M Grade: **1**
Clock Start/From: **5**
Clock To:
1st Value:
2nd Value:
Value Percent:
Continuous Index:
Within 8" of Joint: **YES**
Remarks:

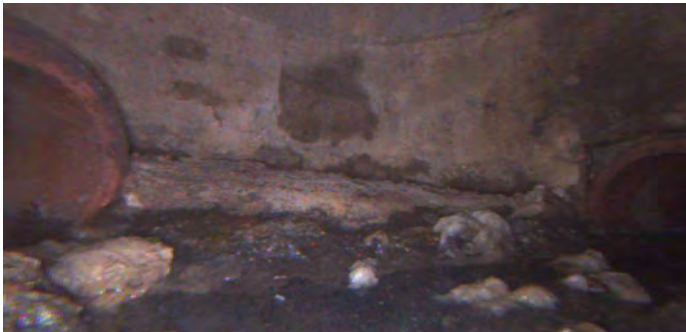
Code: **AMH**
Description: **Manhole**

Distance (ft): **163.2**
Structural Grade: **0**
O&M Grade: **0**
Clock Start/From:
Clock To:
1st Value:
2nd Value:
Value Percent:
Continuous Index:
Within 8" of Joint: **NO**
Remarks: **M-108-012**
