## Profile/Photo Observation Report

Date:	<b>03/25/2018</b>	Weather:		Coding:	<b>PACP 6.0</b>
Pipe Length (ft):	<b>165.3</b>	Owner:	<b>NA</b>	Pre Clean:	<b>No Pre-Cleaning</b>
P.O.#:		Surveyor:	<b>Byrd Fitzgerald</b>	PSR:	<b>P-108-012-011</b>
Customer:		Clean Date:	<b>01/01/1900</b>	Shape:	<b>C</b>

Street:	<b>FOXCROFT STREET</b>	Flow Control:	<b>Not Controlled</b>
City:	<b>Hobart, IN</b>	Year Renewed:	
Location:	<b>Light Highway</b>	Tape/Media #:	
Purpose:	<b>Routine Assessment</b>	Dia/Height:	<b>8"</b>
Use:	<b>Sanitary</b>	Material:	<b>VCP</b>
Drain Area:	<b>NA</b>	Lining:	
Category:	<b>NA</b>		
Comment:	<b>Flow direction wrong</b>

Location Details:		Direction of Survey:	<b>Downstream</b>
US MH:	<b>M-108-011</b>	DS MH:	<b>M-108-012</b>
		Total Length Surveyed (ft):	<b>163.2</b>

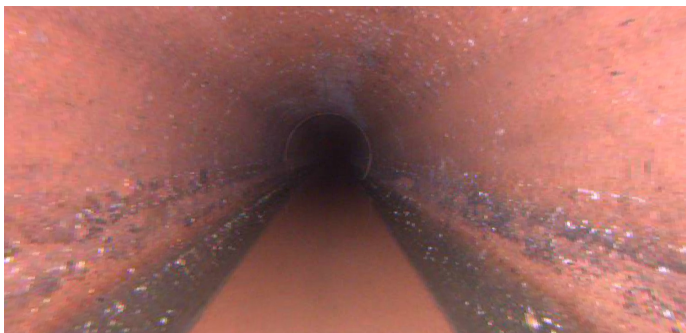
Code: **AMH**  
Description: **Manhole**

Distance (ft): **.0**  
Structural Grade: **0**  
O&M Grade: **0**  
Clock Start/From:  
Clock To:  
1st Value:  
2nd Value:  
Value Percent:  
Continuous Index:  
Within 8" of Joint: **NO**  
Remarks: **M-108-011**

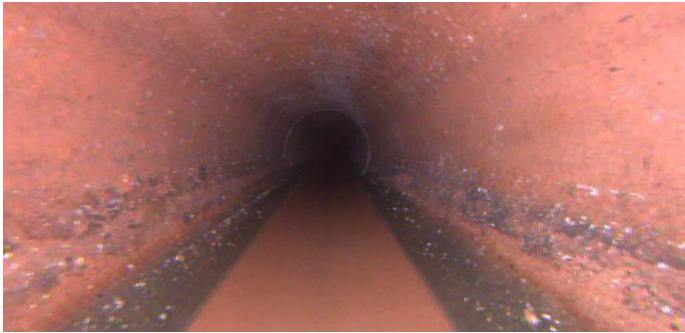
Code:	<b>MWL</b>
Description:	<b>Water Level</b>

Distance (ft):	<b>.0</b>
Structural Grade:	<b>0</b>
O&M Grade:	<b>0</b>
Clock Start/From:	
Clock To:	
1st Value:	
2nd Value:	
Value Percent:	<b>5.000</b>
Continuous Index:	
Within 8" of Joint:	<b>NO</b>
Remarks:

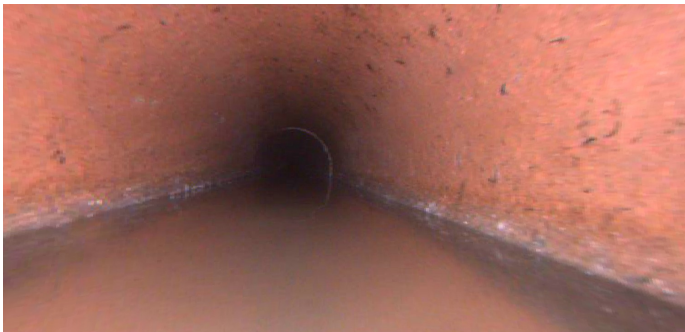
Code:	<b>MWL</b>
Description:	<b>Water Level</b>

Distance (ft):	<b>16.0</b>
Structural Grade:	<b>0</b>
O&M Grade:	<b>0</b>
Clock Start/From:	
Clock To:	
1st Value:	
2nd Value:	
Value Percent:	<b>15.000</b>
Continuous Index:	
Within 8" of Joint:	<b>NO</b>
Remarks:

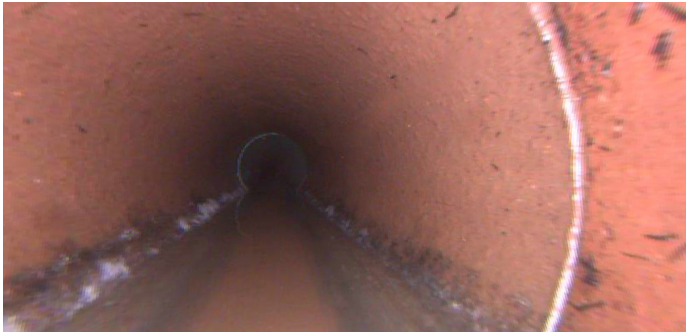
Code: **MWL**  
Description: **Water Level**

Distance (ft): **23.4**  
Structural Grade: **0**  
O&M Grade: **0**  
Clock Start/From:  
Clock To:  
1st Value:  
2nd Value:  
Value Percent: **5.000**  
Continuous Index:  
Within 8" of Joint: **NO**  
Remarks:

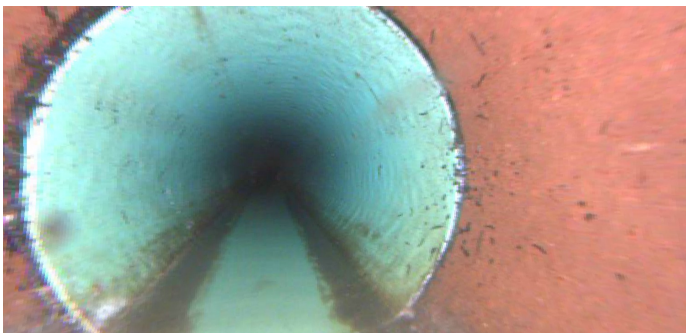
Code: **MMC**  
Description: **Material Change**

Distance (ft): **25.8**  
Structural Grade: **0**  
O&M Grade: **0**  
Clock Start/From:  
Clock To:  
1st Value:  
2nd Value:  
Value Percent:  
Continuous Index:  
Within 8" of Joint: **NO**  
Remarks: **pvc**

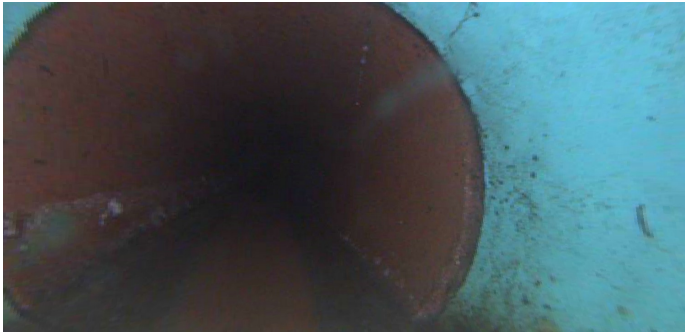
Code: **MMC**  
Description: **Material Change**

Distance (ft): **33.5**  
Structural Grade: **0**  
O&M Grade: **0**  
Clock Start/From:  
Clock To:  
1st Value:  
2nd Value:  
Value Percent:  
Continuous Index:  
Within 8" of Joint: **NO**  
Remarks: **vcp**

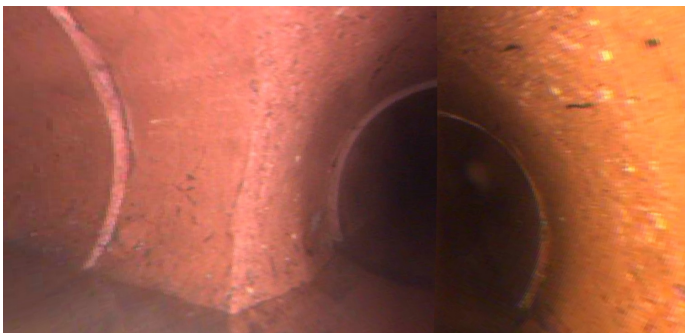
Code: **TF**  
Description: **Tap Factory**

Distance (ft): **40.1**  
Structural Grade: **0**  
O&M Grade: **0**  
Clock Start/From: **3**  
Clock To:  
1st Value: **4.000**  
2nd Value:  
Value Percent:  
Continuous Index:  
Within 8" of Joint: **YES**  
Remarks:

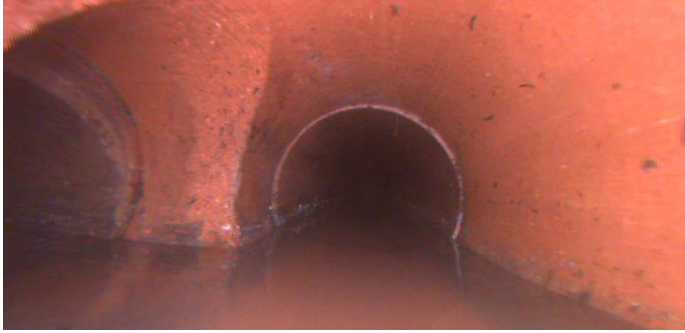
Code: **TF**  
Description: **Tap Factory**

Distance (ft): **41.7**  
Structural Grade: **0**  
O&M Grade: **0**  
Clock Start/From: **9**  
Clock To:  
1st Value: **4.000**  
2nd Value:  
Value Percent:  
Continuous Index:  
Within 8" of Joint: **YES**  
Remarks:

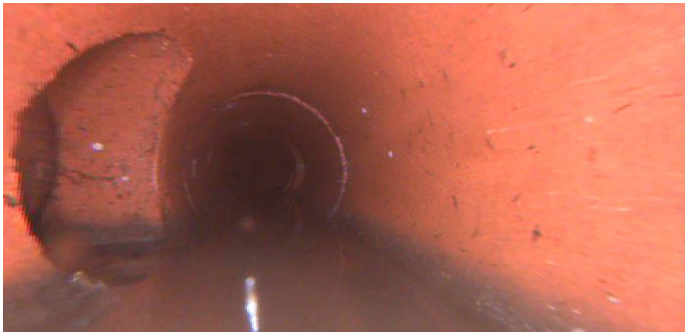
Code: **TF**  
Description: **Tap Factory**

Distance (ft): **98.7**  
Structural Grade: **0**  
O&M Grade: **0**  
Clock Start/From: **9**  
Clock To:  
1st Value: **4.000**  
2nd Value:  
Value Percent:  
Continuous Index:  
Within 8" of Joint: **YES**  
Remarks:

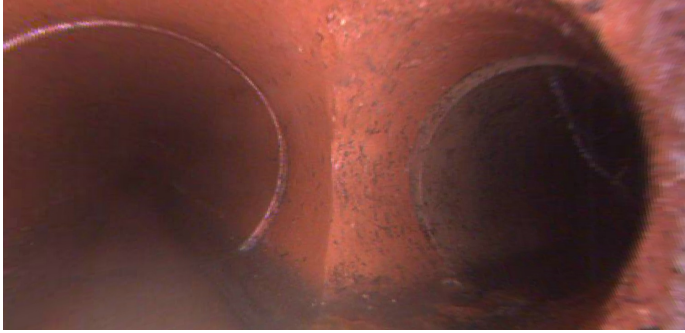
Code: **TF**  
Description: **Tap Factory**

Distance (ft): **101.2**  
Structural Grade: **0**  
O&M Grade: **0**  
Clock Start/From: **3**  
Clock To:  
1st Value: **4.000**  
2nd Value:  
Value Percent:  
Continuous Index:  
Within 8" of Joint: **YES**  
Remarks:

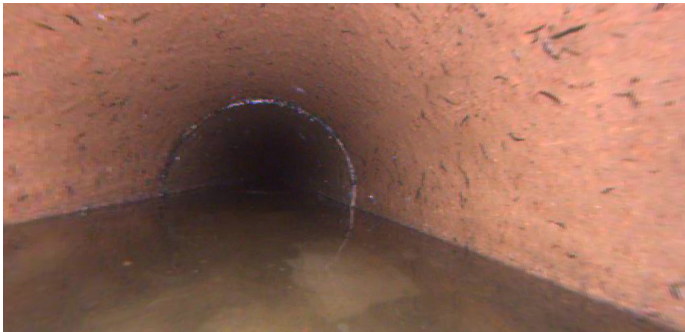
Code: **MWL**  
Description: **Water Level**

Distance (ft): **130.9**  
Structural Grade: **0**  
O&M Grade: **0**  
Clock Start/From:  
Clock To:  
1st Value:  
2nd Value:  
Value Percent: **25.000**  
Continuous Index:  
Within 8" of Joint: **NO**  
Remarks:

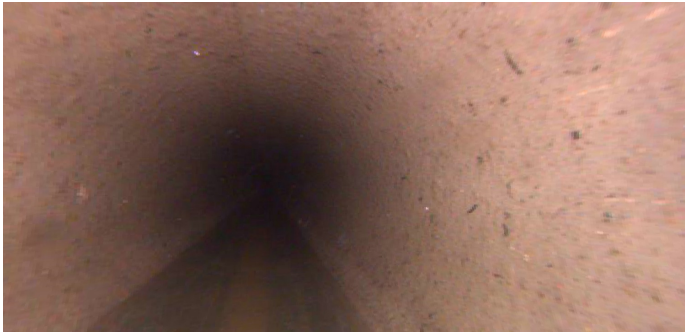
Code: **MWL**  
Description: **Water Level**

Distance (ft): **137.9**  
Structural Grade: **0**  
O&M Grade: **0**  
Clock Start/From:  
Clock To:  
1st Value:  
2nd Value:  
Value Percent: **5.000**  
Continuous Index:  
Within 8" of Joint: **NO**  
Remarks:

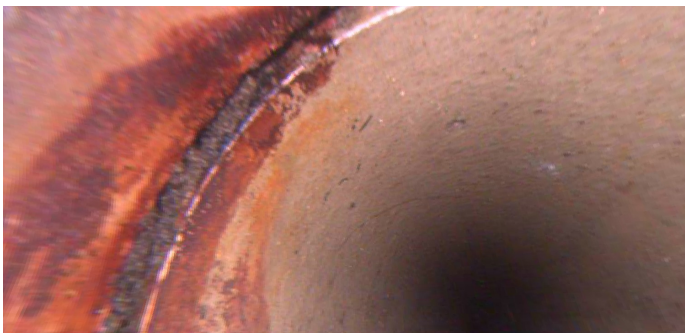
Code: **IS**  
Description: **Infil Stain**

Distance (ft): **146.9**  
Structural Grade: **0**  
O&M Grade: **0**  
Clock Start/From: **11**  
Clock To:  
1st Value:  
2nd Value:  
Value Percent:  
Continuous Index:  
Within 8" of Joint: **YES**  
Remarks:

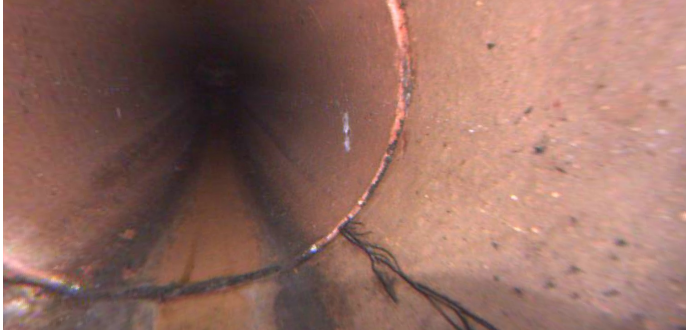
Code: **RFJ**  
Description: **Roots Fine Joint**

Distance (ft): **156.7**  
Structural Grade: **0**  
O&M Grade: **1**  
Clock Start/From: **5**  
Clock To:  
1st Value:  
2nd Value:  
Value Percent:  
Continuous Index:  
Within 8" of Joint: **YES**  
Remarks:

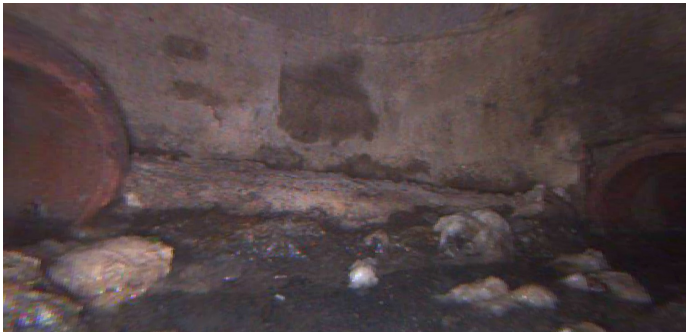
Code: **AMH**  
Description: **Manhole**

Distance (ft): **163.2**  
Structural Grade: **0**  
O&M Grade: **0**  
Clock Start/From:  
Clock To:  
1st Value:  
2nd Value:  
Value Percent:  
Continuous Index:  
Within 8" of Joint: **NO**  
Remarks: **M-108-012**
