## Profile/Photo Observation Report

Date:	<b>03/25/2018</b>	Weather:		Coding:	<b>PACP 6.0</b>
Pipe Length (ft):	<b>133.1</b>	Owner:	<b>NA</b>	Pre Clean:	<b>No Pre-Cleaning</b>
P.O.#:		Surveyor:	<b>Byrd Fitzgerald</b>	PSR:	<b>P-108-014-013</b>
Customer:		Clean Date:	<b>01/01/1900</b>	Shape:	<b>C</b>

Street:	<b>15TH PL</b>	Flow Control:	<b>Not Controlled</b>
City:	<b>Hobart, IN</b>	Year Renewed:	
Location:	<b>Light Highway</b>	Tape/Media #:	
Purpose:	<b>Routine Assessment</b>	Dia/Height:	<b>8"</b>
Use:	<b>Sanitary</b>	Material:	<b>VCP</b>
Drain Area:	<b>NA</b>	Lining:	
Category:	<b>NA</b>		
Comment:	<b>Flow direction wrong</b>

Location Details:		Direction of Survey:	<b>Upstream</b>
US MH:	<b>M-108-013</b>	DS MH:	<b>M-108-014</b>
		Total Length Surveyed (ft):	<b>134.5</b>

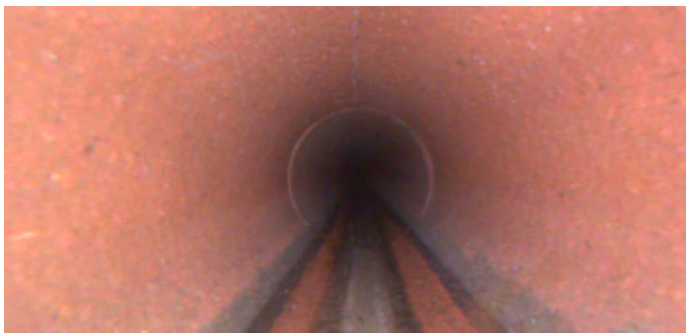
Code: **AMH**  
Description: **Manhole**

Distance (ft): **.0**  
Structural Grade: **0**  
O&M Grade: **0**  
Clock Start/From:  
Clock To:  
1st Value:  
2nd Value:  
Value Percent:  
Continuous Index:  
Within 8" of Joint: **NO**  
Remarks: **M-108-014**

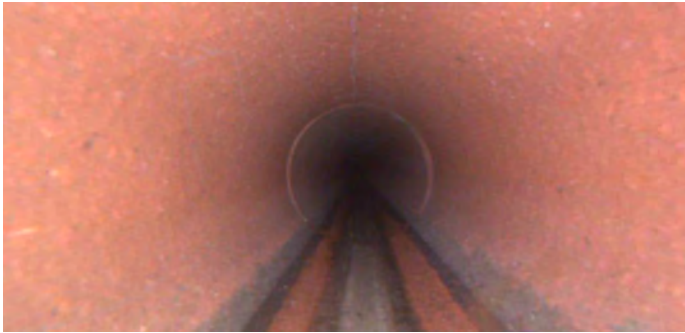
Code:	<b>MWL</b>
Description:	<b>Water Level</b>

Distance (ft):	<b>.0</b>
Structural Grade:	<b>0</b>
O&M Grade:	<b>0</b>
Clock Start/From:	
Clock To:	
1st Value:	
2nd Value:	
Value Percent:	<b>5.000</b>
Continuous Index:	
Within 8" of Joint:	<b>NO</b>
Remarks:

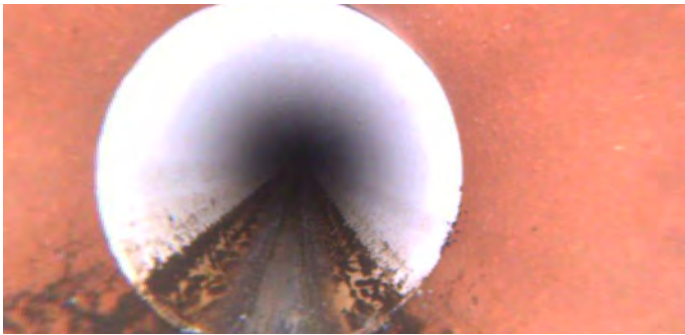
Code:	<b>MMC</b>
Description:	<b>Material Change</b>

Distance (ft):	<b>10.7</b>
Structural Grade:	<b>0</b>
O&M Grade:	<b>0</b>
Clock Start/From:	
Clock To:	
1st Value:	
2nd Value:	
Value Percent:	
Continuous Index:	
Within 8" of Joint:	<b>NO</b>
Remarks:	<b>pvc</b>

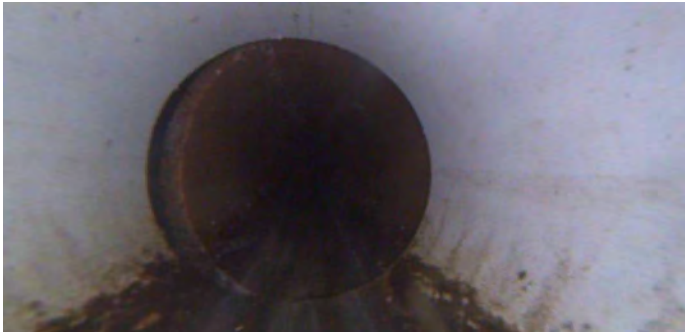
Code: **MMC**  
Description: **Material Change**

Distance (ft): **17.2**  
Structural Grade: **0**  
O&M Grade: **0**  
Clock Start/From:  
Clock To:  
1st Value:  
2nd Value:  
Value Percent:  
Continuous Index:  
Within 8" of Joint: **NO**  
Remarks: **vcp**

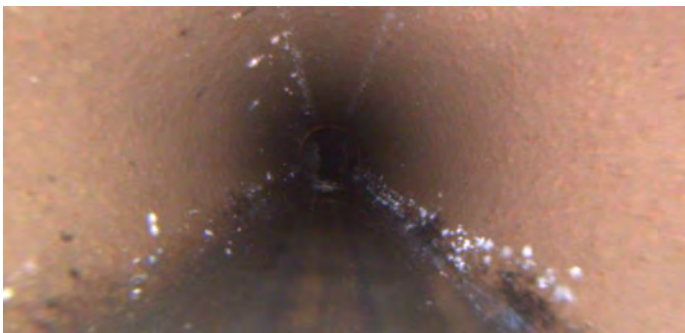
Code: **DAGS**  
Description: **Deposits Attached Grease**

Distance (ft): **39.7**  
Structural Grade: **0**  
O&M Grade: **2**  
Clock Start/From: **8**  
Clock To: **4**  
1st Value:  
2nd Value:  
Value Percent: **5.000**  
Continuous Index: **S03**  
Within 8" of Joint: **NO**  
Remarks:

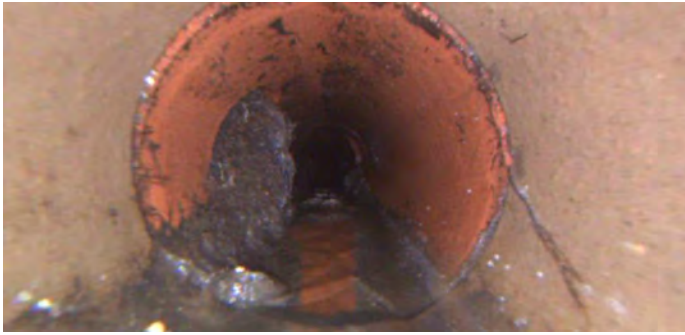
Code: **RFJ**  
Description: **Roots Fine Joint**

Distance (ft): **42.4**  
Structural Grade: **0**  
O&M Grade: **1**  
Clock Start/From: **8**  
Clock To: **4**  
1st Value:  
2nd Value:  
Value Percent:  
Continuous Index:  
Within 8" of Joint: **YES**  
Remarks:

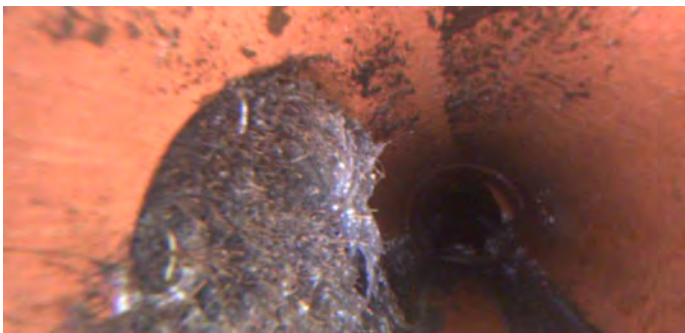
Code: **RML**  
Description: **Roots Medium Lateral**

Distance (ft): **43.1**  
Structural Grade: **0**  
O&M Grade: **3**  
Clock Start/From: **7**  
Clock To: **11**  
1st Value:  
2nd Value:  
Value Percent: **20.000**  
Continuous Index:  
Within 8" of Joint: **NO**  
Remarks:

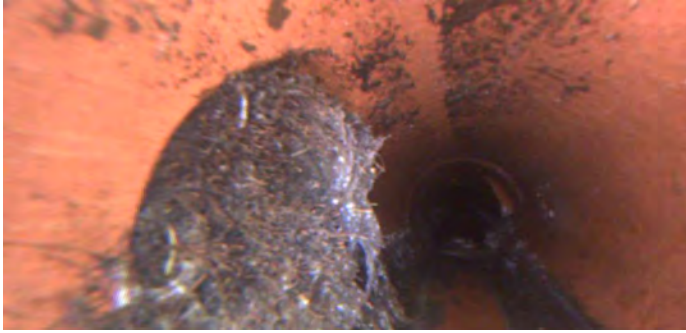
Code: **TFD**  
Description: **Tap Factory Defective**

Distance (ft): **43.1**  
Structural Grade: **0**  
O&M Grade: **2**  
Clock Start/From: **9**  
Clock To:  
1st Value: **4.000**  
2nd Value:  
Value Percent:  
Continuous Index:  
Within 8" of Joint:  
Remarks: **blocked by heavy roots**

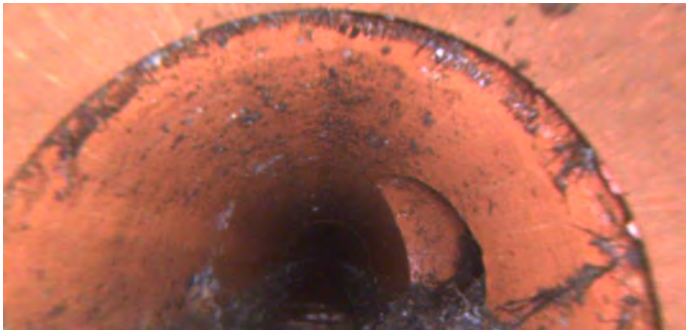
Code: **RFJ**  
Description: **Roots Fine Joint**

Distance (ft): **44.8**  
Structural Grade: **0**  
O&M Grade: **1**  
Clock Start/From: **8**  
Clock To: **4**  
1st Value:  
2nd Value:  
Value Percent:  
Continuous Index:  
Within 8" of Joint: **YES**  
Remarks:

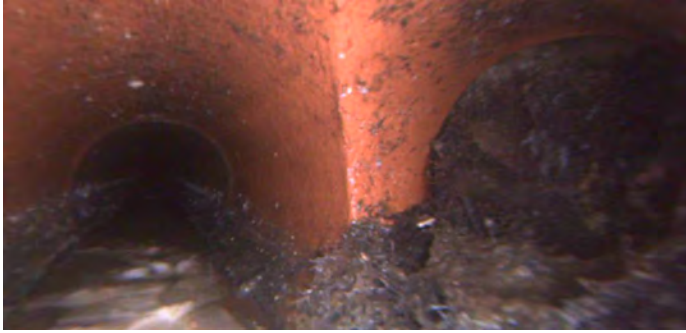
Code: **TFD**  
Description: **Tap Factory Defective**

Distance (ft): **45.4**  
Structural Grade: **0**  
O&M Grade: **2**  
Clock Start/From: **3**  
Clock To:  
1st Value: **4.000**  
2nd Value:  
Value Percent:  
Continuous Index:  
Within 8" of Joint:  
Remarks: **ROOTS**

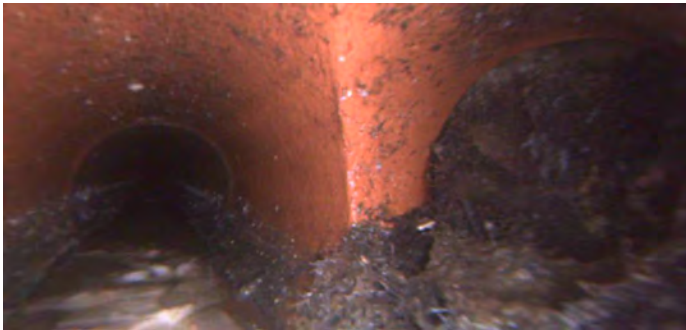
Code: **RML**  
Description: **Roots Medium Lateral**

Distance (ft): **45.4**  
Structural Grade: **0**  
O&M Grade: **3**  
Clock Start/From: **3**  
Clock To: **4**  
1st Value:  
2nd Value:  
Value Percent: **10.000**  
Continuous Index:  
Within 8" of Joint: **NO**  
Remarks:

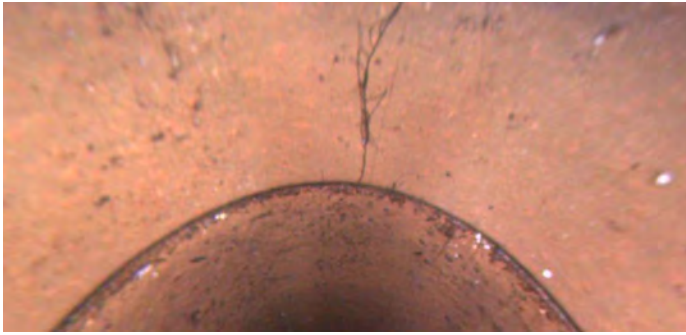
Code: **RFJ**  
Description: **Roots Fine Joint**

Distance (ft): **62.5**  
Structural Grade: **0**  
O&M Grade: **1**  
Clock Start/From: **12**  
Clock To:  
1st Value:  
2nd Value:  
Value Percent:  
Continuous Index:  
Within 8" of Joint: **YES**  
Remarks:

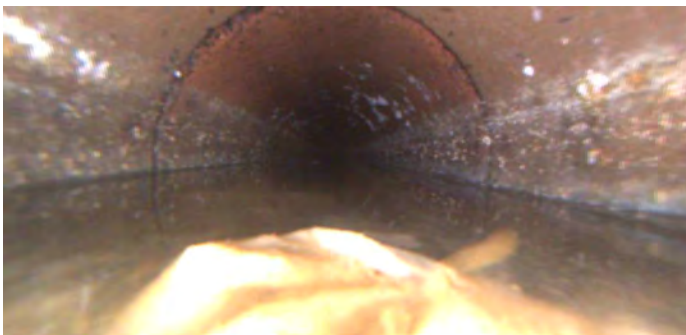
Code: **MWLS**  
Description: **Water Level Sag**

Distance (ft): **89.1**  
Structural Grade: **2**  
O&M Grade: **3**  
Clock Start/From:  
Clock To:  
1st Value:  
2nd Value:  
Value Percent: **10.000**  
Continuous Index:  
Within 8" of Joint: **NO**  
Remarks:

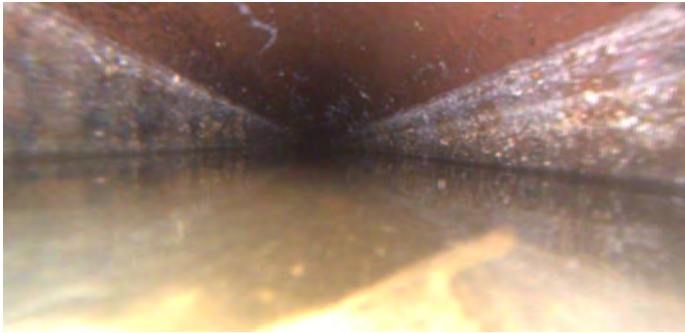
Code: **MWLS**  
Description: **Water Level Sag**

Distance (ft): **102.0**  
Structural Grade: **2**  
O&M Grade: **3**  
Clock Start/From:  
Clock To:  
1st Value:  
2nd Value:  
Value Percent: **10.000**  
Continuous Index:  
Within 8" of Joint: **NO**  
Remarks:

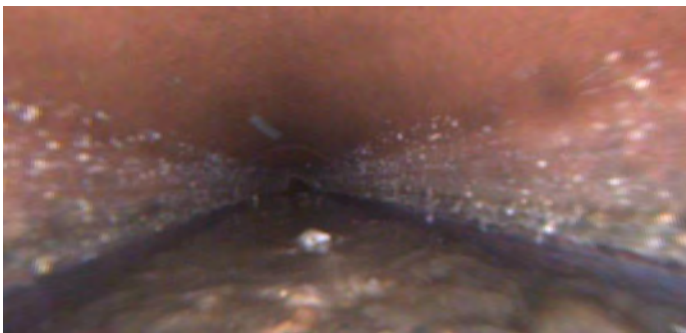
Code: **MGO**  
Description: **General Observation**

Distance (ft): **115.0**  
Structural Grade: **0**  
O&M Grade: **0**  
Clock Start/From:  
Clock To:  
1st Value:  
2nd Value:  
Value Percent:  
Continuous Index:  
Within 8" of Joint: **NO**  
Remarks: **rear camera/mcu**

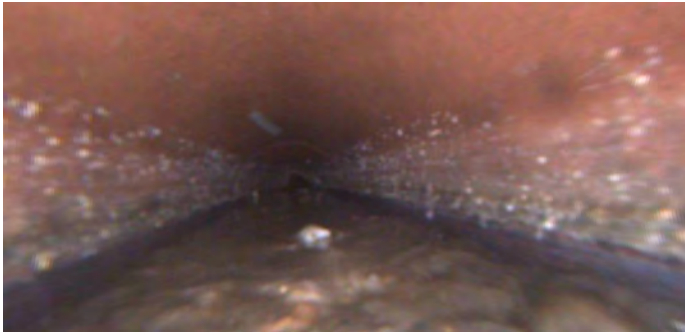
Code: **MCU**  
Description: **Camera Underwater**

Distance (ft): **115.0**  
Structural Grade: **0**  
O&M Grade: **4**  
Clock Start/From:  
Clock To:  
1st Value:  
2nd Value:  
Value Percent:  
Continuous Index: **F02**  
Within 8" of Joint: **NO**  
Remarks:
