Profile/Photo Observation Report

| Street: | FOXCROFT STREET | Flow Control: | Not Controlled |

| US MH: | M-108-015 | DS MH: | M-108-008 |

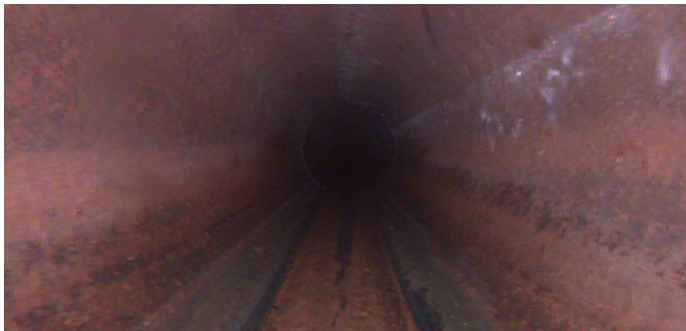
Code: **AMH**
Description: **Manhole**

Distance (ft): **.0**
Structural Grade: **0**
O&M Grade: **0**
Clock Start/From:
Clock To:
1st Value:
2nd Value:
Value Percent:
Continuous Index:
Within 8" of Joint: **NO**
Remarks: **M-108-008**

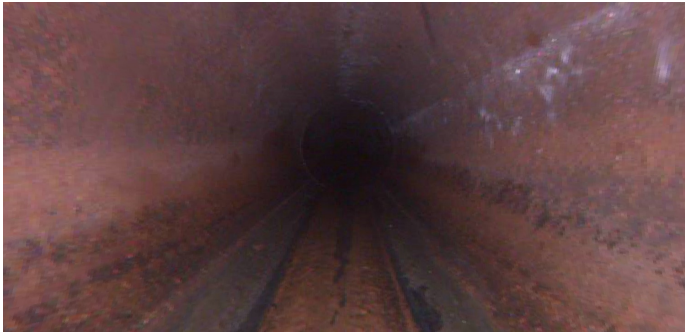
| Code: | MWL |
| Description: | Water Level |

| Value Percent: | 5.000 |

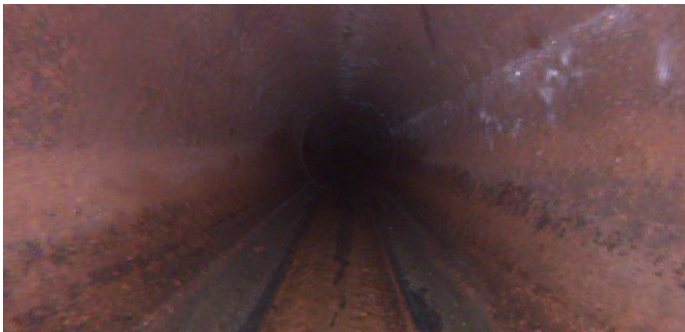
| Code: | DAGS |
| Description: | Deposits Attached Grease |

| O&M Grade: | 2 |
| Clock Start/From: | 7 |
| Clock To: | 5 |
| Value Percent: | 5.000 |
| Remarks: | WANDER |

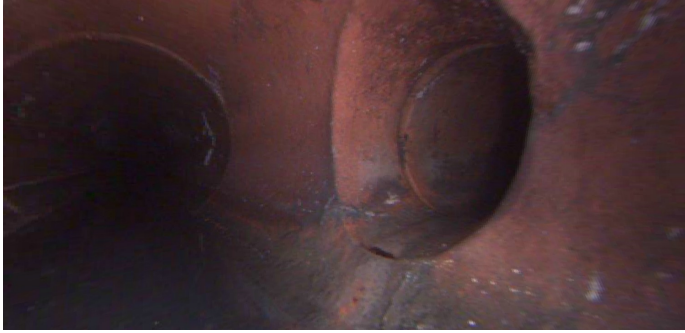
Code: **TF**
Description: **Tap Factory**

Distance (ft): **51.7**
Structural Grade: **0**
O&M Grade: **0**
Clock Start/From: **3**
Clock To:
1st Value: **4.000**
2nd Value:
Value Percent:
Continuous Index:
Within 8" of Joint:
Remarks:

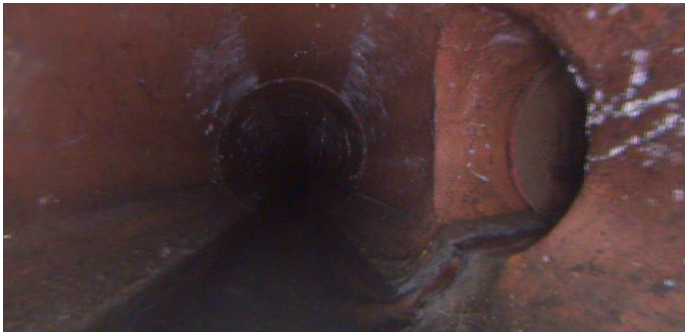
Code: **TF**
Description: **Tap Factory**

Distance (ft): **107.4**
Structural Grade: **0**
O&M Grade: **0**
Clock Start/From: **3**
Clock To:
1st Value: **4.000**
2nd Value:
Value Percent:
Continuous Index:
Within 8" of Joint:
Remarks:

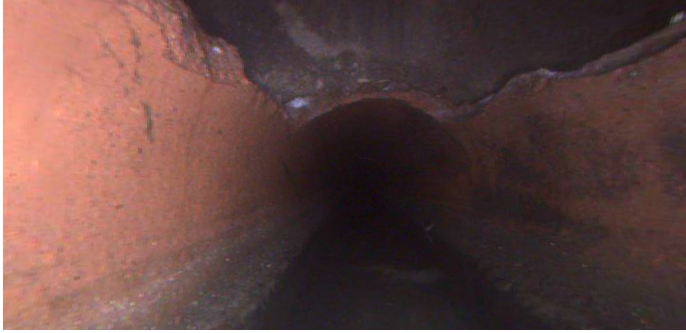
Code: **AMH**
Description: **Manhole**

Distance (ft): **146.2**
Structural Grade: **0**
O&M Grade: **0**
Clock Start/From:
Clock To:
1st Value:
2nd Value:
Value Percent:
Continuous Index:
Within 8" of Joint: **NO**
Remarks: **M-108-015**

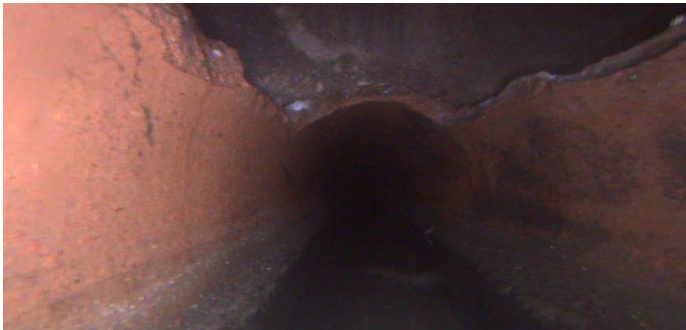
Code: **DAGS**
Description: **Deposits Attached Grease**

Distance (ft): **146.2**
Structural Grade: **0**
O&M Grade: **2**
Clock Start/From: **7**
Clock To: **5**
1st Value:
2nd Value:
Value Percent: **5.000**
Continuous Index: **F01**
Within 8" of Joint: **YES**
Remarks: **WANDER**
