Profile/Photo Observation Report

Date:	03/24/2018	Weather:		Coding:	PACP 6.0
Pipe Length (ft):	153.3	Owner:	NA	Pre Clean:	No Pre-Cleaning
P.O.#:		Surveyor:	Justin Gonzales	PSR:	P-108-015-016
Customer:		Clean Date:	01/01/1900	Shape:	C

Street:	14TH LN	Flow Control:	Not Controlled
City:	Hobart, IN	Year Renewed:	
Location:	Light Highway	Tape/Media #:	
Purpose:	Routine Assessment	Dia/Height:	12"
Use:	Sanitary	Material:	VCP
Drain Area:	NA	Lining:	
Category:	NA		
Comment:	R_M at 134 ft debris . Flow direction		
Location Details:		Direction of Survey:	Downstream
US MH:	M-108-016	DS MH:	M-108-015
		Total Length Surveyed (ft):	135.9

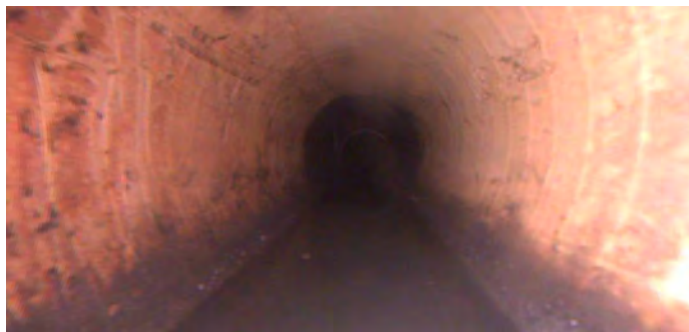
Code: **AMH**
Description: **Manhole**

Distance (ft): **.0**
Structural Grade: **0**
O&M Grade: **0**
Clock Start/From:
Clock To:
1st Value:
2nd Value:
Value Percent:
Continuous Index:
Within 8" of Joint: **NO**
Remarks: **M-108-016**

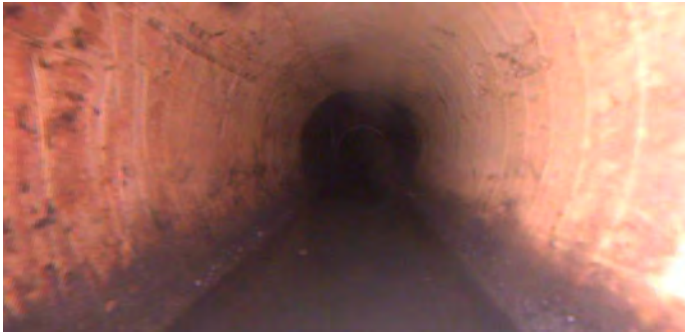
Code:	MWL
Description:	Water Level

Distance (ft):	.0
Structural Grade:	0
O&M Grade:	0
Clock Start/From:	
Clock To:	
1st Value:	
2nd Value:	
Value Percent:	5.000
Continuous Index:	
Within 8" of Joint:	NO
Remarks:

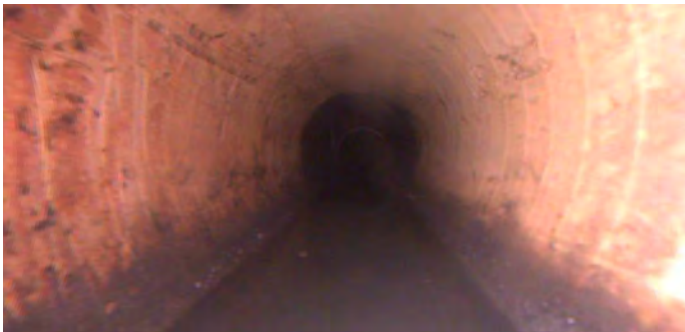
Code:	RPR
Description:	Repair Point Pipe Replaced

Distance (ft):	.0
Structural Grade:	0
O&M Grade:	0
Clock Start/From:	
Clock To:	
1st Value:	
2nd Value:	
Value Percent:	
Continuous Index:	
Within 8" of Joint:	
Remarks:	CIP LINER

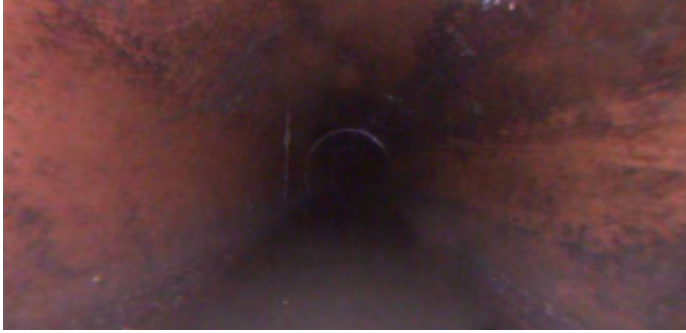
Code: **RPR**
Description: **Repair Point Pipe Replaced**

Distance (ft): **3.0**
Structural Grade: **0**
O&M Grade: **0**
Clock Start/From:
Clock To:
1st Value:
2nd Value:
Value Percent:
Continuous Index:
Within 8" of Joint: **NO**
Remarks: **CIP LINER END**

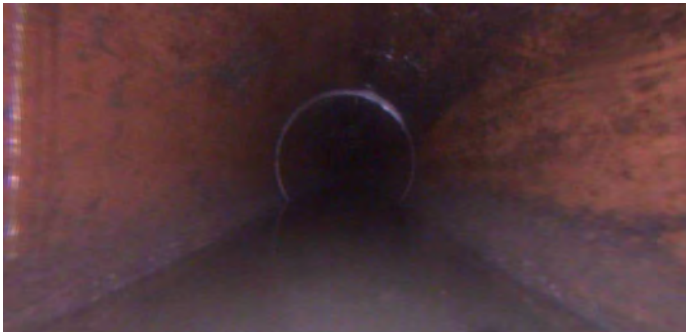
Code: **DAGS**
Description: **Deposits Attached Grease**

Distance (ft): **4.1**
Structural Grade: **0**
O&M Grade: **2**
Clock Start/From: **7**
Clock To: **5**
1st Value:
2nd Value:
Value Percent: **5.000**
Continuous Index: **S01**
Within 8" of Joint: **YES**
Remarks: **WANDER**

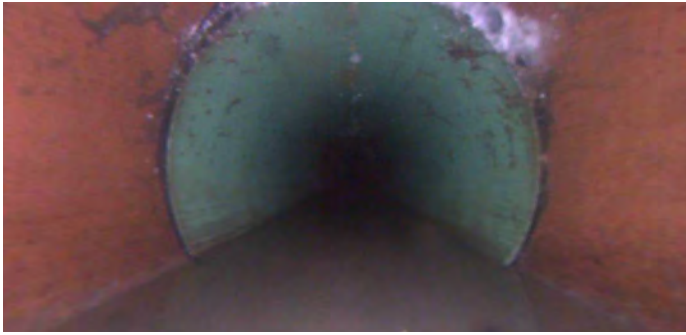
Code: **RPR**
Description: **Repair Point Pipe Replaced**

Distance (ft): **37.4**
Structural Grade: **0**
O&M Grade: **0**
Clock Start/From:
Clock To:
1st Value:
2nd Value:
Value Percent:
Continuous Index:
Within 8" of Joint: **NO**
Remarks: **PVC**

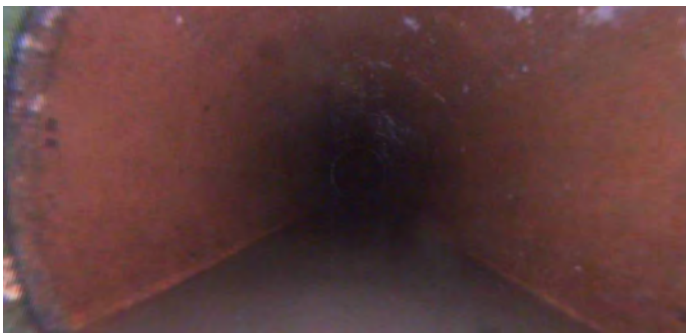
Code: **RPR**
Description: **Repair Point Pipe Replaced**

Distance (ft): **40.7**
Structural Grade: **0**
O&M Grade: **0**
Clock Start/From:
Clock To:
1st Value:
2nd Value:
Value Percent:
Continuous Index:
Within 8" of Joint: **NO**
Remarks: **PVC END**

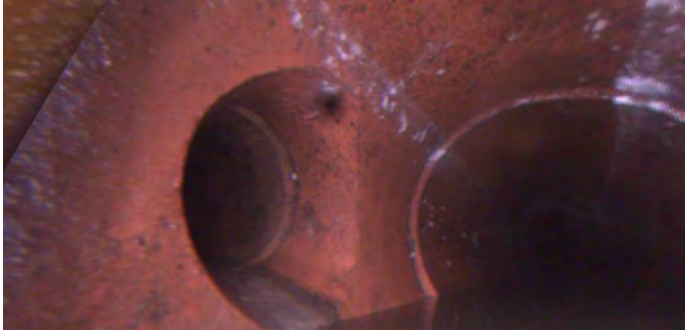
Code: **TF**
Description: **Tap Factory**

Distance (ft): **110.3**
Structural Grade: **0**
O&M Grade: **0**
Clock Start/From: **9**
Clock To:
1st Value: **4.000**
2nd Value:
Value Percent:
Continuous Index:
Within 8" of Joint:
Remarks:

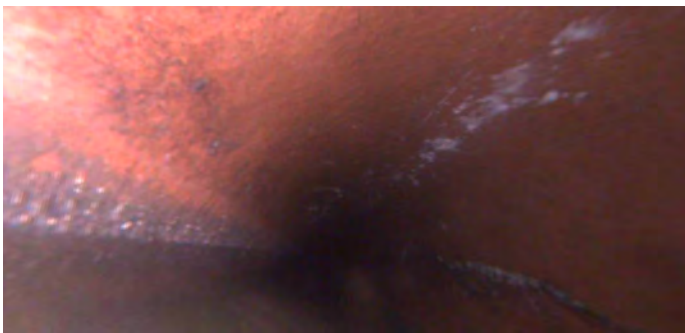
Code: **MSA**
Description: **Abandoned Survey**

Distance (ft): **135.9**
Structural Grade: **0**
O&M Grade: **0**
Clock Start/From:
Clock To:
1st Value:
2nd Value:
Value Percent:
Continuous Index:
Within 8" of Joint: **NO**
Remarks: **ROBOT HAS TURNED OVER**

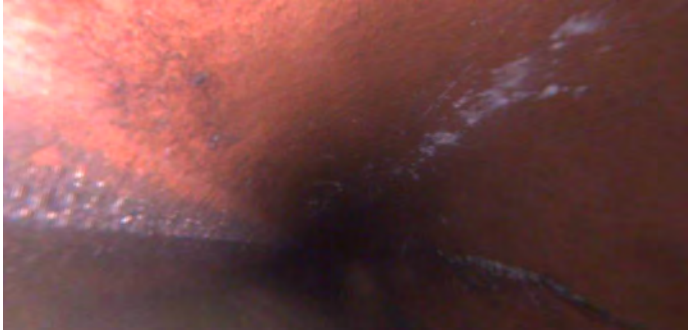
Code:	DAGS
Description:	Deposits Attached Grease
Distance (ft):	135.9
Structural Grade:	0
O&M Grade:	2
Clock Start/From:	7
Clock To:	5
1st Value:	
2nd Value:	
Value Percent:	5.000
Continuous Index:	F01
Within 8" of Joint:	YES
Remarks:	WANDER
