## Profile/Photo Observation Report

Date:	<b>03/24/2018</b>	Weather:		Coding:	<b>PACP 6.0</b>
Pipe Length (ft):	<b>153.3</b>	Owner:	<b>NA</b>	Pre Clean:	<b>No Pre-Cleaning</b>
P.O.#:		Surveyor:	<b>Justin Gonzales</b>	PSR:	<b>P-108-015-016</b>
Customer:		Clean Date:	<b>01/01/1900</b>	Shape:	<b>C</b>

Street:	<b>FOXCROFT STREET</b>	Flow Control:	<b>Not Controlled</b>
City:	<b>Hobart, IN</b>	Year Renewed:	
Location:	<b>Light Highway</b>	Tape/Media #:	
Purpose:	<b>Routine Assessment</b>	Dia/Height:	<b>12"</b>
Use:	<b>Sanitary</b>	Material:	<b>VCP</b>
Drain Area:	<b>NA</b>	Lining:	
Category:	<b>NA</b>		
Comment:	<b>R_M at 134 ft debris . Flow direction</b>		
Location Details:		Direction of Survey:	<b>Downstream</b>
US MH:	<b>M-108-016</b>	DS MH:	<b>M-108-015</b>
		Total Length Surveyed (ft):	<b>135.9</b>

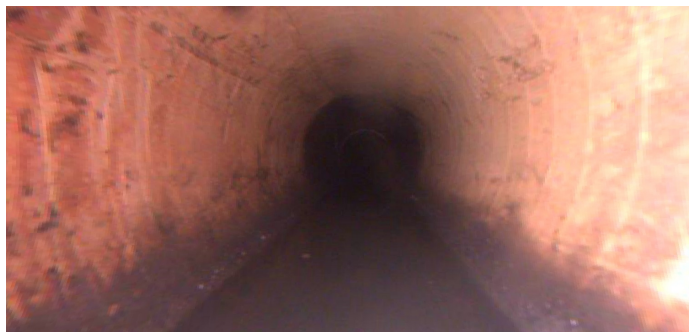
Code: **AMH**  
 Description: **Manhole**  
 Distance (ft): **.0**  
 Structural Grade: **0**  
 O&M Grade: **0**  
 Clock Start/From:  
 Clock To:  
 1st Value:  
 2nd Value:  
 Value Percent:  
 Continuous Index:  
 Within 8" of Joint: **NO**  
 Remarks: **M-108-016**

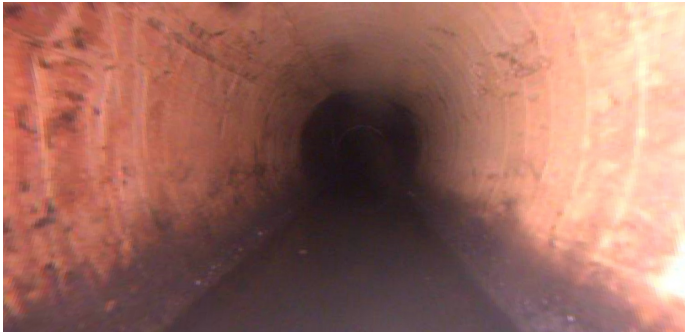
Code:	<b>MWL</b>
Description:	<b>Water Level</b>

Distance (ft):	<b>.0</b>
Structural Grade:	<b>0</b>
O&M Grade:	<b>0</b>
Clock Start/From:	
Clock To:	
1st Value:	
2nd Value:	
Value Percent:	<b>5.000</b>
Continuous Index:	
Within 8" of Joint:	<b>NO</b>
Remarks:

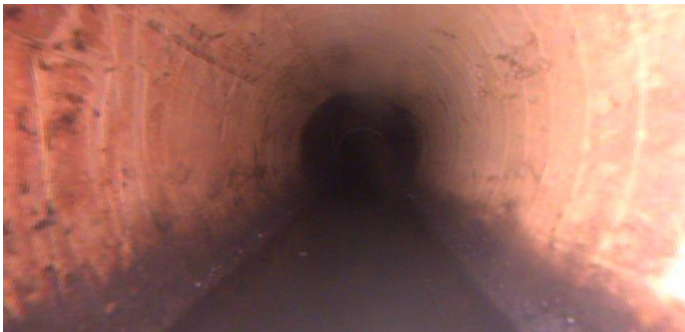
Code:	<b>RPR</b>
Description:	<b>Repair Point Pipe Replaced</b>

Distance (ft):	<b>.0</b>
Structural Grade:	<b>0</b>
O&M Grade:	<b>0</b>
Clock Start/From:	
Clock To:	
1st Value:	
2nd Value:	
Value Percent:	
Continuous Index:	
Within 8" of Joint:	
Remarks:	<b>CIP LINER</b>

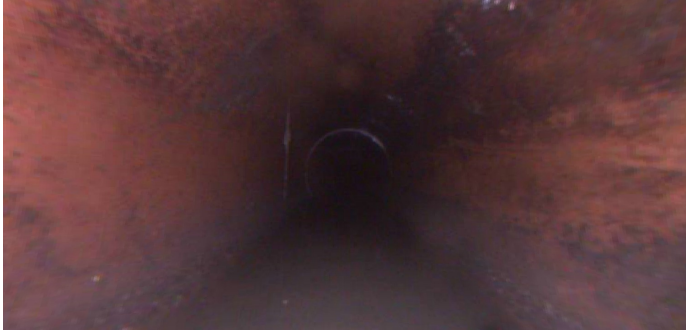
Code: **RPR**  
Description: **Repair Point Pipe Replaced**

Distance (ft): **3.0**  
Structural Grade: **0**  
O&M Grade: **0**  
Clock Start/From:  
Clock To:  
1st Value:  
2nd Value:  
Value Percent:  
Continuous Index:  
Within 8" of Joint: **NO**  
Remarks: **CIP LINER END**

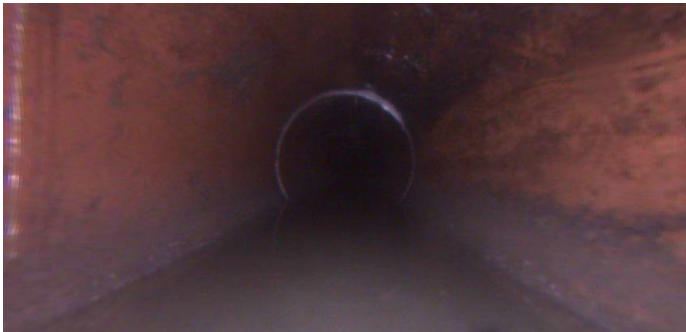
Code: **DAGS**  
Description: **Deposits Attached Grease**

Distance (ft): **4.1**  
Structural Grade: **0**  
O&M Grade: **2**  
Clock Start/From: **7**  
Clock To: **5**  
1st Value:  
2nd Value:  
Value Percent: **5.000**  
Continuous Index: **S01**  
Within 8" of Joint: **YES**  
Remarks: **WANDER**

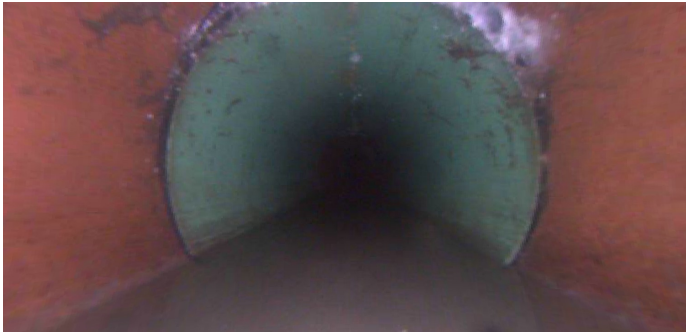
Code: **RPR**  
Description: **Repair Point Pipe Replaced**

Distance (ft): **37.4**  
Structural Grade: **0**  
O&M Grade: **0**  
Clock Start/From:  
Clock To:  
1st Value:  
2nd Value:  
Value Percent:  
Continuous Index:  
Within 8" of Joint: **NO**  
Remarks: **PVC**

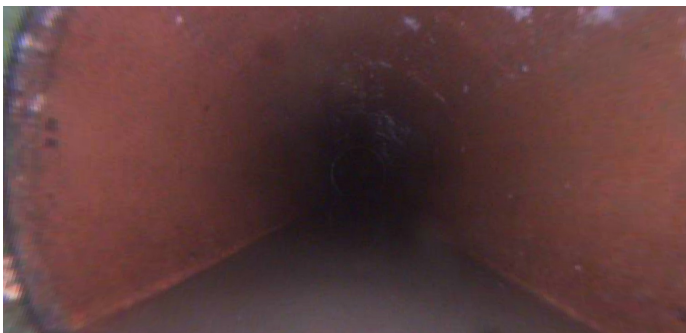
Code: **RPR**  
Description: **Repair Point Pipe Replaced**

Distance (ft): **40.7**  
Structural Grade: **0**  
O&M Grade: **0**  
Clock Start/From:  
Clock To:  
1st Value:  
2nd Value:  
Value Percent:  
Continuous Index:  
Within 8" of Joint: **NO**  
Remarks: **PVC END**

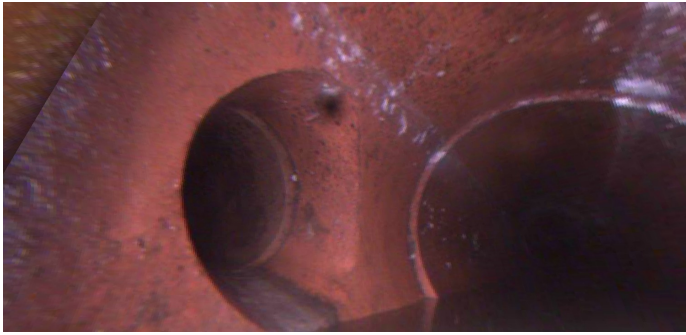
Code: **TF**  
Description: **Tap Factory**

Distance (ft): **110.3**  
Structural Grade: **0**  
O&M Grade: **0**  
Clock Start/From: **9**  
Clock To:  
1st Value: **4.000**  
2nd Value:  
Value Percent:  
Continuous Index:  
Within 8" of Joint:  
Remarks:

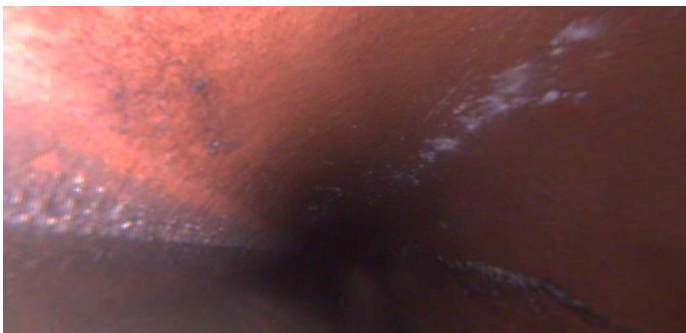
Code: **MSA**  
Description: **Abandoned Survey**

Distance (ft): **135.9**  
Structural Grade: **0**  
O&M Grade: **0**  
Clock Start/From:  
Clock To:  
1st Value:  
2nd Value:  
Value Percent:  
Continuous Index:  
Within 8" of Joint: **NO**  
Remarks: **ROBOT HAS TURNED OVER**

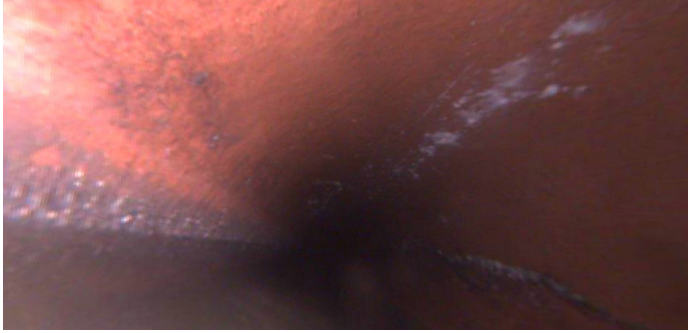
Code:	<b>DAGS</b>
Description:	<b>Deposits Attached Grease</b>
Distance (ft):	<b>135.9</b>
Structural Grade:	<b>0</b>
O&M Grade:	<b>2</b>
Clock Start/From:	<b>7</b>
Clock To:	<b>5</b>
1st Value:	
2nd Value:	
Value Percent:	<b>5.000</b>
Continuous Index:	<b>F01</b>
Within 8" of Joint:	<b>YES</b>
Remarks:	<b>WANDER</b>
