## Profile/Photo Observation Report

Street:	<b>14TH LN</b>	Flow Control:	<b>Not Controlled</b>
City:	<b>Hobart, IN</b>	Year Renewed:	
Location:	<b>Light Highway</b>	Tape/Media #:	
Purpose:	<b>Routine Assessment</b>	Dia/Height:	<b>12"</b>
Use:	<b>Sanitary</b>	Material:	<b>VCP</b>
Drain Area:	<b>NA</b>	Lining:	
Category:	<b>NA</b>		
Comment:	<b>Flow direction wrong</b>

Location Details:		Direction of Survey:	<b>Upstream</b>
US MH:	<b>M-108-016</b>	DS MH:	<b>M-108-015</b>
		Total Length Surveyed (ft):	<b>147.6</b>

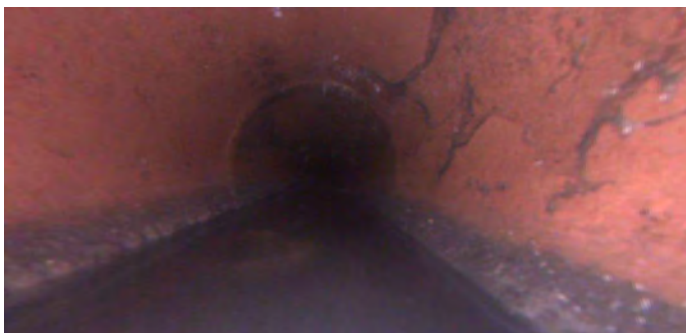
Code: **AMH**  
Description: **Manhole**

Distance (ft): **.0**  
Structural Grade: **0**  
O&M Grade: **0**  
Clock Start/From:  
Clock To:  
1st Value:  
2nd Value:  
Value Percent:  
Continuous Index:  
Within 8" of Joint: **NO**  
Remarks: **M-108-015**

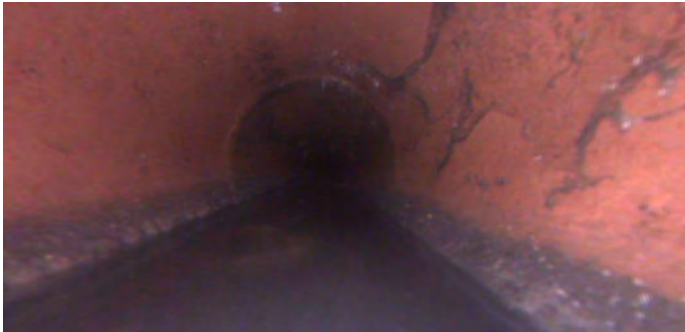
Code:	<b>MWL</b>
Description:	<b>Water Level</b>

Distance (ft):	<b>.0</b>
Structural Grade:	<b>0</b>
O&M Grade:	<b>0</b>
Clock Start/From:	
Clock To:	
1st Value:	
2nd Value:	
Value Percent:	<b>10.000</b>
Continuous Index:	
Within 8" of Joint:	<b>NO</b>
Remarks:

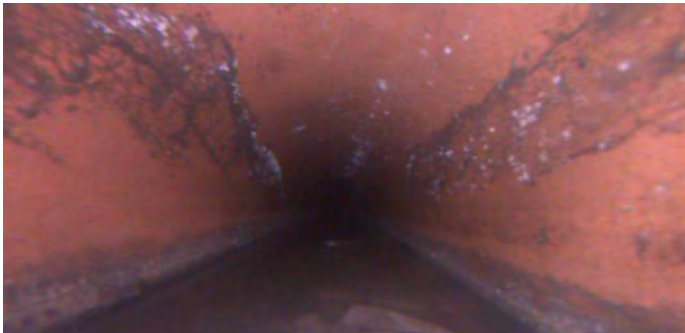
Code:	<b>DAZ</b>
Description:	<b>Deposits Attached Other</b>

Distance (ft):	<b>5.1</b>
Structural Grade:	<b>0</b>
O&M Grade:	<b>2</b>
Clock Start/From:	<b>7</b>
Clock To:	<b>5</b>
1st Value:	
2nd Value:	
Value Percent:	<b>5.000</b>
Continuous Index:	<b>S01</b>
Within 8" of Joint:	<b>YES</b>
Remarks:	<b>WANDER</b>

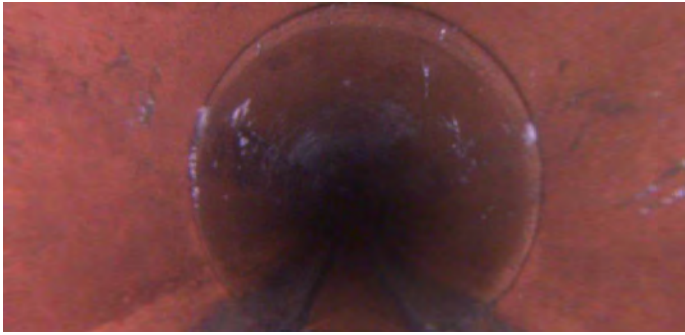
Code: **DAGS**  
Description: **Deposits Attached Grease**

Distance (ft): **25.3**  
Structural Grade: **0**  
O&M Grade: **2**  
Clock Start/From: **7**  
Clock To: **5**  
1st Value:  
2nd Value:  
Value Percent: **5.000**  
Continuous Index: **S02**  
Within 8" of Joint: **YES**  
Remarks: **WANDER**

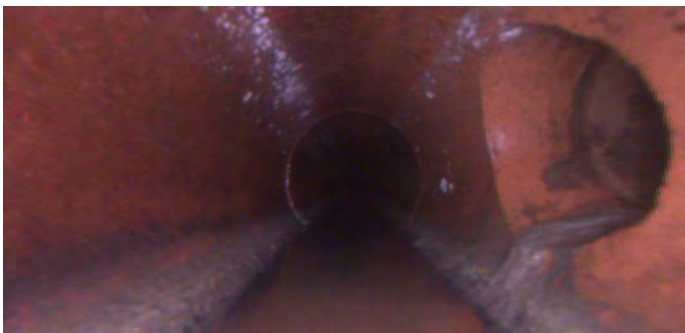
Code: **TF**  
Description: **Tap Factory**

Distance (ft): **31.9**  
Structural Grade: **0**  
O&M Grade: **0**  
Clock Start/From: **3**  
Clock To:  
1st Value: **4.000**  
2nd Value:  
Value Percent:  
Continuous Index:  
Within 8" of Joint:  
Remarks:

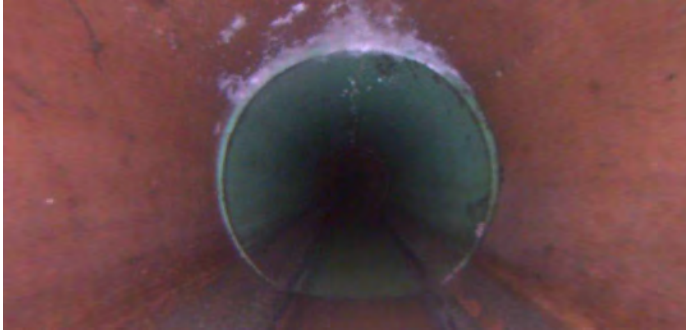
Code: **RPR**  
Description: **Repair Point Pipe Replaced**

Distance (ft): **102.1**  
Structural Grade: **0**  
O&M Grade: **0**  
Clock Start/From:  
Clock To:  
1st Value:  
2nd Value:  
Value Percent:  
Continuous Index:  
Within 8" of Joint: **NO**  
Remarks: **PVC**

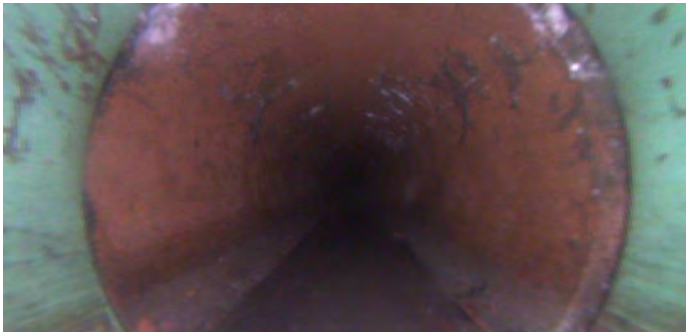
Code: **RPR**  
Description: **Repair Point Pipe Replaced**

Distance (ft): **105.5**  
Structural Grade: **0**  
O&M Grade: **0**  
Clock Start/From:  
Clock To:  
1st Value:  
2nd Value:  
Value Percent:  
Continuous Index:  
Within 8" of Joint: **NO**  
Remarks: **PVC END**

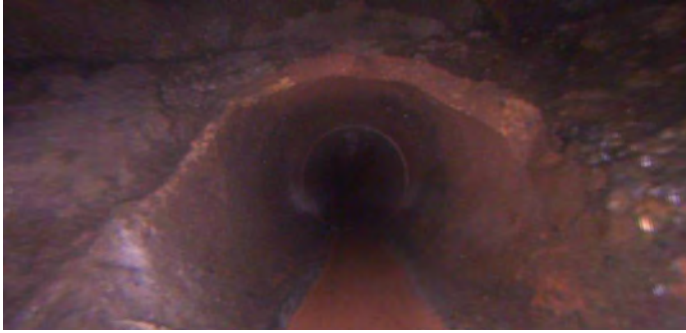
Code: **AMH**  
Description: **Manhole**

Distance (ft): **147.6**  
Structural Grade: **0**  
O&M Grade: **0**  
Clock Start/From:  
Clock To:  
1st Value:  
2nd Value:  
Value Percent:  
Continuous Index:  
Within 8" of Joint: **NO**  
Remarks: **M-108-016**

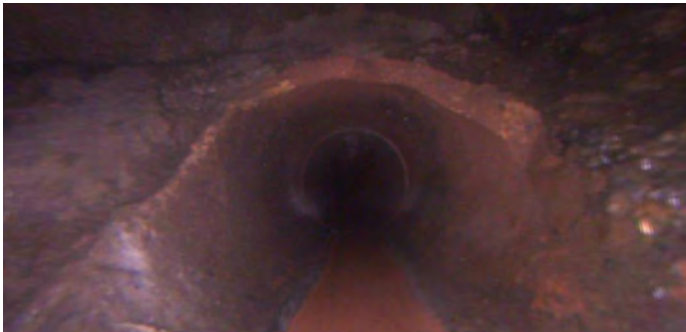
Code: **DAZ**  
Description: **Deposits Attached Other**

Distance (ft): **147.6**  
Structural Grade: **0**  
O&M Grade: **2**  
Clock Start/From: **7**  
Clock To: **5**  
1st Value:  
2nd Value:  
Value Percent: **5.000**  
Continuous Index: **F01**  
Within 8" of Joint: **YES**  
Remarks: **WANDER**

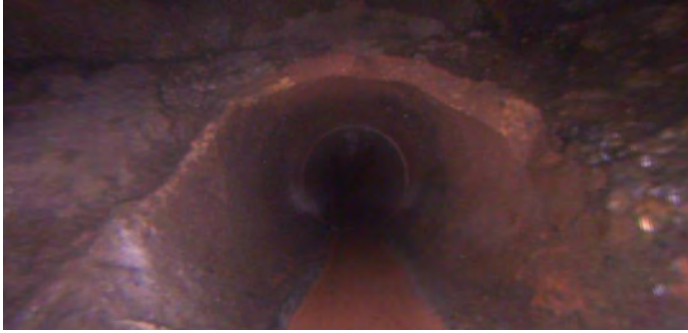
Code:	<b>DAGS</b>
Description:	<b>Deposits Attached Grease</b>
Distance (ft):	<b>147.6</b>
Structural Grade:	<b>0</b>
O&M Grade:	<b>2</b>
Clock Start/From:	<b>7</b>
Clock To:	<b>5</b>
1st Value:	
2nd Value:	
Value Percent:	<b>5.000</b>
Continuous Index:	<b>F02</b>
Within 8" of Joint:	<b>YES</b>
Remarks:	<b>WANDER</b>
