## Profile/Photo Observation Report

Date:	<b>03/24/2018</b>	Weather:		Coding:	<b>PACP 6.0</b>
Pipe Length (ft):	<b>153.3</b>	Owner:	<b>NA</b>	Pre Clean:	<b>No Pre-Cleaning</b>
P.O.#:		Surveyor:	<b>Justin Gonzales</b>	PSR:	<b>P-108-015-016</b>
Customer:		Clean Date:	<b>01/01/1900</b>	Shape:	<b>C</b>

Street:	<b>FOXCROFT STREET</b>	Flow Control:	<b>Not Controlled</b>
City:	<b>Hobart, IN</b>	Year Renewed:	
Location:	<b>Light Highway</b>	Tape/Media #:	
Purpose:	<b>Routine Assessment</b>	Dia/Height:	<b>12"</b>
Use:	<b>Sanitary</b>	Material:	<b>VCP</b>
Drain Area:	<b>NA</b>	Lining:	
Category:	<b>NA</b>		
Comment:	<b>Flow direction wrong</b>

Location Details:		Direction of Survey:	<b>Upstream</b>
US MH:	<b>M-108-016</b>	DS MH:	<b>M-108-015</b>
		Total Length Surveyed (ft):	<b>147.6</b>

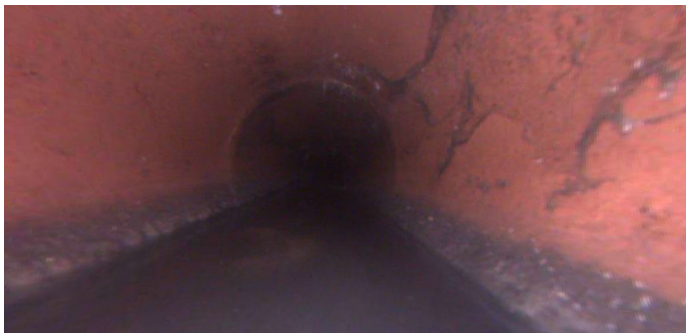
Code: **AMH**  
Description: **Manhole**

Distance (ft): **.0**  
Structural Grade: **0**  
O&M Grade: **0**  
Clock Start/From:  
Clock To:  
1st Value:  
2nd Value:  
Value Percent:  
Continuous Index:  
Within 8" of Joint: **NO**  
Remarks: **M-108-015**

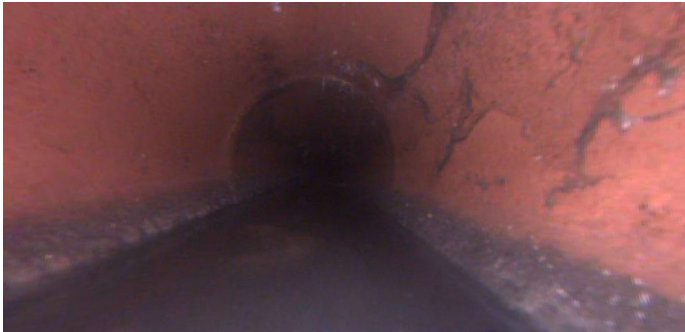
Code:	<b>MWL</b>
Description:	<b>Water Level</b>

Distance (ft):	<b>.0</b>
Structural Grade:	<b>0</b>
O&M Grade:	<b>0</b>
Clock Start/From:	
Clock To:	
1st Value:	
2nd Value:	
Value Percent:	<b>10.000</b>
Continuous Index:	
Within 8" of Joint:	<b>NO</b>
Remarks:

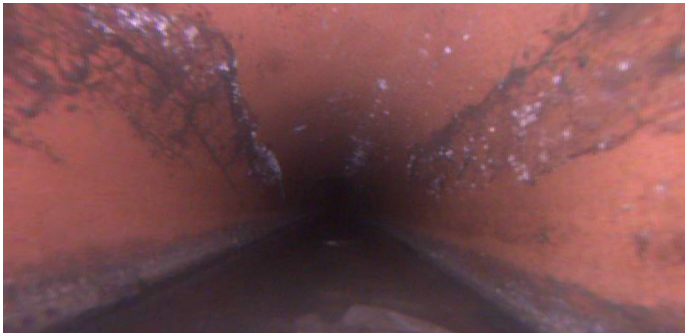
Code:	<b>DAZ</b>
Description:	<b>Deposits Attached Other</b>

Distance (ft):	<b>5.1</b>
Structural Grade:	<b>0</b>
O&M Grade:	<b>2</b>
Clock Start/From:	<b>7</b>
Clock To:	<b>5</b>
1st Value:	
2nd Value:	
Value Percent:	<b>5.000</b>
Continuous Index:	<b>S01</b>
Within 8" of Joint:	<b>YES</b>
Remarks:	<b>WANDER</b>

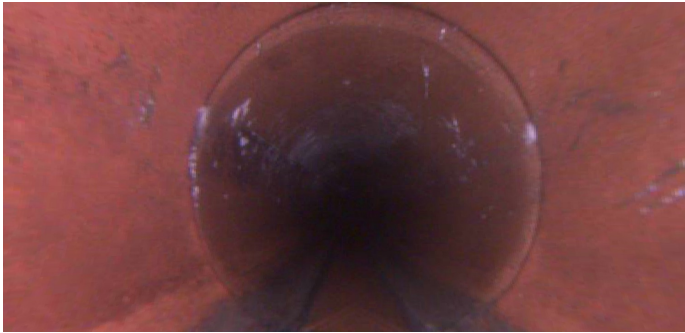
Code: **DAGS**  
Description: **Deposits Attached Grease**

Distance (ft): **25.3**  
Structural Grade: **0**  
O&M Grade: **2**  
Clock Start/From: **7**  
Clock To: **5**  
1st Value:  
2nd Value:  
Value Percent: **5.000**  
Continuous Index: **S02**  
Within 8" of Joint: **YES**  
Remarks: **WANDER**

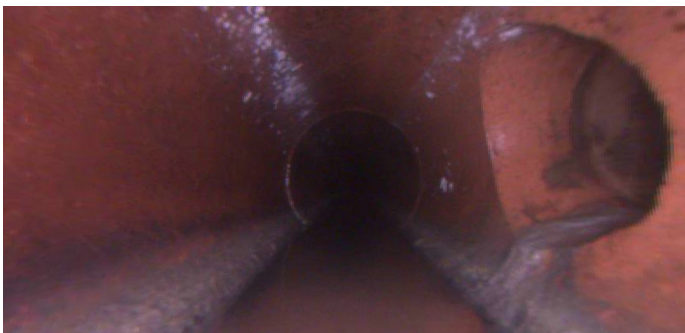
Code: **TF**  
Description: **Tap Factory**

Distance (ft): **31.9**  
Structural Grade: **0**  
O&M Grade: **0**  
Clock Start/From: **3**  
Clock To:  
1st Value: **4.000**  
2nd Value:  
Value Percent:  
Continuous Index:  
Within 8" of Joint:  
Remarks:

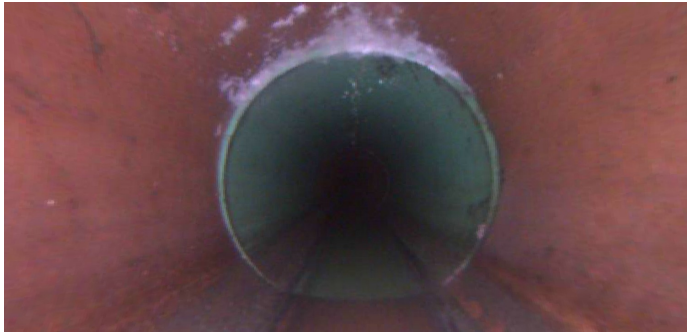
Code: **RPR**  
Description: **Repair Point Pipe Replaced**

Distance (ft): **102.1**  
Structural Grade: **0**  
O&M Grade: **0**  
Clock Start/From:  
Clock To:  
1st Value:  
2nd Value:  
Value Percent:  
Continuous Index:  
Within 8" of Joint: **NO**  
Remarks: **PVC**

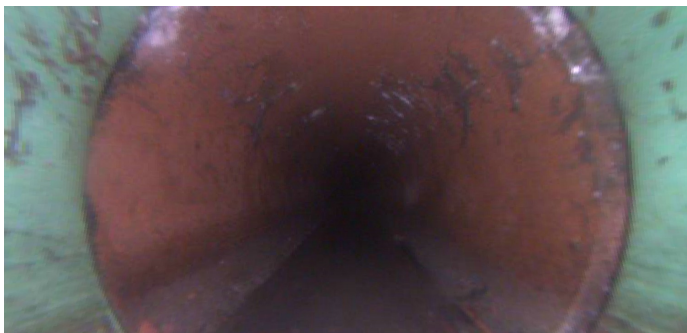
Code: **RPR**  
Description: **Repair Point Pipe Replaced**

Distance (ft): **105.5**  
Structural Grade: **0**  
O&M Grade: **0**  
Clock Start/From:  
Clock To:  
1st Value:  
2nd Value:  
Value Percent:  
Continuous Index:  
Within 8" of Joint: **NO**  
Remarks: **PVC END**

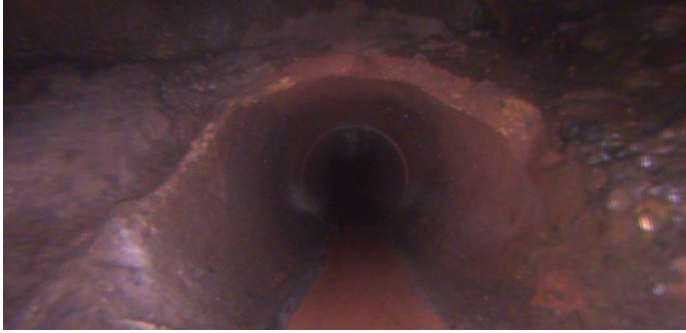
Code: **AMH**  
Description: **Manhole**

Distance (ft): **147.6**  
Structural Grade: **0**  
O&M Grade: **0**  
Clock Start/From:  
Clock To:  
1st Value:  
2nd Value:  
Value Percent:  
Continuous Index:  
Within 8" of Joint: **NO**  
Remarks: **M-108-016**

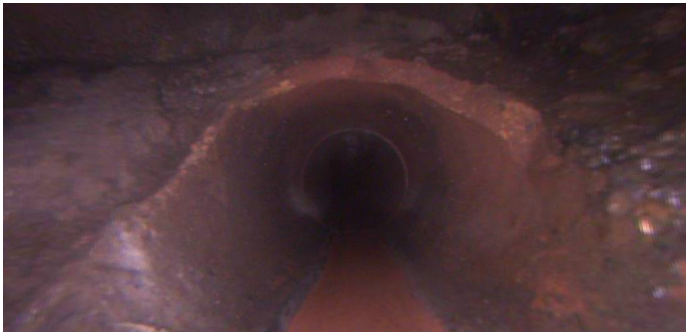
Code: **DAZ**  
Description: **Deposits Attached Other**

Distance (ft): **147.6**  
Structural Grade: **0**  
O&M Grade: **2**  
Clock Start/From: **7**  
Clock To: **5**  
1st Value:  
2nd Value:  
Value Percent: **5.000**  
Continuous Index: **F01**  
Within 8" of Joint: **YES**  
Remarks: **WANDER**

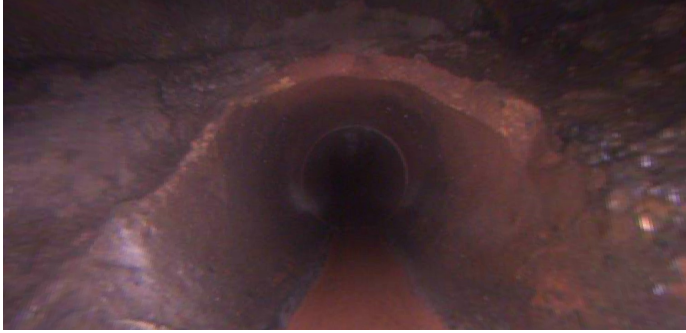
Code:	<b>DAGS</b>
Description:	<b>Deposits Attached Grease</b>
Distance (ft):	<b>147.6</b>
Structural Grade:	<b>0</b>
O&M Grade:	<b>2</b>
Clock Start/From:	<b>7</b>
Clock To:	<b>5</b>
1st Value:	
2nd Value:	
Value Percent:	<b>5.000</b>
Continuous Index:	<b>F02</b>
Within 8" of Joint:	<b>YES</b>
Remarks:	<b>WANDER</b>
