Profile/Photo Observation Report

Street:	FOXCROFT STREET	Flow Control:	Not Controlled
City:	Hobart, IN	Year Renewed:	
Location:	Light Highway	Tape/Media #:	
Purpose:	Routine Assessment	Dia/Height:	8"
Use:	Sanitary	Material:	VCP
Drain Area:	NA	Lining:	
Category:	NA		
Comment:	Flow direction wrong

Location Details:		Direction of Survey:	Downstream
US MH:	M-108-016	DS MH:	M-108-018
		Total Length Surveyed (ft):	141.9

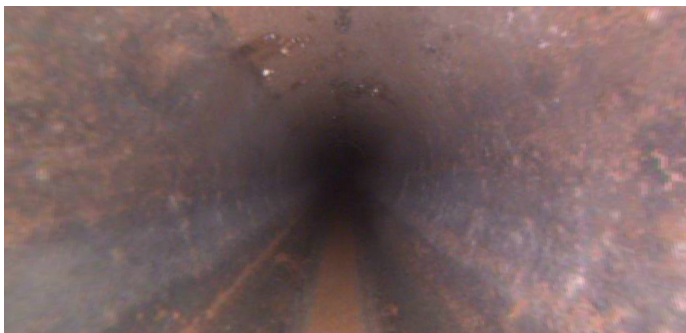
Code: **AMH**
Description: **Manhole**

Distance (ft): **.0**
Structural Grade: **0**
O&M Grade: **0**
Clock Start/From:
Clock To:
1st Value:
2nd Value:
Value Percent:
Continuous Index:
Within 8" of Joint: **NO**
Remarks: **M-108-016**

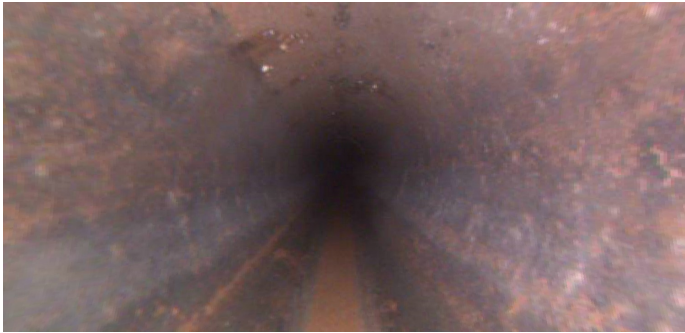
Code:	MWL
Description:	Water Level

Distance (ft):	.0
Structural Grade:	0
O&M Grade:	0
Clock Start/From:	
Clock To:	
1st Value:	
2nd Value:	
Value Percent:	5.000
Continuous Index:	
Within 8" of Joint:	NO
Remarks:

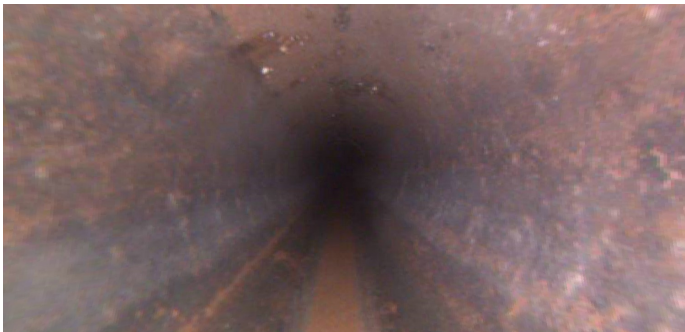
Code:	DAZ
Description:	Deposits Attached Other

Distance (ft):	.0
Structural Grade:	0
O&M Grade:	2
Clock Start/From:	7
Clock To:	5
1st Value:	
2nd Value:	
Value Percent:	5.000
Continuous Index:	S01
Within 8" of Joint:	YES
Remarks:	WANDER

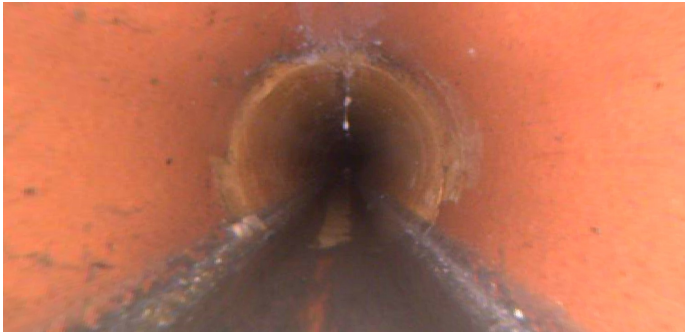
Code: **RPR**
Description: **Repair Point Pipe Replaced**

Distance (ft): **73.9**
Structural Grade: **0**
O&M Grade: **0**
Clock Start/From:
Clock To:
1st Value:
2nd Value:
Value Percent:
Continuous Index:
Within 8" of Joint: **NO**
Remarks: **CIP LINER**

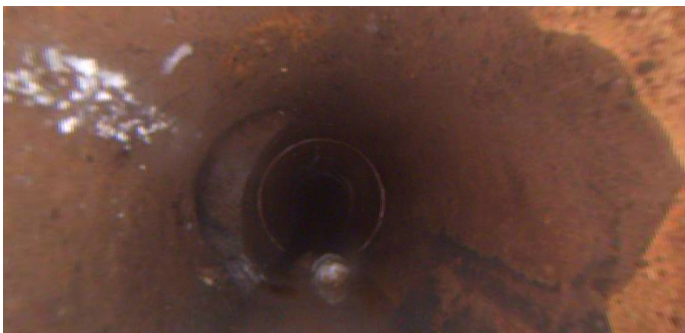
Code: **RPR**
Description: **Repair Point Pipe Replaced**

Distance (ft): **79.0**
Structural Grade: **0**
O&M Grade: **0**
Clock Start/From:
Clock To:
1st Value:
2nd Value:
Value Percent:
Continuous Index:
Within 8" of Joint: **NO**
Remarks: **CIP LINER END**

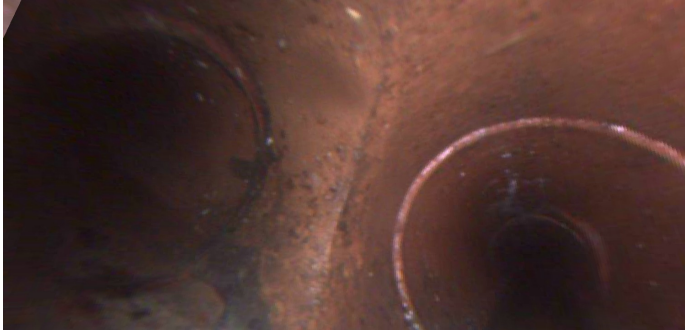
Code: **TF**
Description: **Tap Factory**

Distance (ft): **79.8**
Structural Grade: **0**
O&M Grade: **0**
Clock Start/From: **10**
Clock To:
1st Value: **4.000**
2nd Value:
Value Percent:
Continuous Index:
Within 8" of Joint:
Remarks:

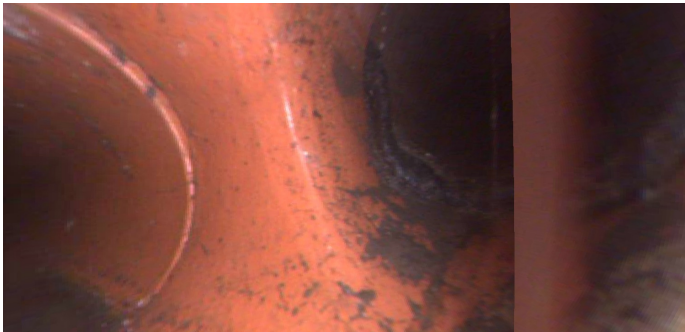
Code: **TF**
Description: **Tap Factory**

Distance (ft): **82.2**
Structural Grade: **0**
O&M Grade: **0**
Clock Start/From: **2**
Clock To:
1st Value: **4.000**
2nd Value:
Value Percent:
Continuous Index:
Within 8" of Joint:
Remarks:

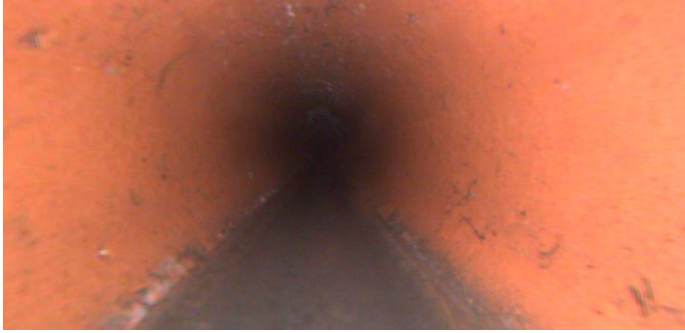
Code: **DAGS**
Description: **Deposits Attached Grease**

Distance (ft): **88.3**
Structural Grade: **0**
O&M Grade: **2**
Clock Start/From: **7**
Clock To: **5**
1st Value:
2nd Value:
Value Percent: **5.000**
Continuous Index: **S02**
Within 8" of Joint: **YES**
Remarks: **WANDER**

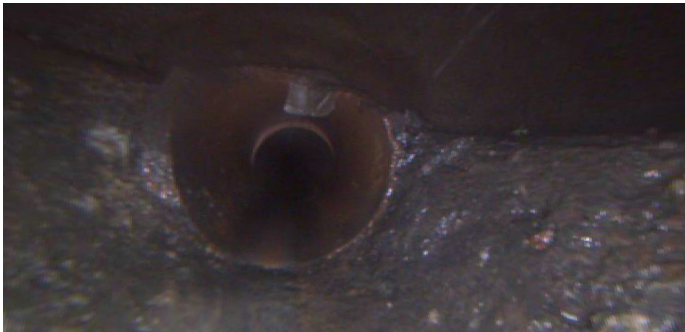
Code: **AMH**
Description: **Manhole**

Distance (ft): **141.9**
Structural Grade: **0**
O&M Grade: **0**
Clock Start/From:
Clock To:
1st Value:
2nd Value:
Value Percent:
Continuous Index:
Within 8" of Joint: **NO**
Remarks: **M-108-018**

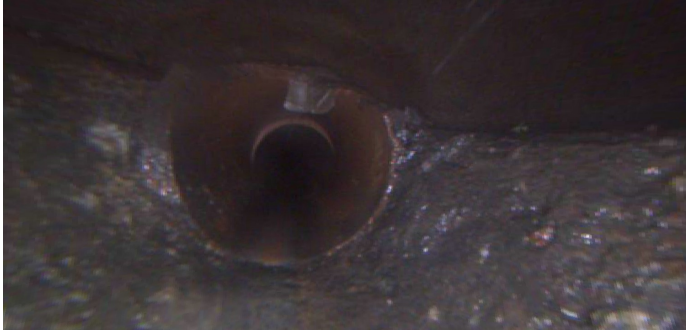
Code: **DAZ**
Description: **Deposits Attached Other**

Distance (ft): **141.9**
Structural Grade: **0**
O&M Grade: **2**
Clock Start/From: **7**
Clock To: **5**
1st Value:
2nd Value:
Value Percent: **5.000**
Continuous Index: **F01**
Within 8" of Joint: **YES**
Remarks: **WANDER**

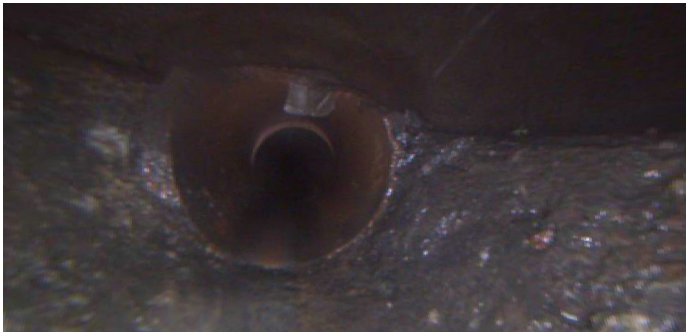
Code: **DAGS**
Description: **Deposits Attached Grease**

Distance (ft): **141.9**
Structural Grade: **0**
O&M Grade: **2**
Clock Start/From: **7**
Clock To: **5**
1st Value:
2nd Value:
Value Percent: **5.000**
Continuous Index: **F02**
Within 8" of Joint: **YES**
Remarks: **WANDER**
