Profile/Photo Observation Report

Date:	03/24/2018	Weather:		Coding:	PACP 6.0
Pipe Length (ft):	223.6	Owner:	NA	Pre Clean:	No Pre-Cleaning
P.O.#:		Surveyor:	Byrd Fitzgerald	PSR:	P-108-021-016
Customer:		Clean Date:	01/01/1900	Shape:	C

Street:	14TH LN	Flow Control:	Not Controlled
City:	Hobart, IN	Year Renewed:	
Location:	Light Highway	Tape/Media #:	
Purpose:	Routine Assessment	Dia/Height:	8"
Use:	Sanitary	Material:	VCP
Drain Area:	NA	Lining:	
Category:	NA		
Comment:	Flow direction wrong

Location Details:		Direction of Survey:	Downstream
US MH:	M-108-016	DS MH:	M-108-021
		Total Length Surveyed (ft):	231.6

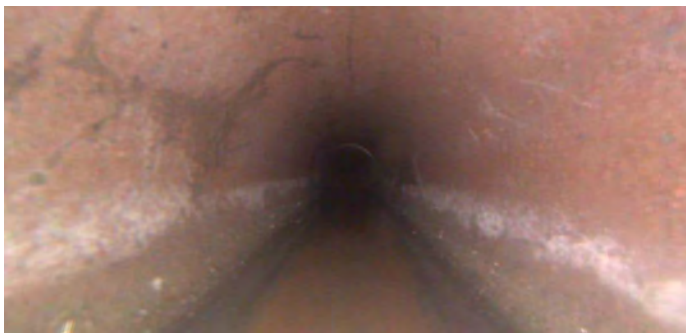
Code: **AMH**
Description: **Manhole**

Distance (ft): **.0**
Structural Grade: **0**
O&M Grade: **0**
Clock Start/From:
Clock To:
1st Value:
2nd Value:
Value Percent:
Continuous Index:
Within 8" of Joint: **NO**
Remarks: **M-108-016**

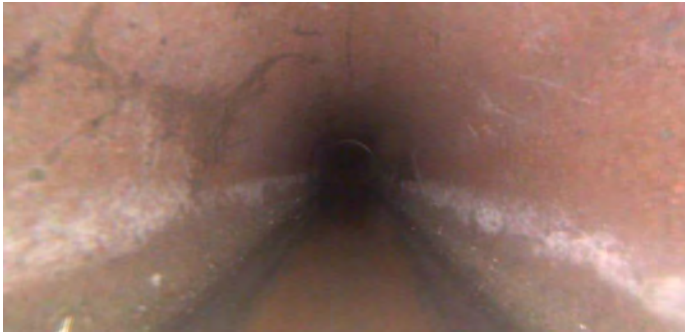
Code:	MWL
Description:	Water Level

Distance (ft):	.0
Structural Grade:	0
O&M Grade:	0
Clock Start/From:	
Clock To:	
1st Value:	
2nd Value:	
Value Percent:	5.000
Continuous Index:	
Within 8" of Joint:	NO
Remarks:

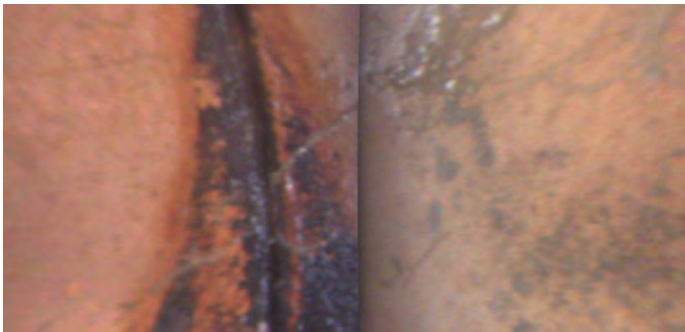
Code:	RFJ
Description:	Roots Fine Joint

Distance (ft):	4.9
Structural Grade:	0
O&M Grade:	1
Clock Start/From:	7
Clock To:	5
1st Value:	
2nd Value:	
Value Percent:	
Continuous Index:	
Within 8" of Joint:	YES
Remarks:

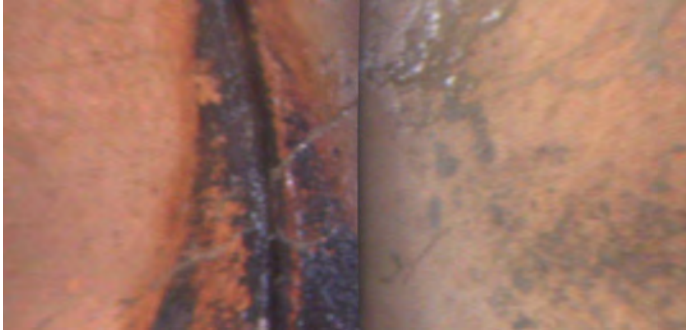
Code: **IS**
Description: **Infil Stain**

Distance (ft): **4.9**
Structural Grade: **0**
O&M Grade: **0**
Clock Start/From: **7**
Clock To: **5**
1st Value:
2nd Value:
Value Percent:
Continuous Index:
Within 8" of Joint: **YES**
Remarks:

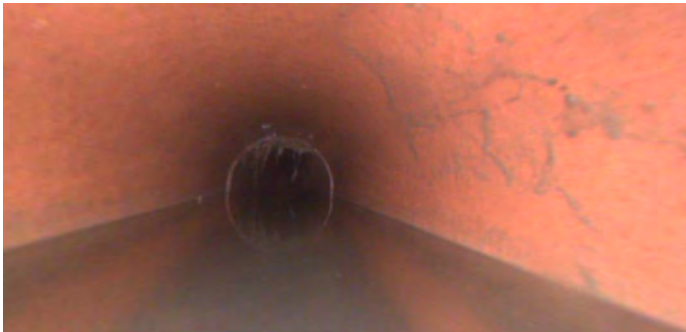
Code: **MWL**
Description: **Water Level**

Distance (ft): **28.4**
Structural Grade: **0**
O&M Grade: **0**
Clock Start/From:
Clock To:
1st Value:
2nd Value:
Value Percent: **25.000**
Continuous Index:
Within 8" of Joint: **NO**
Remarks:

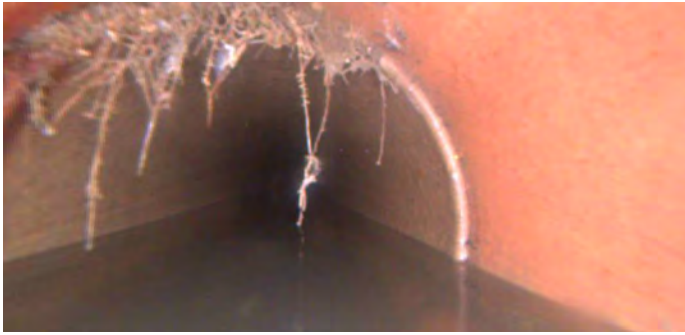
Code: **RFJ**
Description: **Roots Fine Joint**

Distance (ft): **30.0**
Structural Grade: **0**
O&M Grade: **1**
Clock Start/From: **11**
Clock To: **1**
1st Value:
2nd Value:
Value Percent:
Continuous Index: **S01**
Within 8" of Joint: **YES**
Remarks: **wandering**

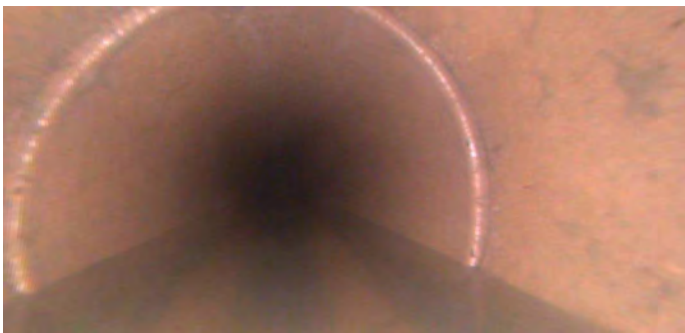
Code: **RFJ**
Description: **Roots Fine Joint**

Distance (ft): **45.6**
Structural Grade: **0**
O&M Grade: **1**
Clock Start/From: **11**
Clock To: **1**
1st Value:
2nd Value:
Value Percent:
Continuous Index: **F01**
Within 8" of Joint: **YES**
Remarks: **wandering**

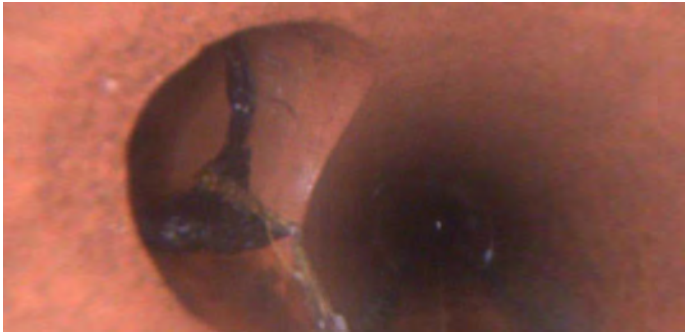
Code: **TFD**
Description: **Tap Factory Defective**

Distance (ft): **53.6**
Structural Grade: **0**
O&M Grade: **2**
Clock Start/From: **3**
Clock To:
1st Value: **4.000**
2nd Value:
Value Percent:
Continuous Index:
Within 8" of Joint:
Remarks: **RFL**

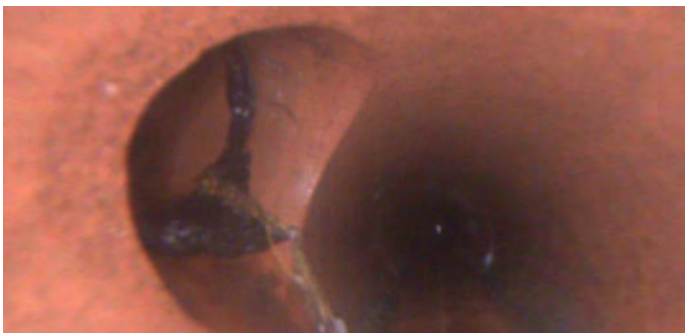
Code: **RFL**
Description: **Roots Fine Lateral**

Distance (ft): **53.6**
Structural Grade: **0**
O&M Grade: **1**
Clock Start/From: **3**
Clock To:
1st Value:
2nd Value:
Value Percent:
Continuous Index:
Within 8" of Joint: **NO**
Remarks:

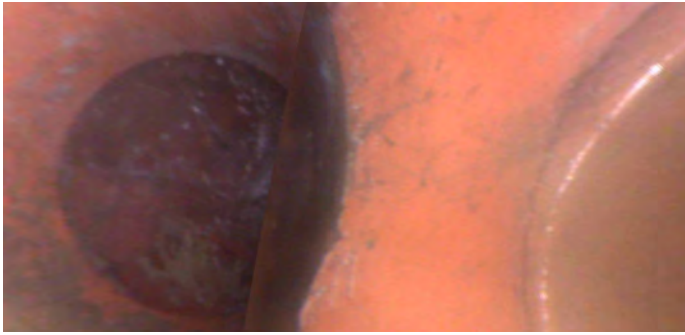
Code: **TFC**
Description: **Tap Factory Capped**

Distance (ft): **55.4**
Structural Grade: **0**
O&M Grade: **0**
Clock Start/From: **10**
Clock To:
1st Value: **4.000**
2nd Value:
Value Percent:
Continuous Index:
Within 8" of Joint: **YES**
Remarks:

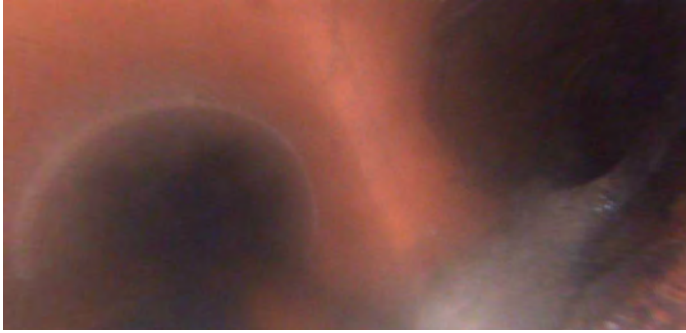
Code: **TF**
Description: **Tap Factory**

Distance (ft): **115.6**
Structural Grade: **0**
O&M Grade: **0**
Clock Start/From: **2**
Clock To:
1st Value: **4.000**
2nd Value:
Value Percent:
Continuous Index:
Within 8" of Joint: **YES**
Remarks:

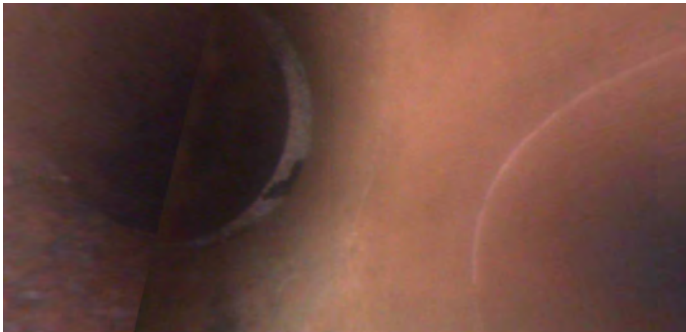
Code: **TF**
Description: **Tap Factory**

Distance (ft): **118.1**
Structural Grade: **0**
O&M Grade: **0**
Clock Start/From: **10**
Clock To:
1st Value: **4.000**
2nd Value:
Value Percent:
Continuous Index:
Within 8" of Joint: **YES**
Remarks:

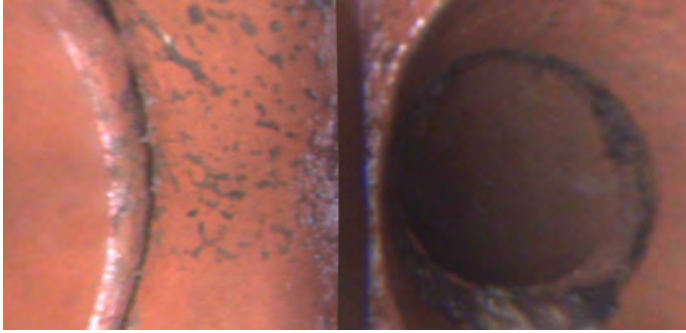
Code: **TF**
Description: **Tap Factory**

Distance (ft): **168.6**
Structural Grade: **0**
O&M Grade: **0**
Clock Start/From: **2**
Clock To:
1st Value: **4.000**
2nd Value:
Value Percent:
Continuous Index:
Within 8" of Joint: **YES**
Remarks:

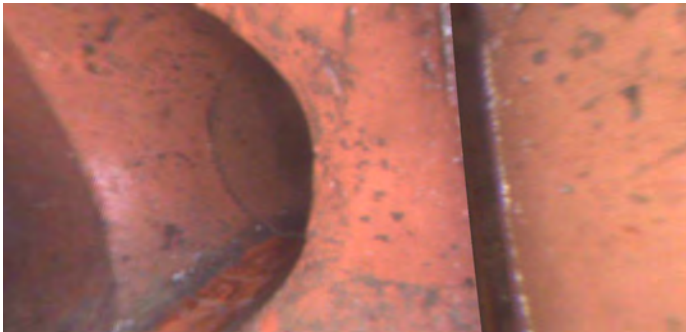
Code: **TF**
Description: **Tap Factory**

Distance (ft): **171.1**
Structural Grade: **0**
O&M Grade: **0**
Clock Start/From: **10**
Clock To:
1st Value: **4.000**
2nd Value:
Value Percent:
Continuous Index:
Within 8" of Joint: **YES**
Remarks:

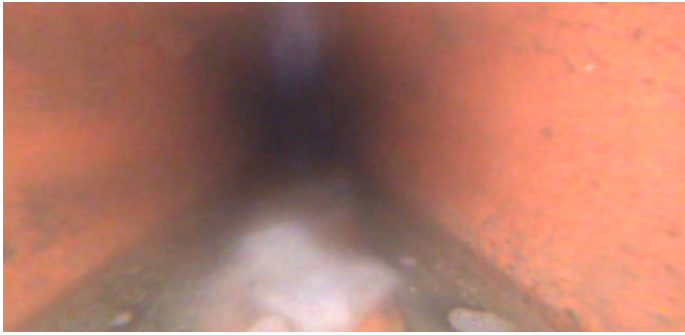
Code: **DSZ**
Description: **Deposits Settled Other**

Distance (ft): **173.5**
Structural Grade: **0**
O&M Grade: **2**
Clock Start/From: **6**
Clock To:
1st Value:
2nd Value:
Value Percent: **5.000**
Continuous Index:
Within 8" of Joint: **NO**
Remarks: **tissue**

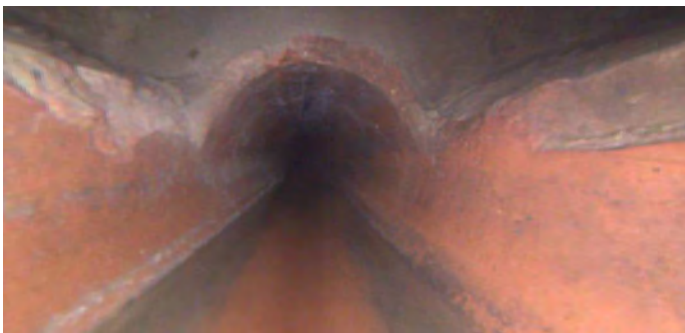
Code: **AMH**
Description: **Manhole**

Distance (ft): **231.6**
Structural Grade: **0**
O&M Grade: **0**
Clock Start/From:
Clock To:
1st Value:
2nd Value:
Value Percent:
Continuous Index:
Within 8" of Joint: **NO**
Remarks: **M-108-021**
