Profile/Photo Observation Report

Street:	FOXCROFT STREET	Flow Control:	Not Controlled
City:	Hobart, IN	Year Renewed:	
Location:	Light Highway	Tape/Media #:	
Purpose:	Routine Assessment	Dia/Height:	8"
Use:	Sanitary	Material:	VCP
Drain Area:	NA	Lining:	
Category:	NA		
Comment:	Flow direction wrong

Location Details:		Direction of Survey:	Downstream
US MH:	M-108-016	DS MH:	M-108-021
		Total Length Surveyed (ft):	231.6

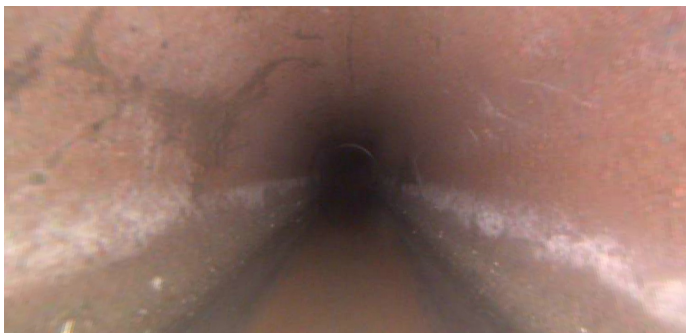
Code: **AMH**
Description: **Manhole**

Distance (ft): **.0**
Structural Grade: **0**
O&M Grade: **0**
Clock Start/From:
Clock To:
1st Value:
2nd Value:
Value Percent:
Continuous Index:
Within 8" of Joint: **NO**
Remarks: **M-108-016**

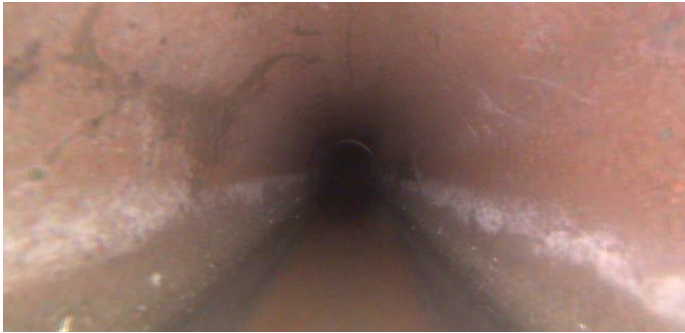
Code:	MWL
Description:	Water Level

Distance (ft):	.0
Structural Grade:	0
O&M Grade:	0
Clock Start/From:	
Clock To:	
1st Value:	
2nd Value:	
Value Percent:	5.000
Continuous Index:	
Within 8" of Joint:	NO
Remarks:

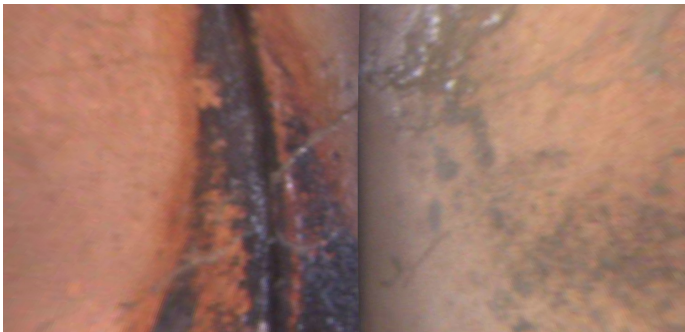
Code:	RFJ
Description:	Roots Fine Joint

Distance (ft):	4.9
Structural Grade:	0
O&M Grade:	1
Clock Start/From:	7
Clock To:	5
1st Value:	
2nd Value:	
Value Percent:	
Continuous Index:	
Within 8" of Joint:	YES
Remarks:

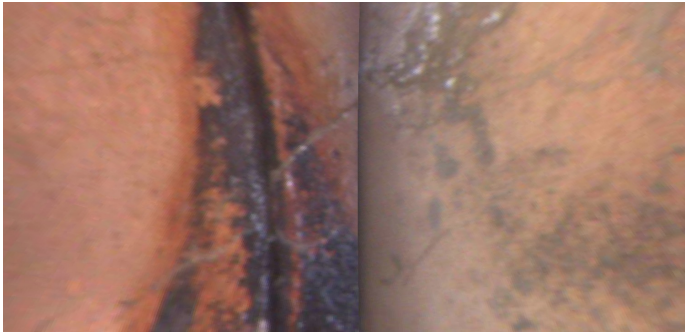
Code: **IS**
Description: **Infil Stain**

Distance (ft): **4.9**
Structural Grade: **0**
O&M Grade: **0**
Clock Start/From: **7**
Clock To: **5**
1st Value:
2nd Value:
Value Percent:
Continuous Index:
Within 8" of Joint: **YES**
Remarks:

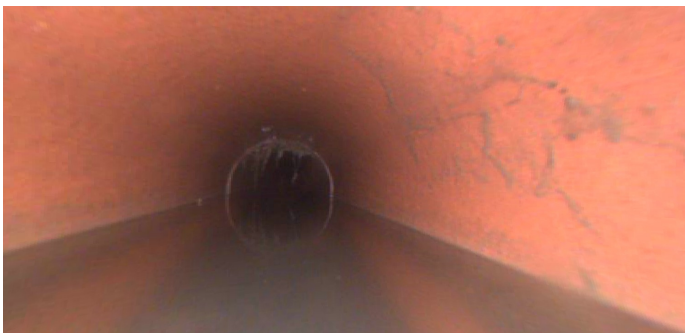
Code: **MWL**
Description: **Water Level**

Distance (ft): **28.4**
Structural Grade: **0**
O&M Grade: **0**
Clock Start/From:
Clock To:
1st Value:
2nd Value:
Value Percent: **25.000**
Continuous Index:
Within 8" of Joint: **NO**
Remarks:

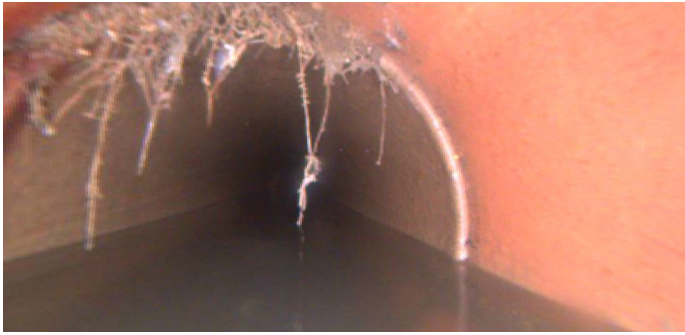
Code: **RFJ**
Description: **Roots Fine Joint**

Distance (ft): **30.0**
Structural Grade: **0**
O&M Grade: **1**
Clock Start/From: **11**
Clock To: **1**
1st Value:
2nd Value:
Value Percent:
Continuous Index: **S01**
Within 8" of Joint: **YES**
Remarks: **wandering**

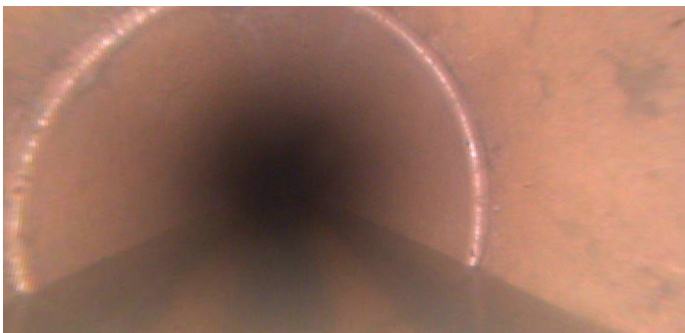
Code: **RFJ**
Description: **Roots Fine Joint**

Distance (ft): **45.6**
Structural Grade: **0**
O&M Grade: **1**
Clock Start/From: **11**
Clock To: **1**
1st Value:
2nd Value:
Value Percent:
Continuous Index: **F01**
Within 8" of Joint: **YES**
Remarks: **wandering**

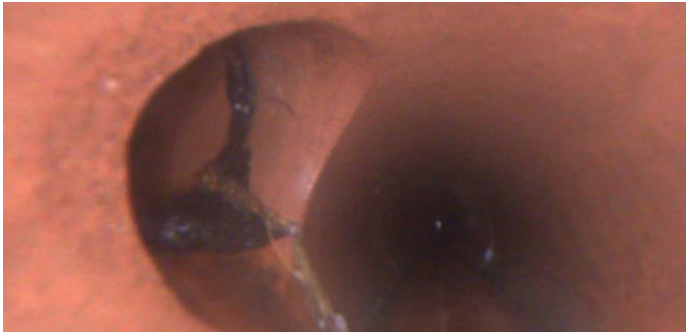
Code: **TFD**
Description: **Tap Factory Defective**

Distance (ft): **53.6**
Structural Grade: **0**
O&M Grade: **2**
Clock Start/From: **3**
Clock To:
1st Value: **4.000**
2nd Value:
Value Percent:
Continuous Index:
Within 8" of Joint:
Remarks: **RFL**

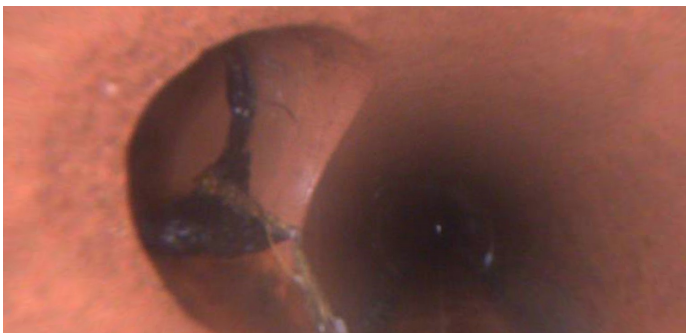
Code: **RFL**
Description: **Roots Fine Lateral**

Distance (ft): **53.6**
Structural Grade: **0**
O&M Grade: **1**
Clock Start/From: **3**
Clock To:
1st Value:
2nd Value:
Value Percent:
Continuous Index:
Within 8" of Joint: **NO**
Remarks:

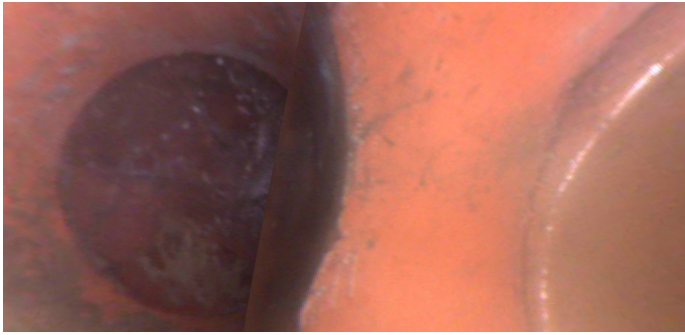
Code: **TFC**
Description: **Tap Factory Capped**

Distance (ft): **55.4**
Structural Grade: **0**
O&M Grade: **0**
Clock Start/From: **10**
Clock To:
1st Value: **4.000**
2nd Value:
Value Percent:
Continuous Index:
Within 8" of Joint: **YES**
Remarks:

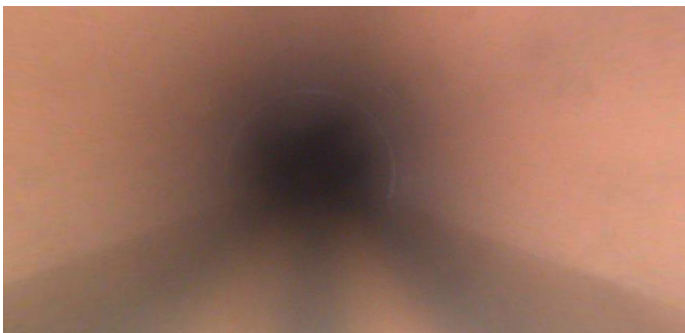
Code: **MGO**
Description: **General Observation**

Distance (ft): **81.1**
Structural Grade: **0**
O&M Grade: **0**
Clock Start/From:
Clock To:
1st Value:
2nd Value:
Value Percent:
Continuous Index:
Within 8" of Joint: **NO**
Remarks: **steam**

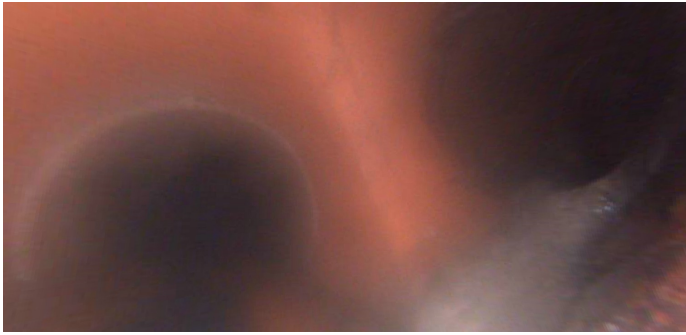
Code: **TF**
Description: **Tap Factory**

Distance (ft): **115.6**
Structural Grade: **0**
O&M Grade: **0**
Clock Start/From: **2**
Clock To:
1st Value: **4.000**
2nd Value:
Value Percent:
Continuous Index:
Within 8" of Joint: **YES**
Remarks:

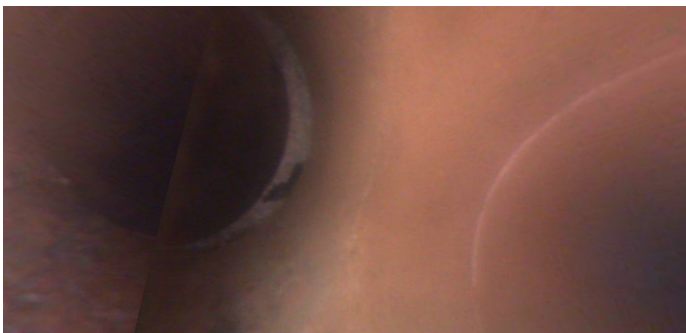
Code: **TF**
Description: **Tap Factory**

Distance (ft): **118.1**
Structural Grade: **0**
O&M Grade: **0**
Clock Start/From: **10**
Clock To:
1st Value: **4.000**
2nd Value:
Value Percent:
Continuous Index:
Within 8" of Joint: **YES**
Remarks:

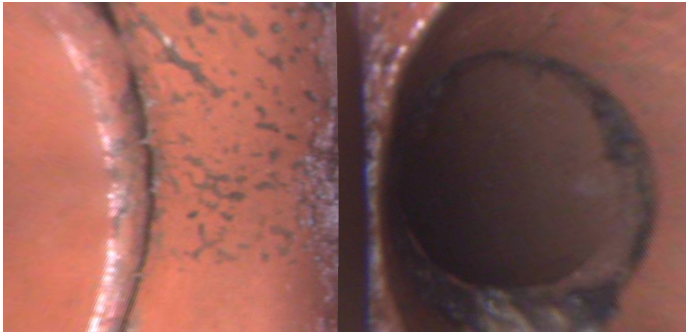
Code: **TF**
Description: **Tap Factory**

Distance (ft): **168.6**
Structural Grade: **0**
O&M Grade: **0**
Clock Start/From: **2**
Clock To:
1st Value: **4.000**
2nd Value:
Value Percent:
Continuous Index:
Within 8" of Joint: **YES**
Remarks:

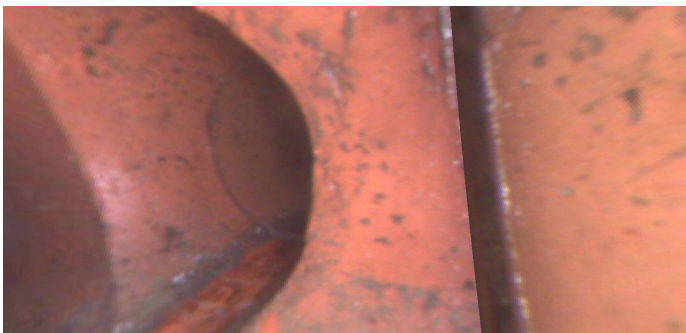
Code: **TF**
Description: **Tap Factory**

Distance (ft): **171.1**
Structural Grade: **0**
O&M Grade: **0**
Clock Start/From: **10**
Clock To:
1st Value: **4.000**
2nd Value:
Value Percent:
Continuous Index:
Within 8" of Joint: **YES**
Remarks:

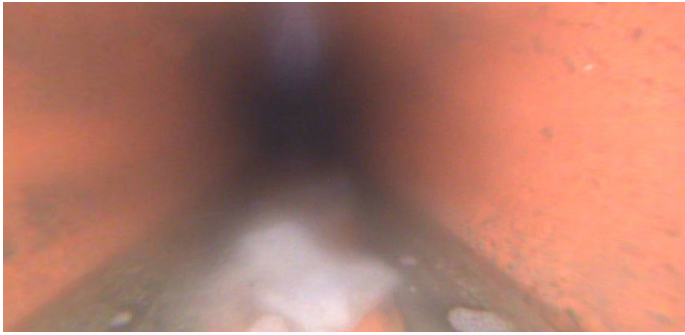
Code: **DSZ**
Description: **Deposits Settled Other**

Distance (ft): **173.5**
Structural Grade: **0**
O&M Grade: **2**
Clock Start/From: **6**
Clock To:
1st Value:
2nd Value:
Value Percent: **5.000**
Continuous Index:
Within 8" of Joint: **NO**
Remarks: **tissue**

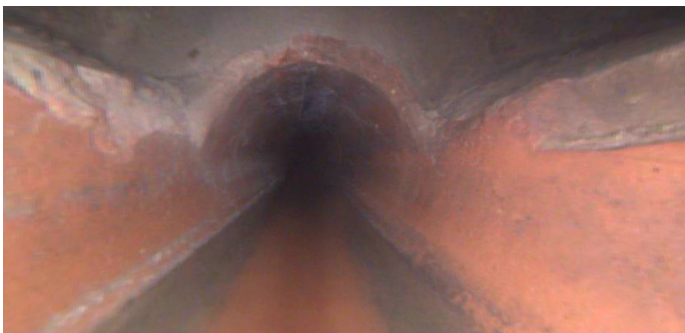
Code: **AMH**
Description: **Manhole**

Distance (ft): **231.6**
Structural Grade: **0**
O&M Grade: **0**
Clock Start/From:
Clock To:
1st Value:
2nd Value:
Value Percent:
Continuous Index:
Within 8" of Joint: **NO**
Remarks: **M-108-021**
