Profile/Photo Observation Report

Date:	03/24/2018	Weather:		Coding:	PACP 6.0
Pipe Length (ft):	135.9	Owner:	NA	Pre Clean:	No Pre-Cleaning
P.O.#:		Surveyor:	Justin Gonzales	PSR:	P-108-016-017
Customer:		Clean Date:	01/01/1900	Shape:	C

Street:	14TH LN & ALABMA ST	Flow Control:	Not Controlled
City:	Hobart, IN	Year Renewed:	
Location:	Light Highway	Tape/Media #:	
Purpose:	Routine Assessment	Dia/Height:	12"
Use:	Sanitary	Material:	VCP
Drain Area:	NA	Lining:	
Category:	NA		
Comment:	Flow direction wrong

Location Details:		Direction of Survey:	Upstream
US MH:	M-108-017	DS MH:	M-108-016
		Total Length Surveyed (ft):	136.0

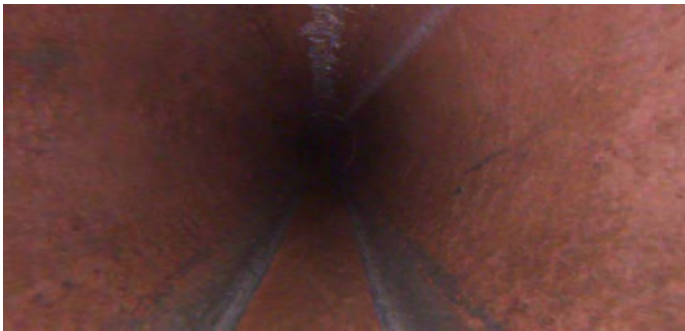
Code: **AMH**
Description: **Manhole**

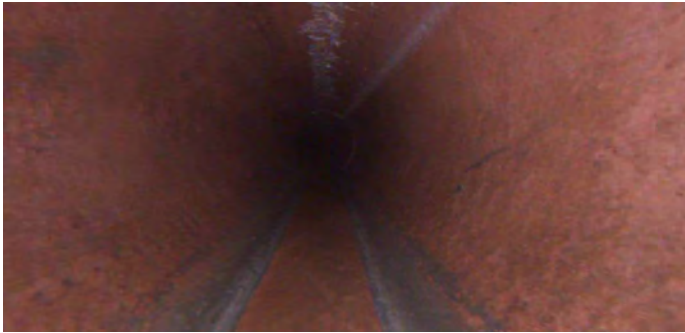
Code:	MWL
Description:	Water Level

Distance (ft):	.0
Structural Grade:	0
O&M Grade:	0
Clock Start/From:	
Clock To:	
1st Value:	
2nd Value:	
Value Percent:	5.000
Continuous Index:	
Within 8" of Joint:	NO
Remarks:

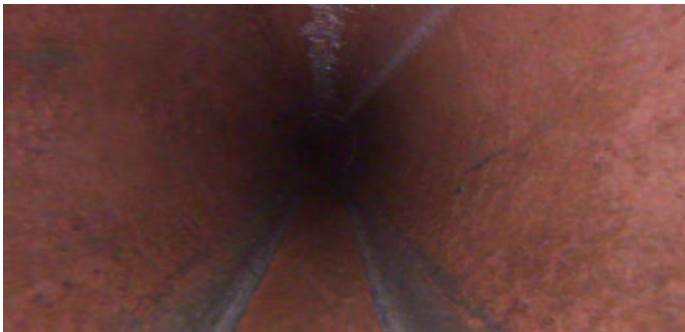
Code:	DAGS
Description:	Deposits Attached Grease

Distance (ft):	.0
Structural Grade:	0
O&M Grade:	2
Clock Start/From:	7
Clock To:	5
1st Value:	
2nd Value:	
Value Percent:	5.000
Continuous Index:	S01
Within 8" of Joint:	YES
Remarks:	WANDER

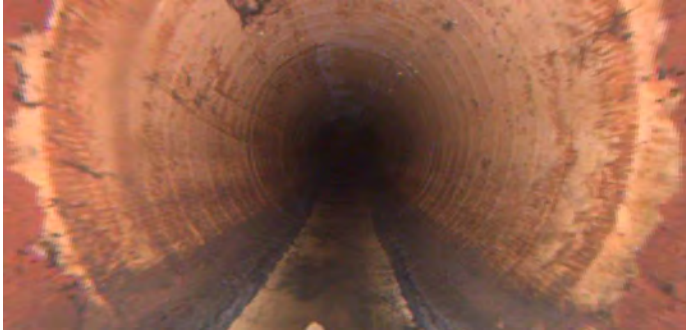
Code: **RPR**
Description: **Repair Point Pipe Replaced**

Distance (ft): **37.9**
Structural Grade: **0**
O&M Grade: **0**
Clock Start/From:
Clock To:
1st Value:
2nd Value:
Value Percent:
Continuous Index:
Within 8" of Joint: **NO**
Remarks: **CIP LINER**

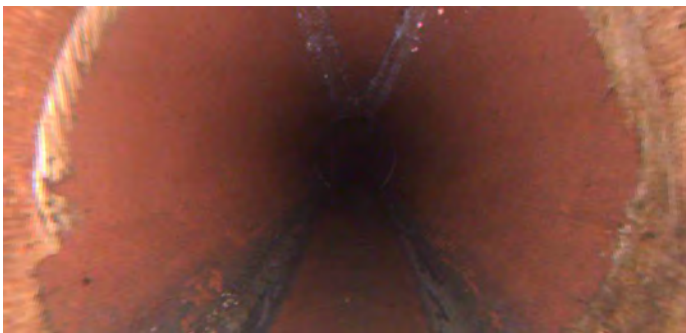
Code: **RPR**
Description: **Repair Point Pipe Replaced**

Distance (ft): **41.9**
Structural Grade: **0**
O&M Grade: **0**
Clock Start/From:
Clock To:
1st Value:
2nd Value:
Value Percent:
Continuous Index:
Within 8" of Joint: **NO**
Remarks: **CIP LINER END**

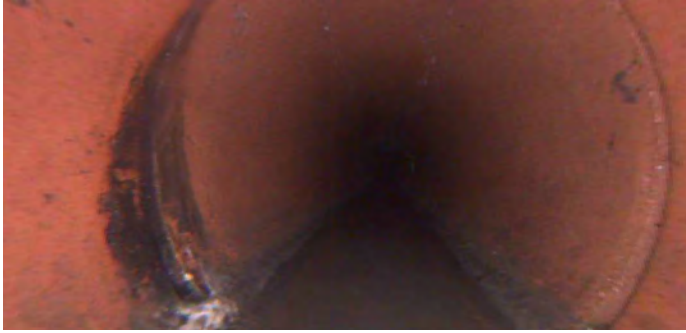
Code: **IS**
Description: **Infil Stain**

Distance (ft): **45.0**
Structural Grade: **0**
O&M Grade: **0**
Clock Start/From: **7**
Clock To: **11**
1st Value:
2nd Value:
Value Percent:
Continuous Index:
Within 8" of Joint: **YES**
Remarks:

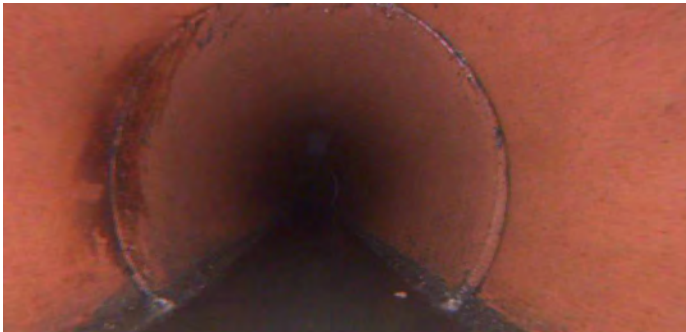
Code: **IS**
Description: **Infil Stain**

Distance (ft): **54.8**
Structural Grade: **0**
O&M Grade: **0**
Clock Start/From: **8**
Clock To: **11**
1st Value:
2nd Value:
Value Percent:
Continuous Index:
Within 8" of Joint: **YES**
Remarks:

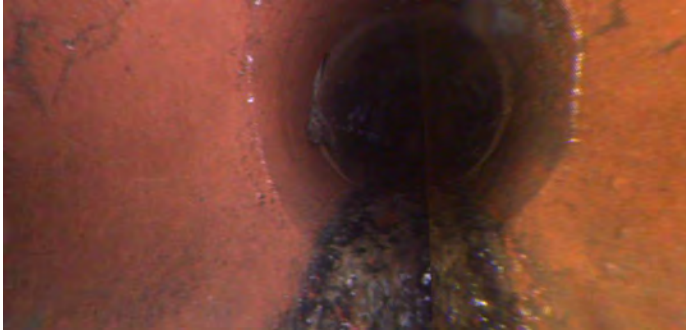
Code: **TF**
Description: **Tap Factory**

Distance (ft): **106.6**
Structural Grade: **0**
O&M Grade: **0**
Clock Start/From: **3**
Clock To:
1st Value: **4.000**
2nd Value:
Value Percent:
Continuous Index:
Within 8" of Joint:
Remarks:

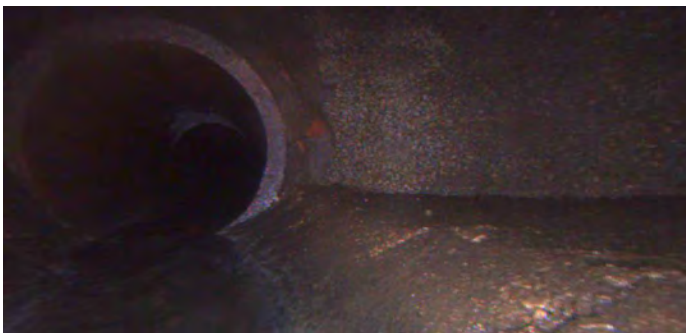
Code: **AMH**
Description: **Manhole**

Distance (ft): **136.0**
Structural Grade: **0**
O&M Grade: **0**
Clock Start/From:
Clock To:
1st Value:
2nd Value:
Value Percent:
Continuous Index:
Within 8" of Joint: **NO**
Remarks: **M-108-017**

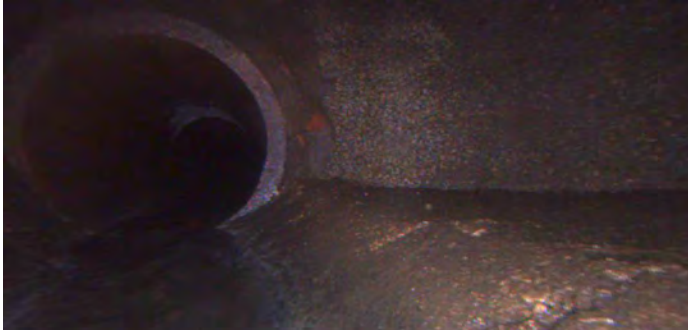
Code:	DAGS
Description:	Deposits Attached Grease
Distance (ft):	136.0
Structural Grade:	0
O&M Grade:	2
Clock Start/From:	7
Clock To:	5
1st Value:	
2nd Value:	
Value Percent:	5.000
Continuous Index:	F01
Within 8" of Joint:	YES
Remarks:	WANDER
