Profile/Photo Observation Report

| Street: | FOXCROFT STREET | Flow Control: | Not Controlled |
| Use: | Sanitary | Material: | VCP |
| US MH: | M-108-017 | DS MH: | M-108-016 |

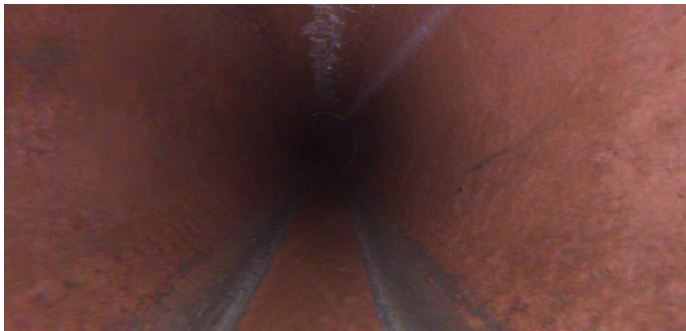
Code: **AMH**
Description: **Manhole**

Distance (ft): **.0**
Structural Grade: **0**
O&M Grade: **0**
Clock Start/From:
Clock To:
1st Value:
2nd Value:
Value Percent:
Continuous Index:
Within 8" of Joint: **NO**
Remarks: **M-108-016**

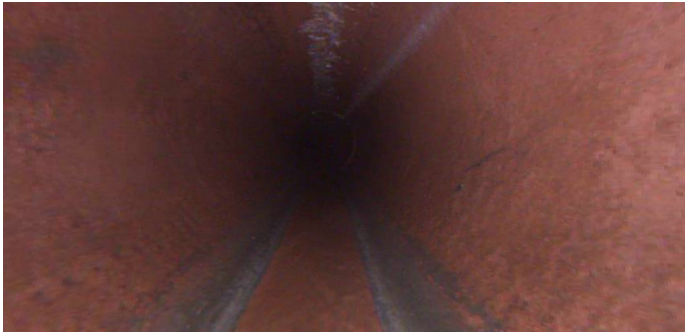
| Code: | MWL |
| Description: | Water Level |

| Value Percent: | 5.000 |

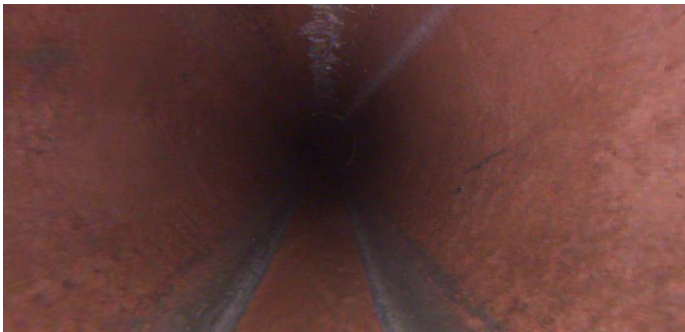
| Code: | DAGS |
| Description: | Deposits Attached Grease |

| O&M Grade: | 2 |
| Clock Start/From: | 7 |
| Clock To: | 5 |
| Remarks: | WANDER |

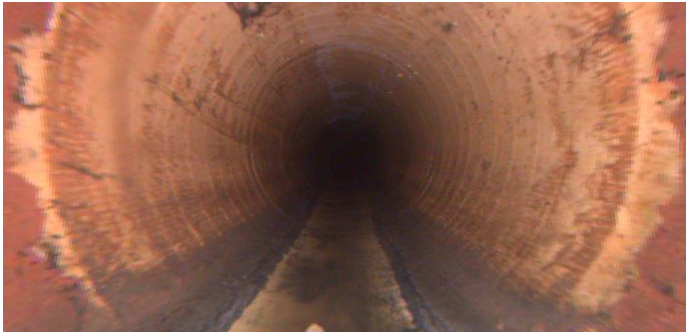
Code: **RPR**
Description: **Repair Point Pipe Replaced**

Distance (ft): **37.9**
Structural Grade: **0**
O&M Grade: **0**
Clock Start/From:
Clock To:
1st Value:
2nd Value:
Value Percent:
Continuous Index:
Within 8" of Joint: **NO**
Remarks: **CIP LINER**

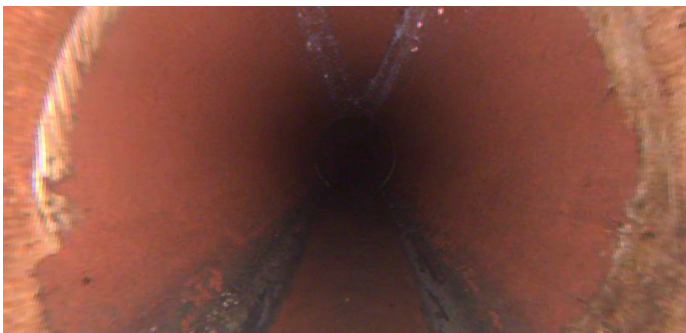
Code: **RPR**
Description: **Repair Point Pipe Replaced**

Distance (ft): **41.9**
Structural Grade: **0**
O&M Grade: **0**
Clock Start/From:
Clock To:
1st Value:
2nd Value:
Value Percent:
Continuous Index:
Within 8" of Joint: **NO**
Remarks: **CIP LINER END**

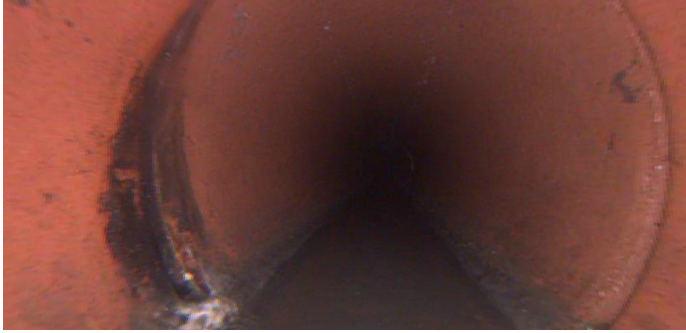
Code: **IS**
Description: **Infil Stain**

Distance (ft): **45.0**
Structural Grade: **0**
O&M Grade: **0**
Clock Start/From: **7**
Clock To: **11**
1st Value:
2nd Value:
Value Percent:
Continuous Index:
Within 8" of Joint: **YES**
Remarks:

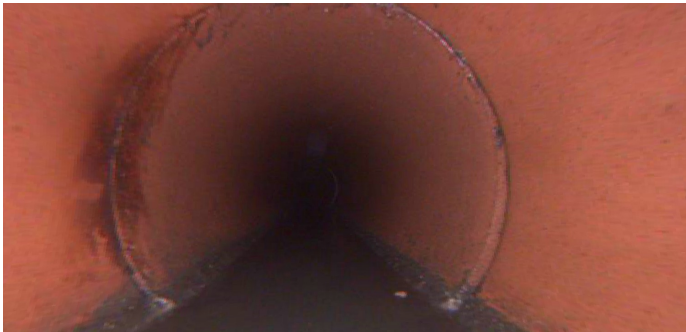
Code: **IS**
Description: **Infil Stain**

Distance (ft): **54.8**
Structural Grade: **0**
O&M Grade: **0**
Clock Start/From: **8**
Clock To: **11**
1st Value:
2nd Value:
Value Percent:
Continuous Index:
Within 8" of Joint: **YES**
Remarks:

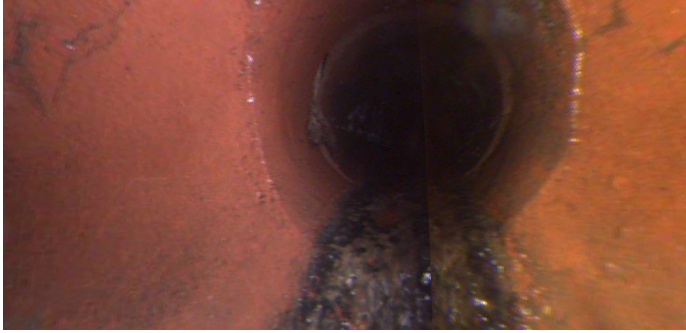
Code: **TF**
Description: **Tap Factory**

Distance (ft): **106.6**
Structural Grade: **0**
O&M Grade: **0**
Clock Start/From: **3**
Clock To:
1st Value: **4.000**
2nd Value:
Value Percent:
Continuous Index:
Within 8" of Joint:
Remarks:

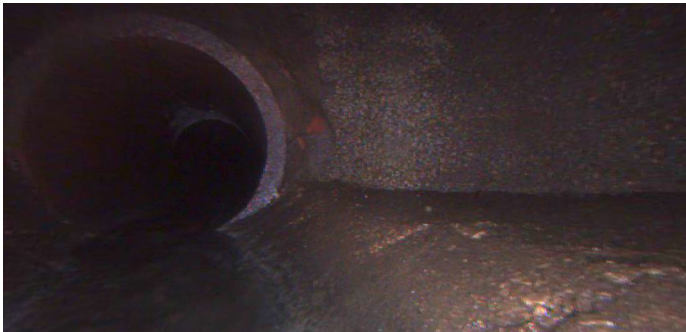
Code: **AMH**
Description: **Manhole**

Distance (ft): **136.0**
Structural Grade: **0**
O&M Grade: **0**
Clock Start/From:
Clock To:
1st Value:
2nd Value:
Value Percent:
Continuous Index:
Within 8" of Joint: **NO**
Remarks: **M-108-017**

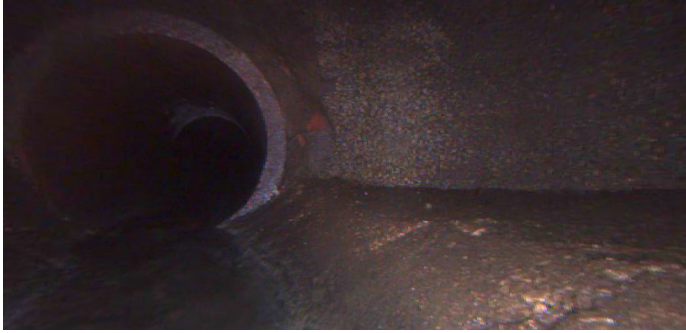
| Code: | DAGS |
| Description: | Deposits Attached Grease |
| O&M Grade: | 2 |
| Clock Start/From: | 7 |
| Clock To: | 5 |
| Remarks: | WANDER |
