Profile/Photo Observation Report

Date:	10/23/2021	Weather:		Coding:	PACP 6.0
Pipe Length (ft):		Owner:	Hobart, IN	Pre Clean:	Not Known
P.O.#:	992_1	Surveyor:	M. Pielacha	PSR:	P-108-022-021
Customer:	Hobart, IN	Clean Date:		Shape:	C

Location Details:		Direction of Survey:	Downstream
US MH:	M-108-21	DS MH:	M-108-22
		Total Length Surveyed (ft):	218.6

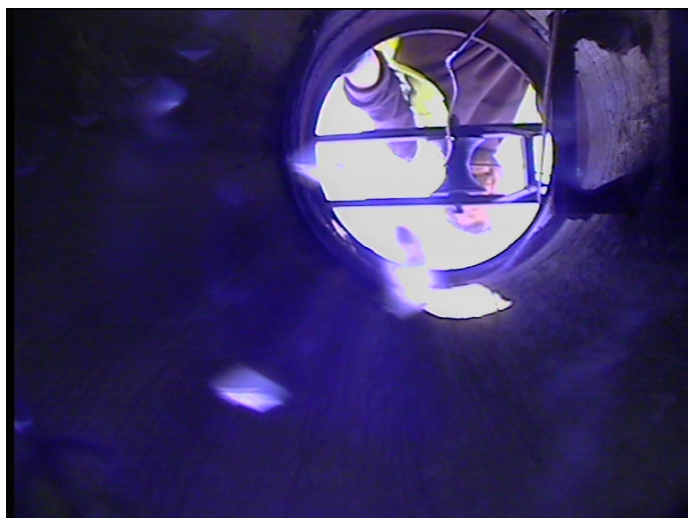
Code: **AMH**
 Description: **Manhole**

Distance (ft): **.0**
 Structural Grade: **0**
 O&M Grade: **0**
 Clock Start/From:
 Clock To:
 1st Value:
 2nd Value:
 Value Percent:
 Continuous Index:
 Within 8" of Joint: **NO**
 Remarks: **M-108-21**

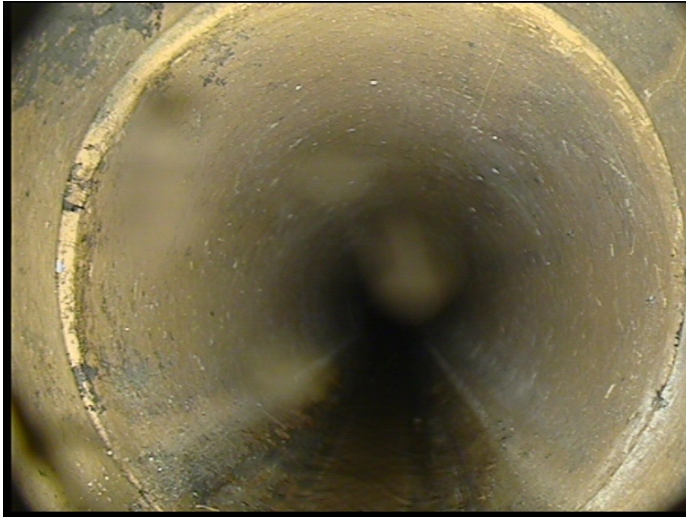
Code:	MWL
Description:	Water Level
Distance (ft):	.0
Structural Grade:	0
O&M Grade:	0
Clock Start/From:	
Clock To:	
1st Value:	
2nd Value:	
Value Percent:	5.000
Continuous Index:	
Within 8" of Joint:	NO
Remarks:

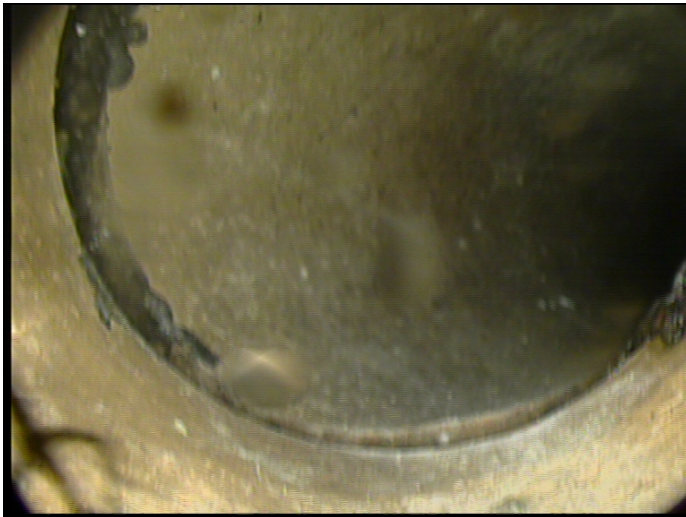
Code:	TF
Description:	Tap Factory
Distance (ft):	17.6
Structural Grade:	0
O&M Grade:	0
Clock Start/From:	2
Clock To:	
1st Value:	4.000
2nd Value:	
Value Percent:	
Continuous Index:	
Within 8" of Joint:	NO
Remarks:

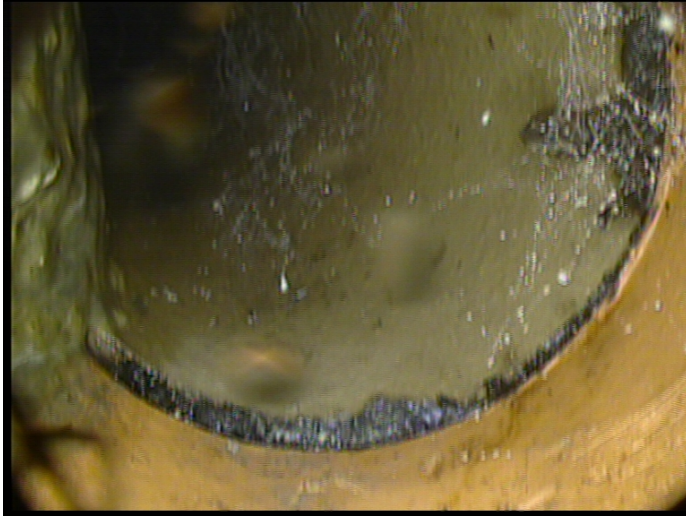
Code: **TF**
Description: **Tap Factory**

Distance (ft): **19.5**
Structural Grade: **0**
O&M Grade: **0**
Clock Start/From: **10**
Clock To:
1st Value: **4.000**
2nd Value:
Value Percent:
Continuous Index:
Within 8" of Joint: **NO**
Remarks:

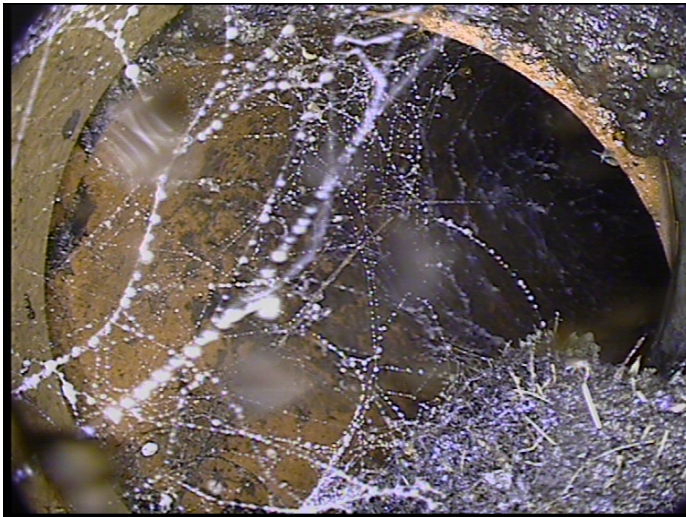
Code: **TFD**
Description: **Tap Factory Defective**

Distance (ft): **92.1**
Structural Grade: **0**
O&M Grade: **2**
Clock Start/From: **3**
Clock To:
1st Value: **4.000**
2nd Value:
Value Percent:
Continuous Index:
Within 8" of Joint: **NO**
Remarks: **roots**

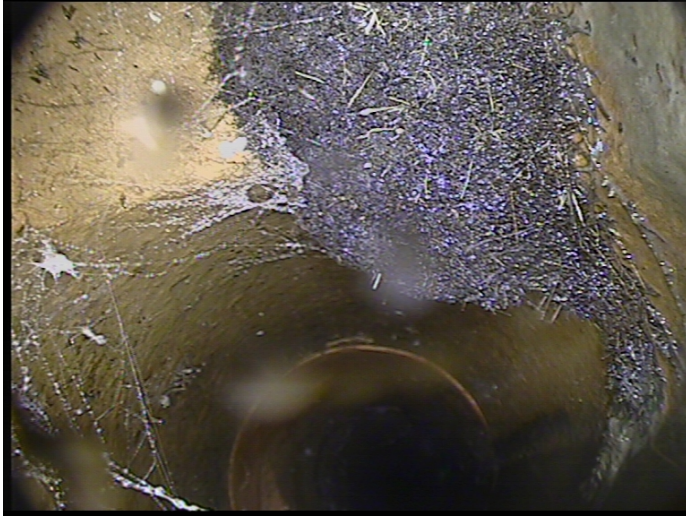
Code:	RML
Description:	Roots Medium Lateral
Distance (ft):	92.1
Structural Grade:	0
O&M Grade:	3
Clock Start/From:	2
Clock To:	4
1st Value:	
2nd Value:	
Value Percent:	5.000
Continuous Index:	
Within 8" of Joint:	NO
Remarks:

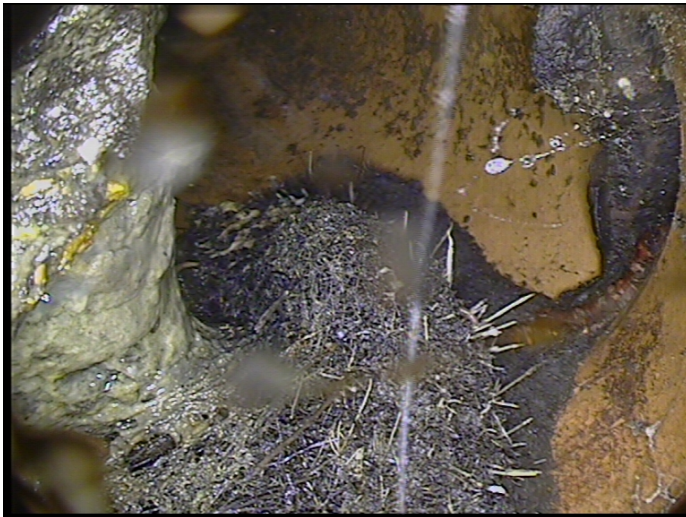
Code:	TFD
Description:	Tap Factory Defective
Distance (ft):	94.1
Structural Grade:	0
O&M Grade:	2
Clock Start/From:	9
Clock To:	
1st Value:	4.000
2nd Value:	
Value Percent:	
Continuous Index:	
Within 8" of Joint:	NO
Remarks:	roots

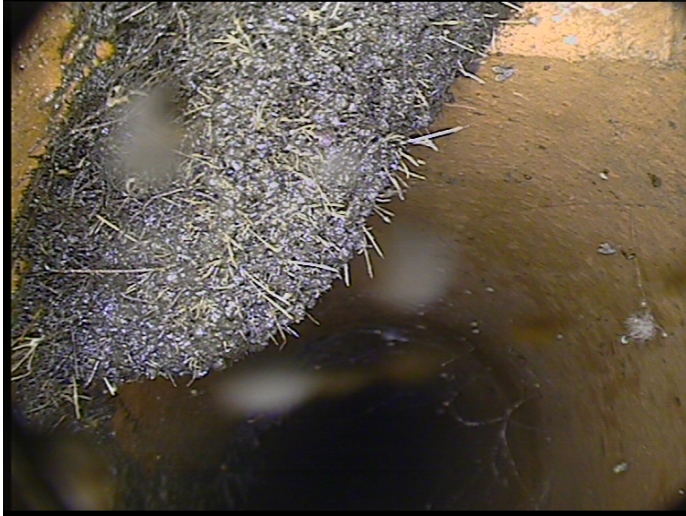
Code:	RML
Description:	Roots Medium Lateral
Distance (ft):	94.1
Structural Grade:	0
O&M Grade:	3
Clock Start/From:	7
Clock To:	9
1st Value:	
2nd Value:	
Value Percent:	10.000
Continuous Index:	
Within 8" of Joint:	NO
Remarks:

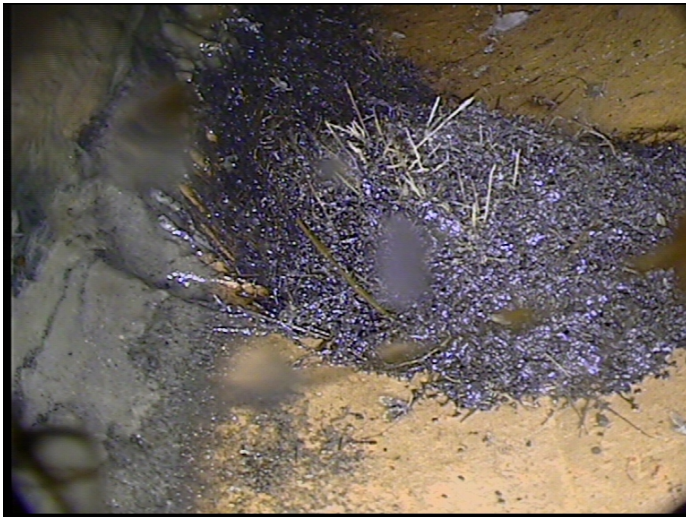
Code:	RMJ
Description:	Roots Medium Joint
Distance (ft):	96.9
Structural Grade:	0
O&M Grade:	3
Clock Start/From:	7
Clock To:	5
1st Value:	
2nd Value:	
Value Percent:	5.000
Continuous Index:	S01
Within 8" of Joint:	YES
Remarks:

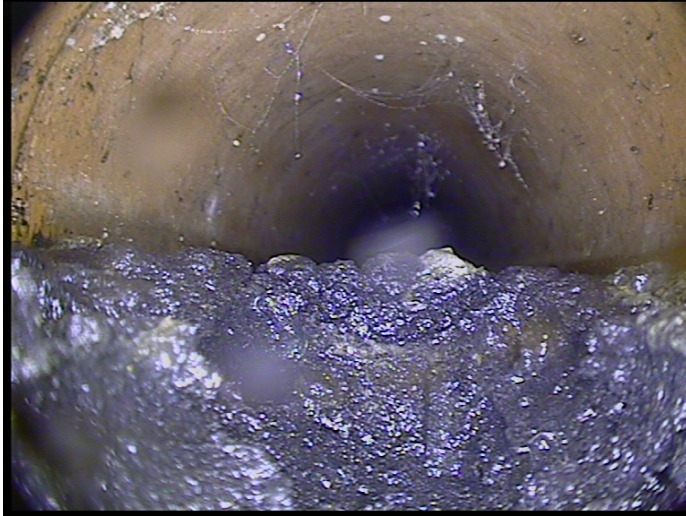
Code: **DSF**
Description: **Deposits Settled Fine**

Distance (ft): **118.7**
Structural Grade: **0**
O&M Grade: **3**
Clock Start/From: **4**
Clock To: **8**
1st Value:
2nd Value:
Value Percent: **20.000**
Continuous Index:
Within 8" of Joint: **YES**
Remarks:

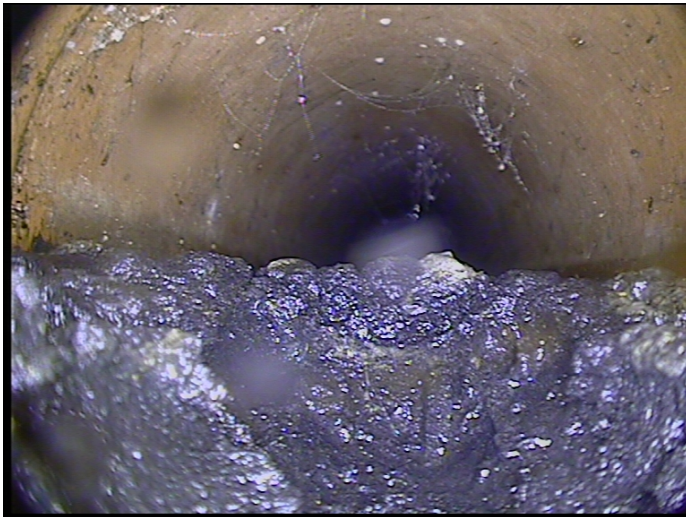
Code: **RMJ**
Description: **Roots Medium Joint**

Distance (ft): **118.8**
Structural Grade: **0**
O&M Grade: **3**
Clock Start/From: **7**
Clock To: **5**
1st Value:
2nd Value:
Value Percent: **5.000**
Continuous Index: **F01**
Within 8" of Joint: **YES**
Remarks:

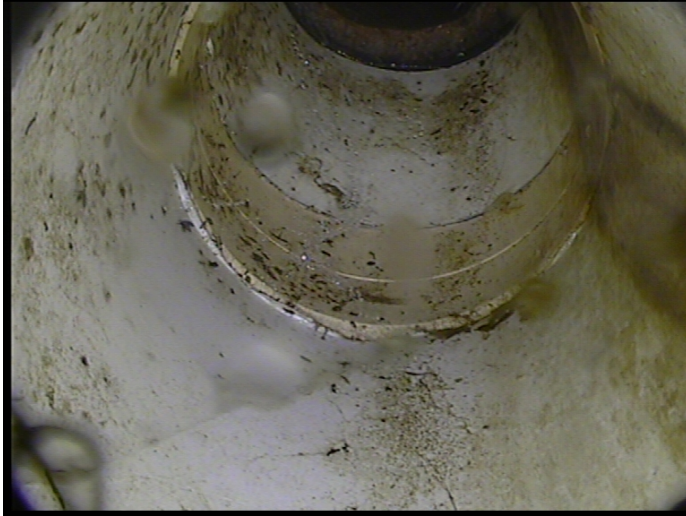
Code: **TF**
Description: **Tap Factory**

Distance (ft): **144.5**
Structural Grade: **0**
O&M Grade: **0**
Clock Start/From: **3**
Clock To:
1st Value: **4.000**
2nd Value:
Value Percent:
Continuous Index:
Within 8" of Joint: **NO**
Remarks:

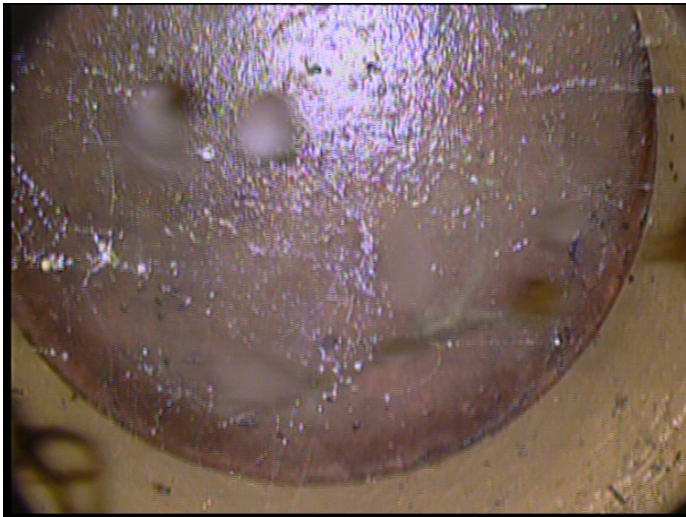
Code: **TFC**
Description: **Tap Factory Capped**

Distance (ft): **157.0**
Structural Grade: **0**
O&M Grade: **0**
Clock Start/From: **3**
Clock To:
1st Value: **4.000**
2nd Value:
Value Percent:
Continuous Index:
Within 8" of Joint: **NO**
Remarks:

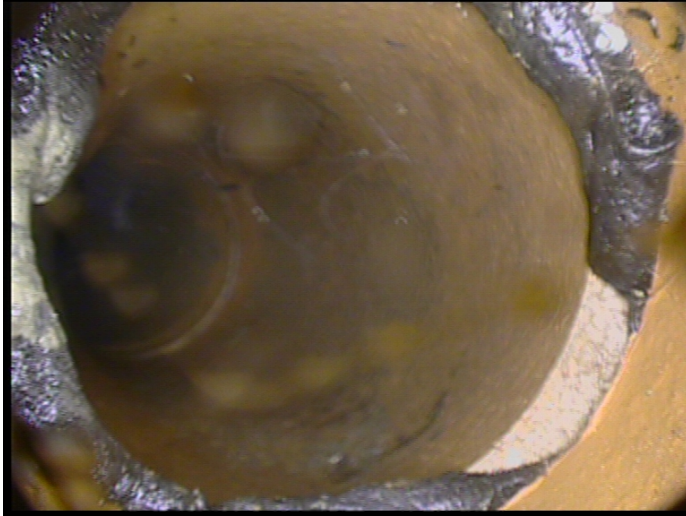
Code: **TF**
Description: **Tap Factory**

Distance (ft): **159.3**
Structural Grade: **0**
O&M Grade: **0**
Clock Start/From: **9**
Clock To:
1st Value: **4.000**
2nd Value:
Value Percent:
Continuous Index:
Within 8" of Joint: **NO**
Remarks:

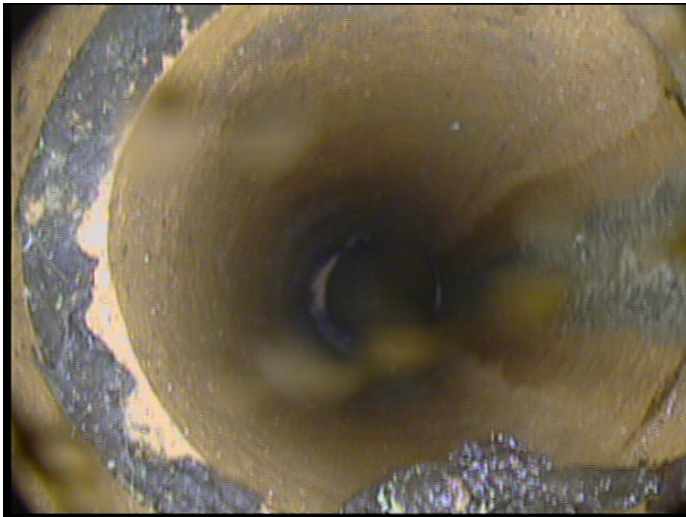
Code: **TF**
Description: **Tap Factory**

Distance (ft): **206.6**
Structural Grade: **0**
O&M Grade: **0**
Clock Start/From: **3**
Clock To:
1st Value: **4.000**
2nd Value:
Value Percent:
Continuous Index:
Within 8" of Joint: **NO**
Remarks:

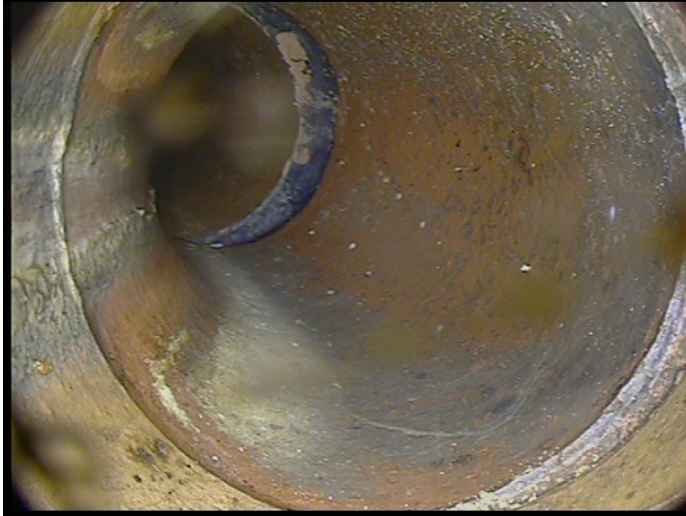
Code: **TF**
Description: **Tap Factory**

Distance (ft): **208.6**
Structural Grade: **0**
O&M Grade: **0**
Clock Start/From: **9**
Clock To:
1st Value: **4.000**
2nd Value:
Value Percent:
Continuous Index:
Within 8" of Joint: **NO**
Remarks:

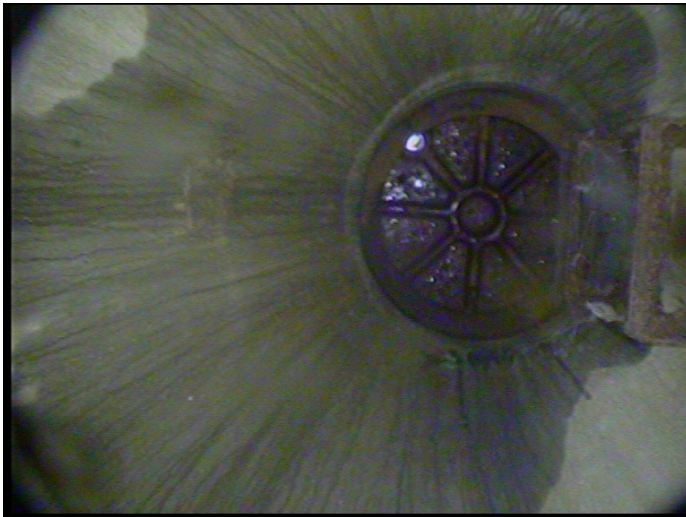
Code: **AMH**
Description: **Manhole**

Distance (ft): **218.6**
Structural Grade: **0**
O&M Grade: **0**
Clock Start/From:
Clock To:
1st Value:
2nd Value:
Value Percent:
Continuous Index:
Within 8" of Joint: **NO**
Remarks: **M-108-22**
