Profile/Photo Observation Report

Date:	10/23/2021	Weather:		Coding:	PACP 6.0
Pipe Length (ft):		Owner:	Hobart, IN	Pre Clean:	Not Known
P.O.#:	991_1	Surveyor:	M. Pielacha	PSR:	P-108-023-022
Customer:	Hobart, IN	Clean Date:		Shape:	C

Street:	Off Maple Street	Flow Control:	
City:	Hobart, IN	Year Renewed:	
Location:	Yard	Tape/Media #:	991
Purpose:	Routine Assessment	Dia/Height:	8"
Use:	Sanitary	Material:	VCP
Drain Area:		Lining:	
Category:	NA		
Comment:

Location Details:		Direction of Survey:	Upstream
US MH:	M-108-22	DS MH:	M-108-23
		Total Length Surveyed (ft):	216.6

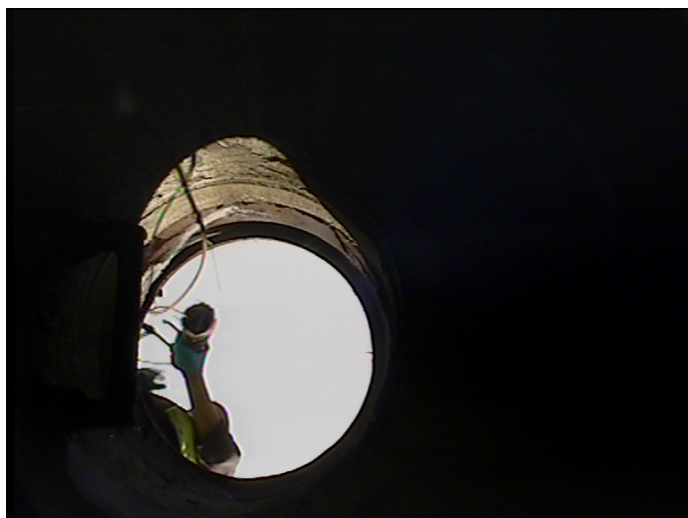
Code: **AMH**
Description: **Manhole**

Distance (ft): **.0**
Structural Grade: **0**
O&M Grade: **0**
Clock Start/From:
Clock To:
1st Value:
2nd Value:
Value Percent:
Continuous Index:
Within 8" of Joint: **NO**
Remarks: **M-108-23**

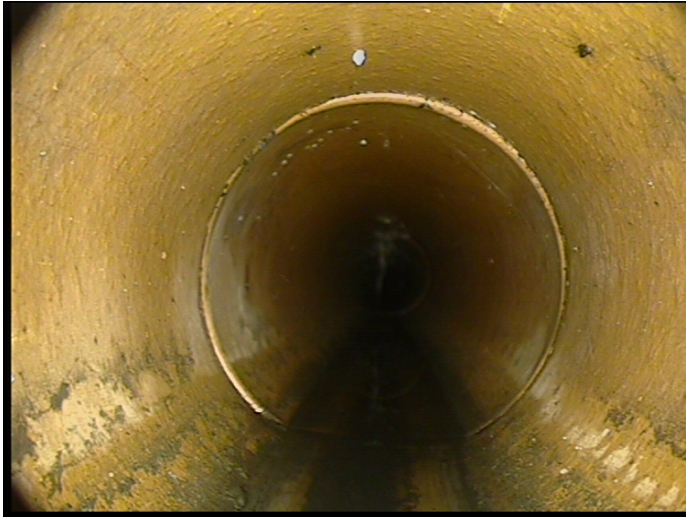
Code:	MWL
Description:	Water Level
Distance (ft):	.0
Structural Grade:	0
O&M Grade:	0
Clock Start/From:	
Clock To:	
1st Value:	
2nd Value:	
Value Percent:	5.000
Continuous Index:	
Within 8" of Joint:	NO
Remarks:

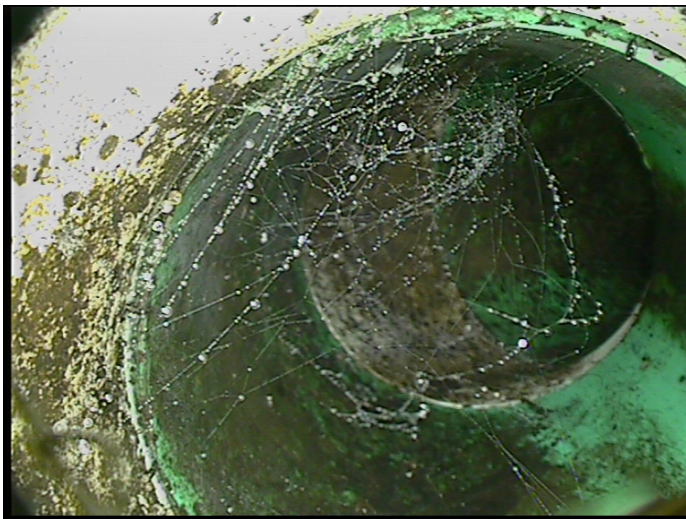
Code:	TF
Description:	Tap Factory
Distance (ft):	44.3
Structural Grade:	0
O&M Grade:	0
Clock Start/From:	2
Clock To:	
1st Value:	4.000
2nd Value:	
Value Percent:	
Continuous Index:	
Within 8" of Joint:	NO
Remarks:

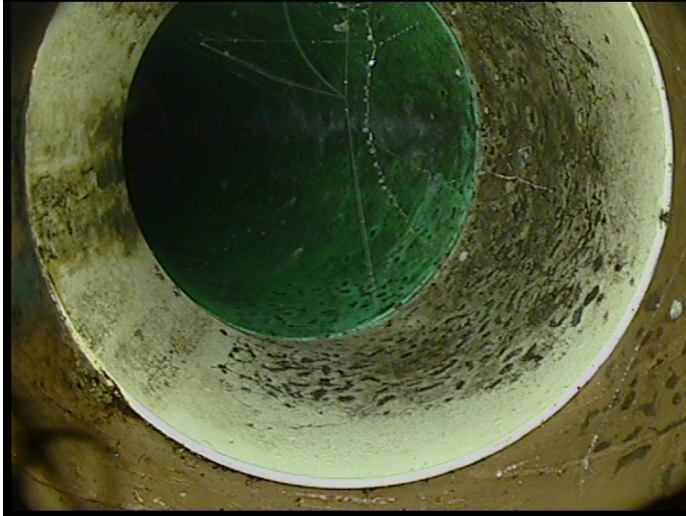
Code: **TF**
Description: **Tap Factory**

Distance (ft): **45.5**
Structural Grade: **0**
O&M Grade: **0**
Clock Start/From: **10**
Clock To:
1st Value: **4.000**
2nd Value:
Value Percent:
Continuous Index:
Within 8" of Joint: **NO**
Remarks:

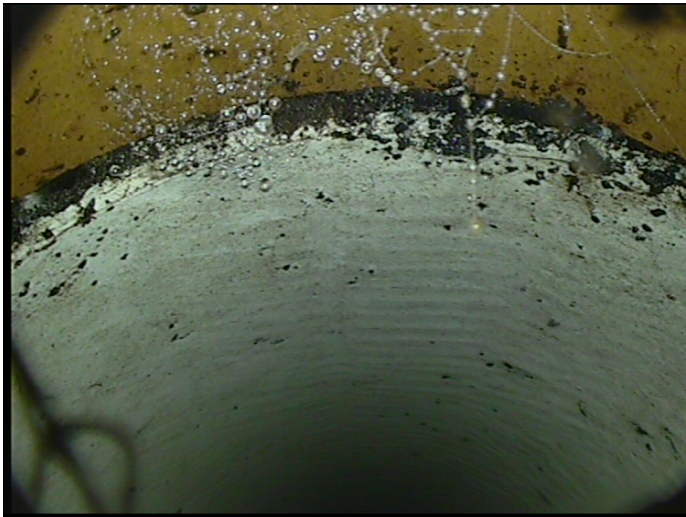
Code: **MMC**
Description: **Material Change**

Distance (ft): **49.9**
Structural Grade: **0**
O&M Grade: **0**
Clock Start/From:
Clock To:
1st Value:
2nd Value:
Value Percent:
Continuous Index:
Within 8" of Joint: **NO**
Remarks: **pvc**

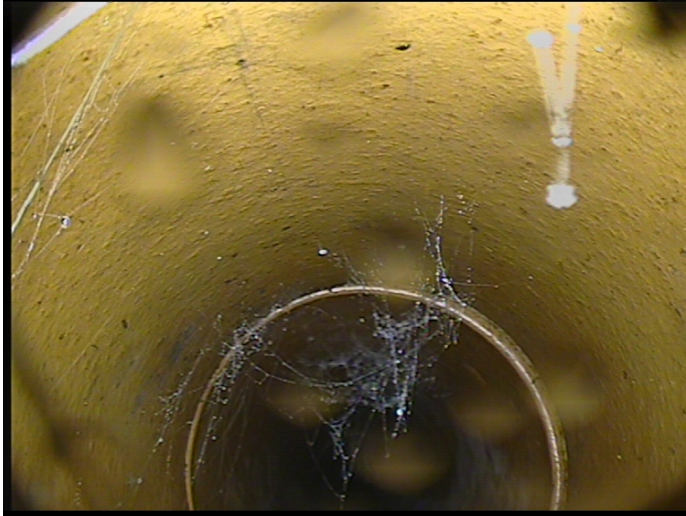
Code: **MMC**
Description: **Material Change**

Distance (ft): **55.2**
Structural Grade: **0**
O&M Grade: **0**
Clock Start/From:
Clock To:
1st Value:
2nd Value:
Value Percent:
Continuous Index:
Within 8" of Joint: **NO**
Remarks: **vcp**

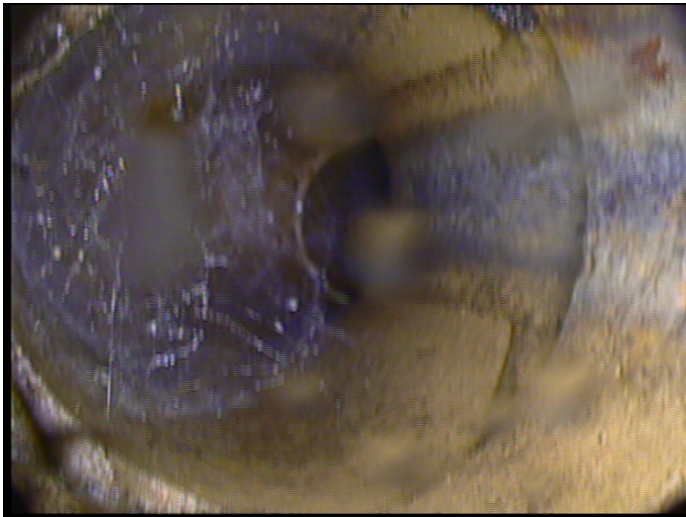
Code: **TF**
Description: **Tap Factory**

Distance (ft): **99.6**
Structural Grade: **0**
O&M Grade: **0**
Clock Start/From: **3**
Clock To:
1st Value: **4.000**
2nd Value:
Value Percent:
Continuous Index:
Within 8" of Joint: **NO**
Remarks:

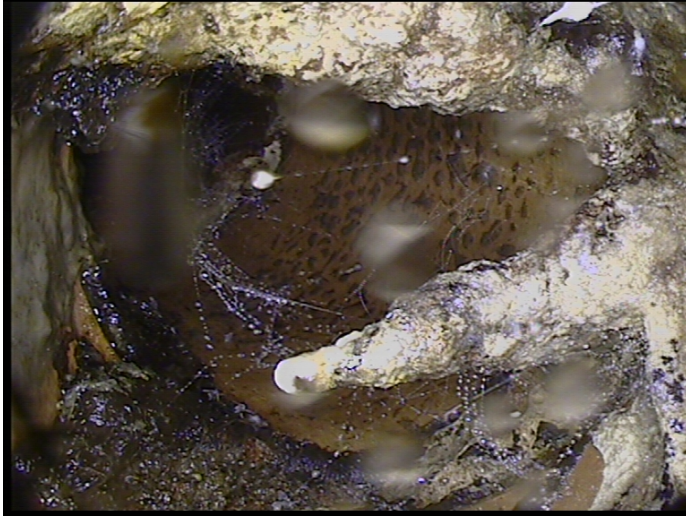
Code:	TF
Description:	Tap Factory
Distance (ft):	100.7
Structural Grade:	0
O&M Grade:	0
Clock Start/From:	9
Clock To:	
1st Value:	4.000
2nd Value:	
Value Percent:	
Continuous Index:	
Within 8" of Joint:	NO
Remarks:

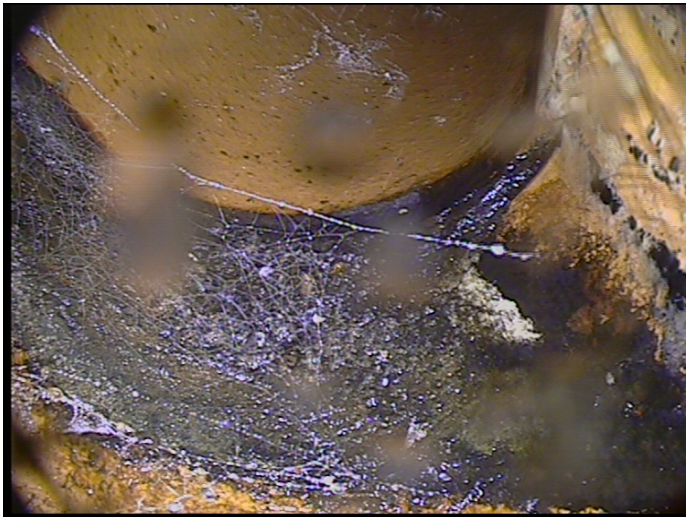
Code:	TFA
Description:	Tap Factory Active
Distance (ft):	159.7
Structural Grade:	0
O&M Grade:	0
Clock Start/From:	2
Clock To:	
1st Value:	4.000
2nd Value:	
Value Percent:	
Continuous Index:	
Within 8" of Joint:	NO
Remarks:

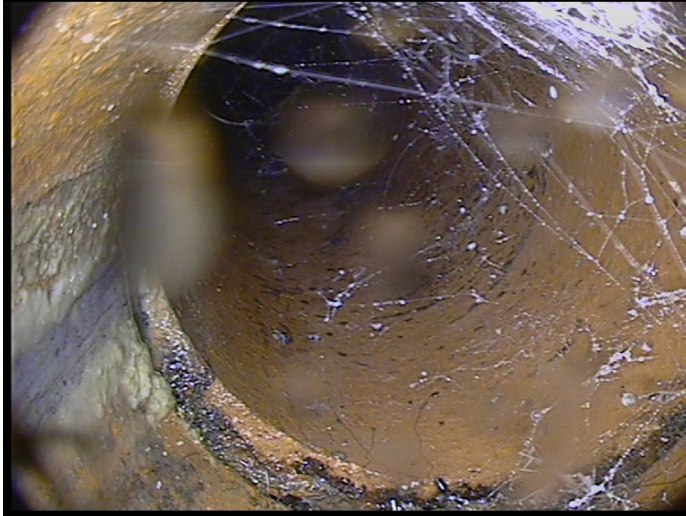
Code: **TF**
Description: **Tap Factory**

Distance (ft): **163.3**
Structural Grade: **0**
O&M Grade: **0**
Clock Start/From: **9**
Clock To:
1st Value: **4.000**
2nd Value:
Value Percent:
Continuous Index:
Within 8" of Joint: **NO**
Remarks:

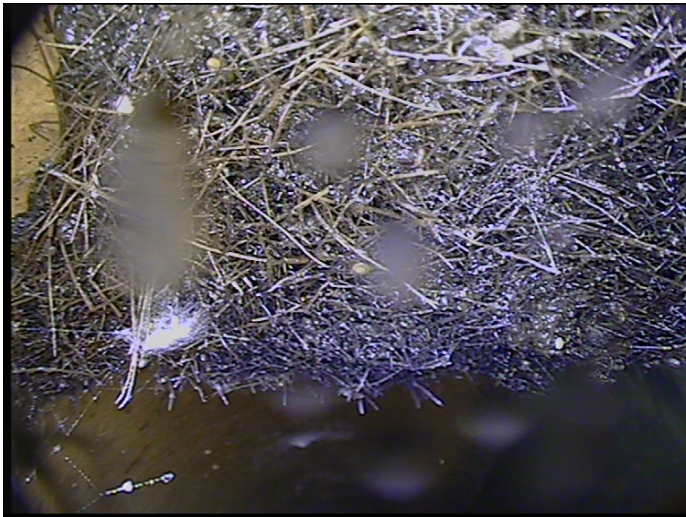
Code: **RMJ**
Description: **Roots Medium Joint**

Distance (ft): **184.6**
Structural Grade: **0**
O&M Grade: **3**
Clock Start/From: **7**
Clock To: **5**
1st Value:
2nd Value:
Value Percent: **15.000**
Continuous Index: **S01**
Within 8" of Joint: **YES**
Remarks:

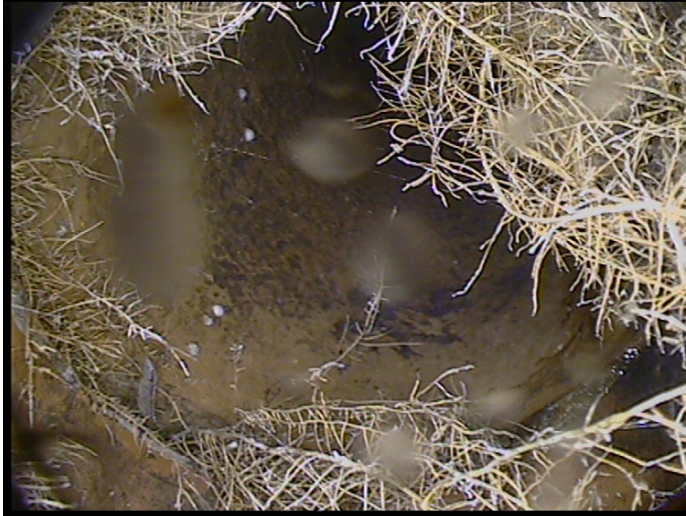
Code: **TFD**
Description: **Tap Factory Defective**

Distance (ft): **213.1**
Structural Grade: **0**
O&M Grade: **2**
Clock Start/From: **3**
Clock To:
1st Value: **4.000**
2nd Value:
Value Percent:
Continuous Index:
Within 8" of Joint: **NO**
Remarks: **Defective**

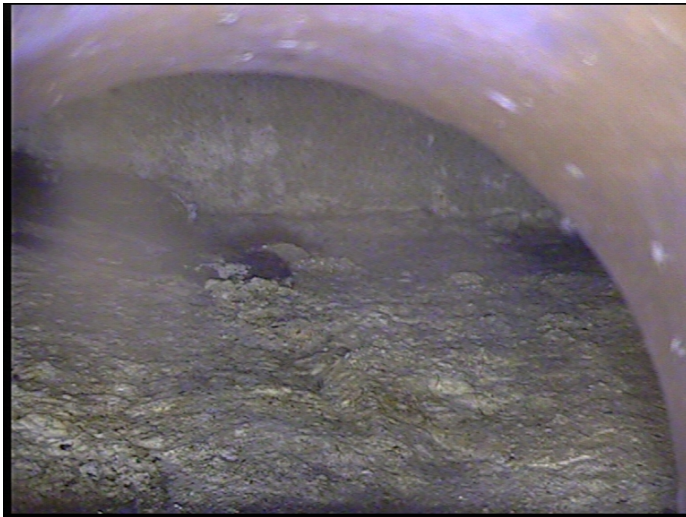
Code: **AMH**
Description: **Manhole**

Distance (ft): **216.5**
Structural Grade: **0**
O&M Grade: **0**
Clock Start/From:
Clock To:
1st Value:
2nd Value:
Value Percent:
Continuous Index:
Within 8" of Joint: **NO**
Remarks: **M-108-22**

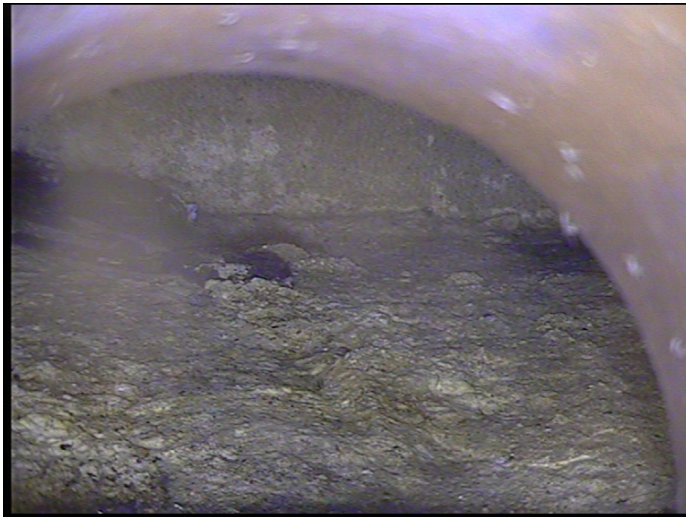
Code:	RMJ
Description:	Roots Medium Joint
Distance (ft):	216.5
Structural Grade:	0
O&M Grade:	3
Clock Start/From:	7
Clock To:	5
1st Value:	
2nd Value:	
Value Percent:	15.000
Continuous Index:	F01
Within 8" of Joint:	YES
Remarks:
